**TRANSPORTATION  
AND OTHER  
DAMAGE**

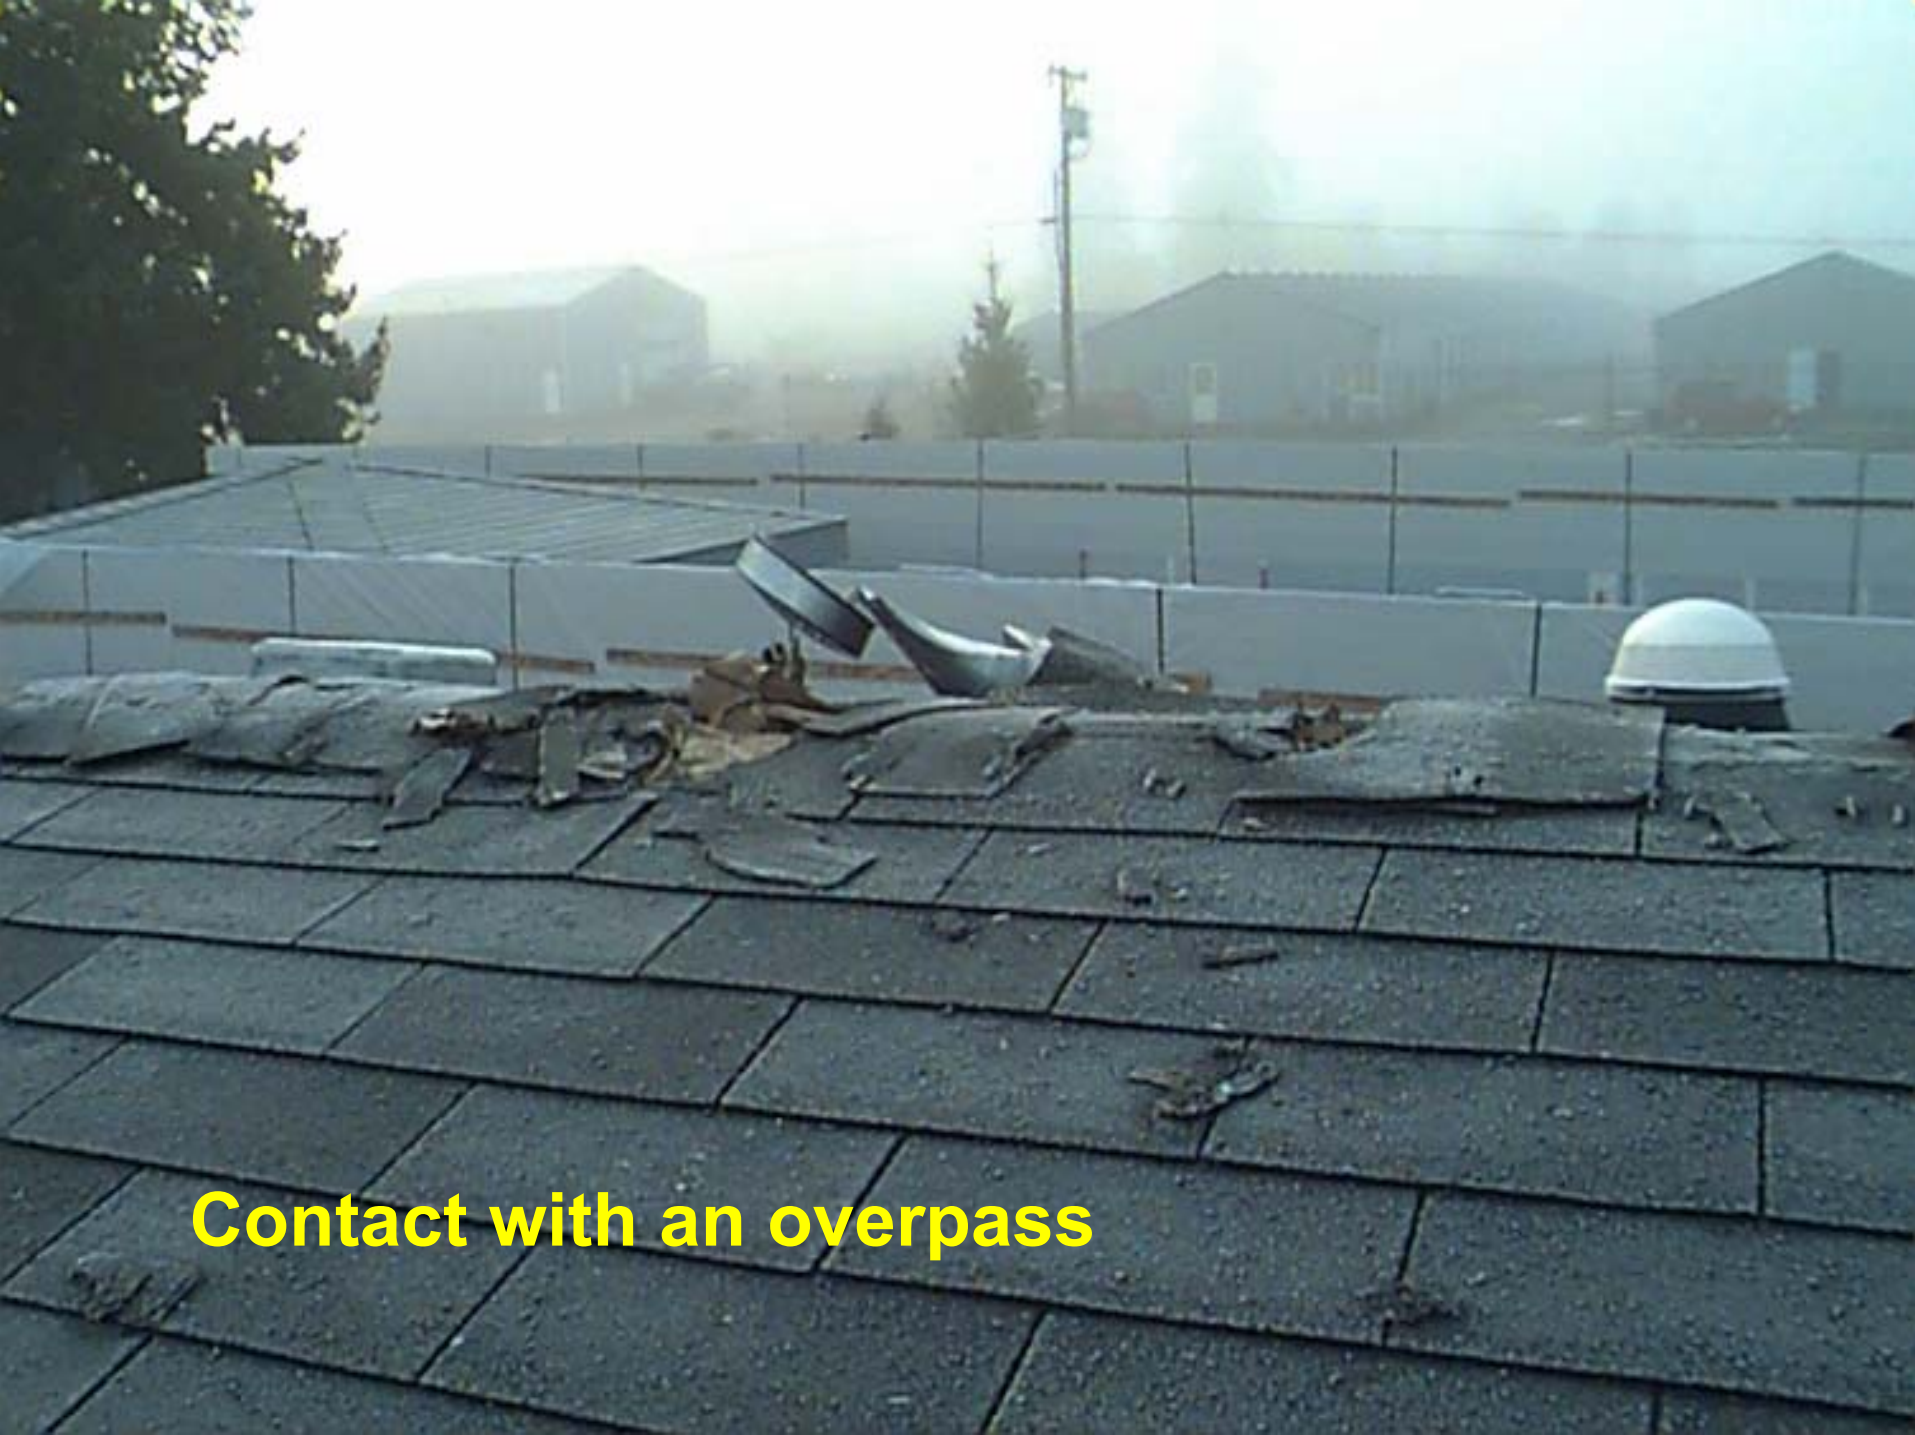
**Contact with an overpass**

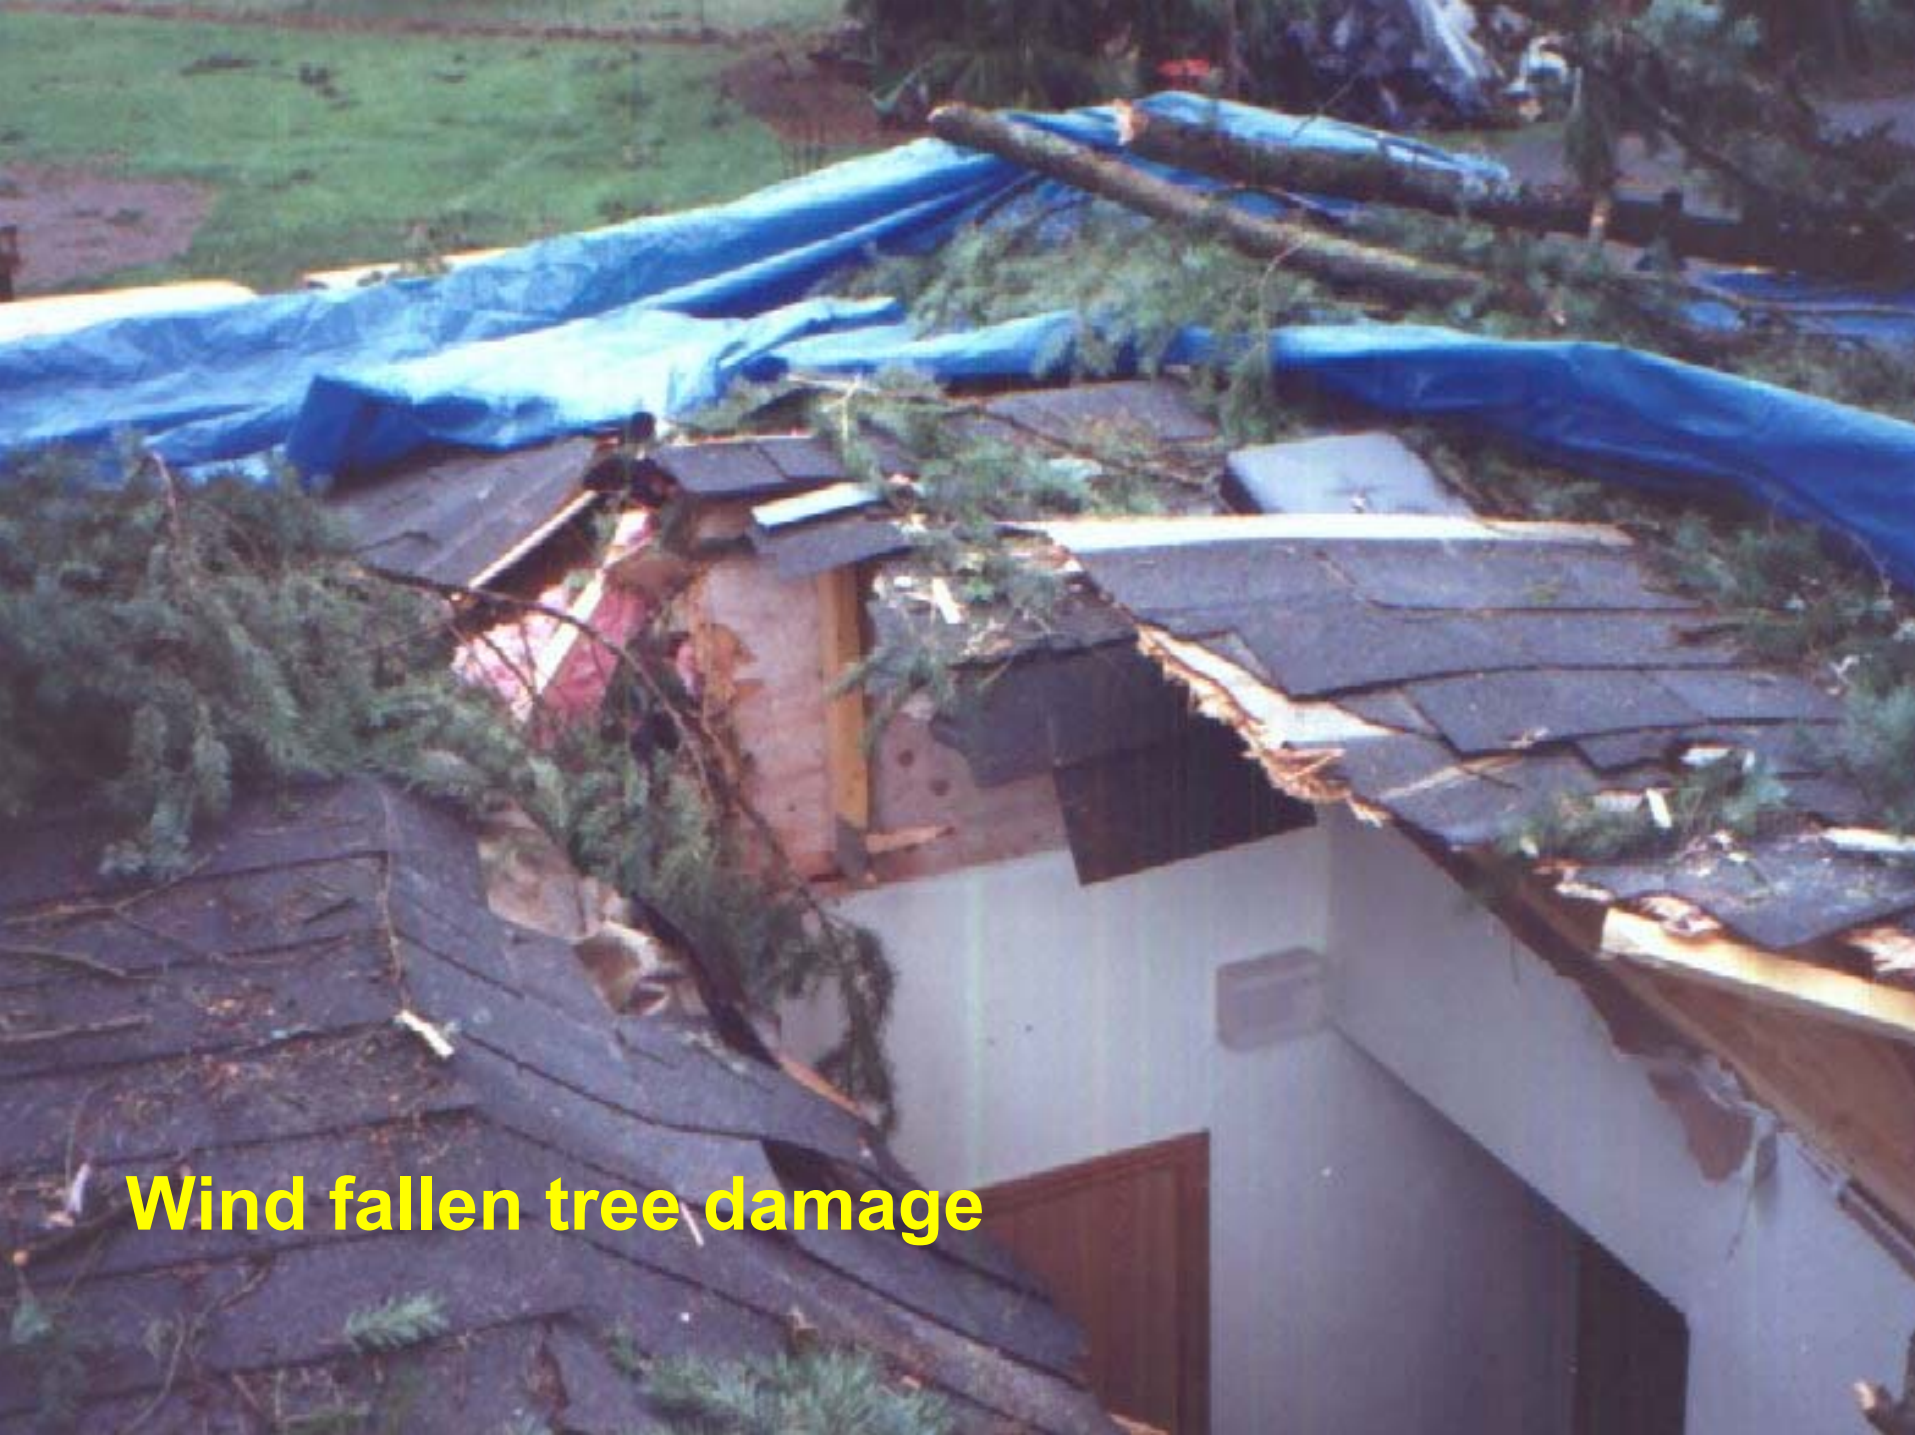
**Wind fallen tree damage**

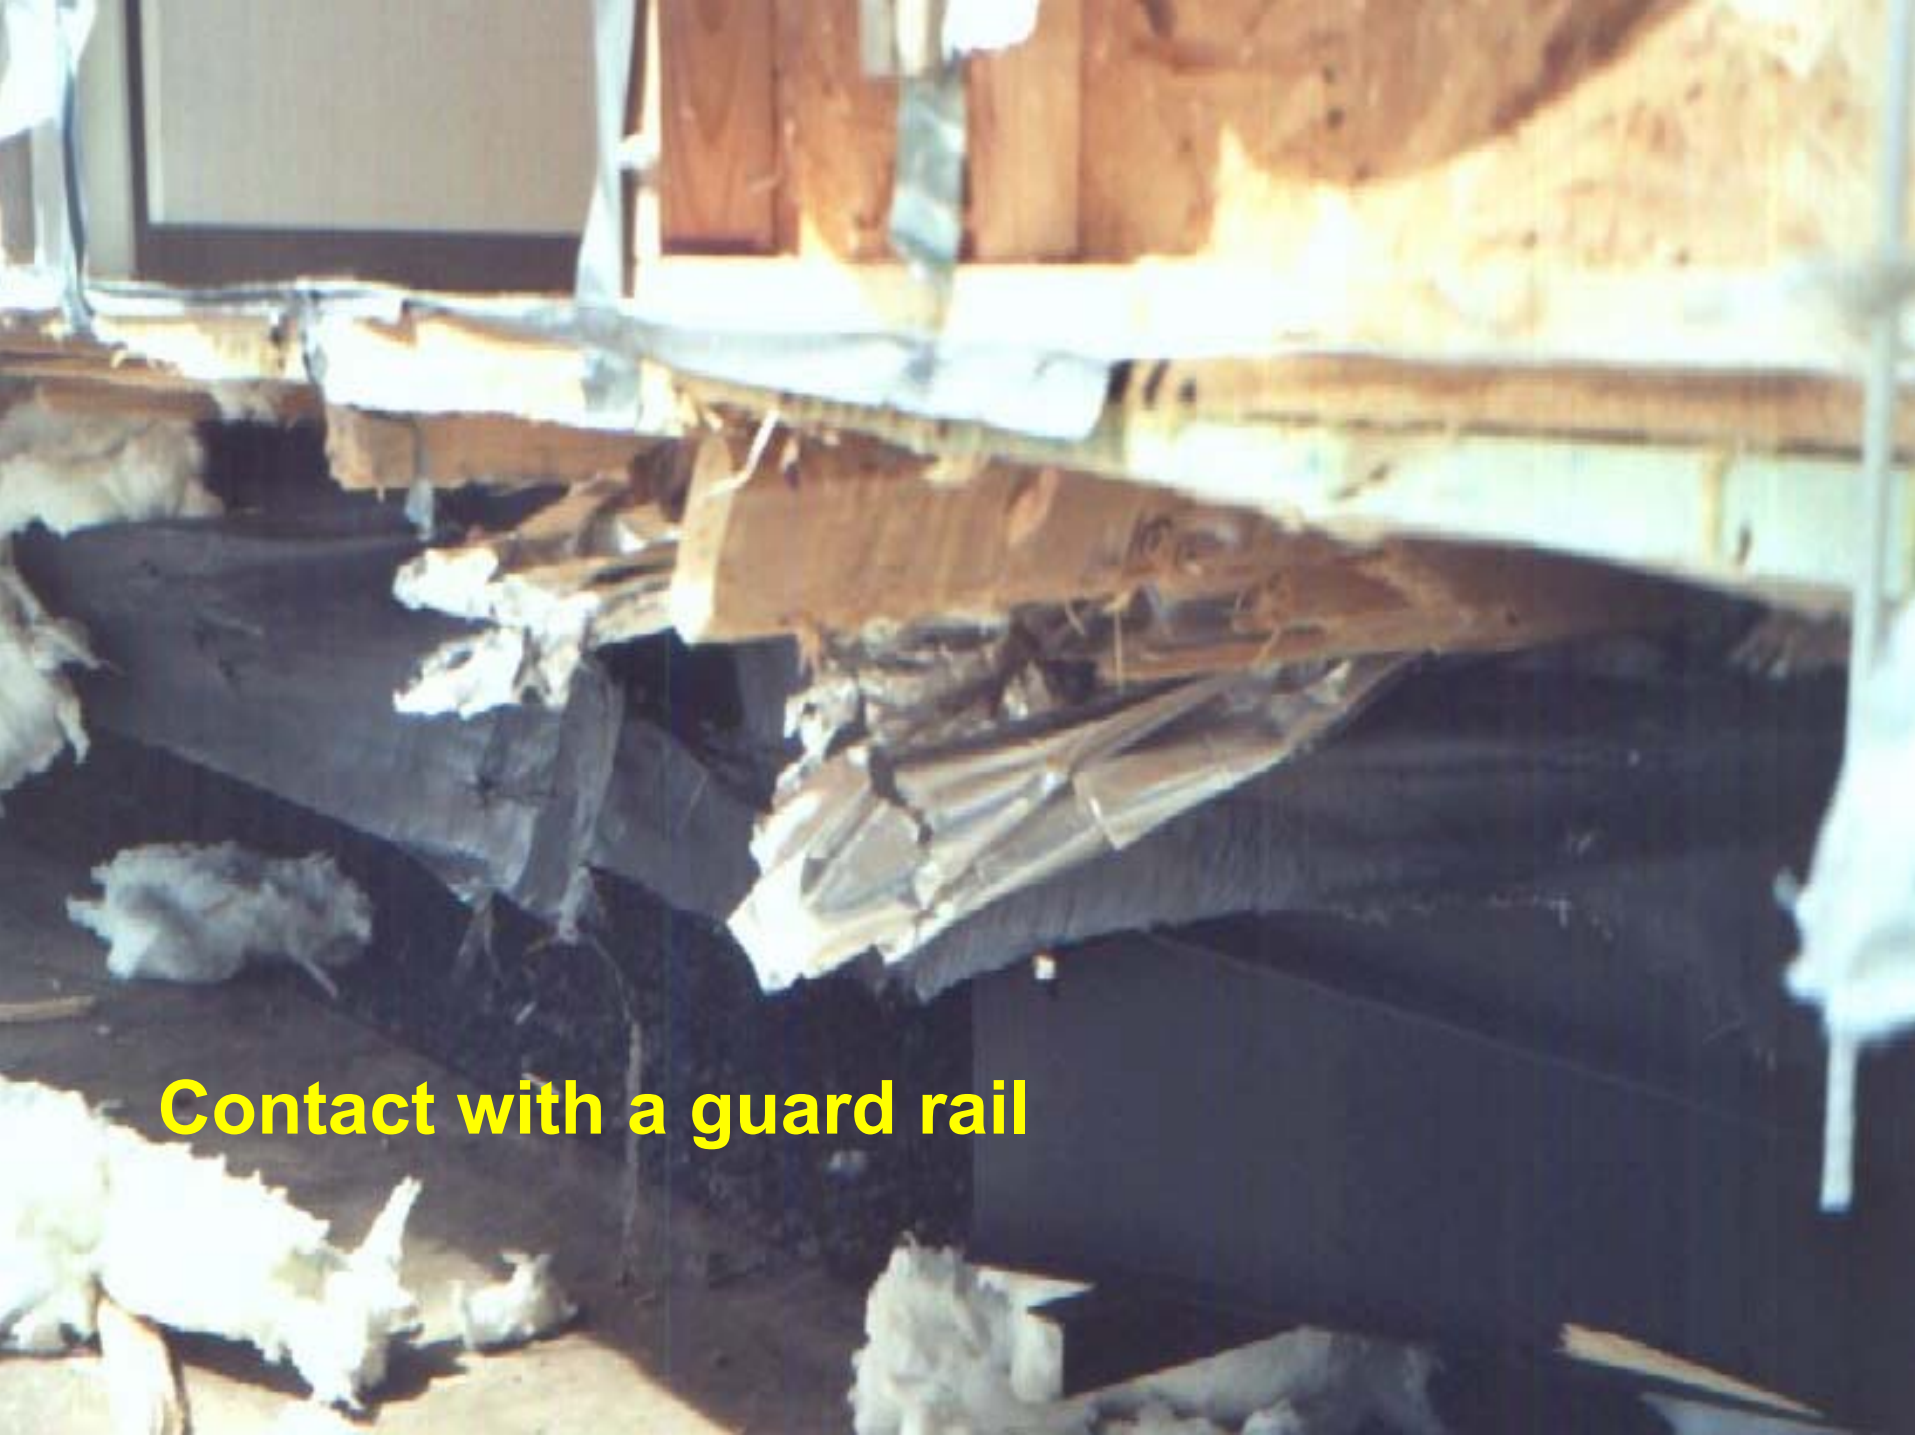
**Contact with a guard rail**

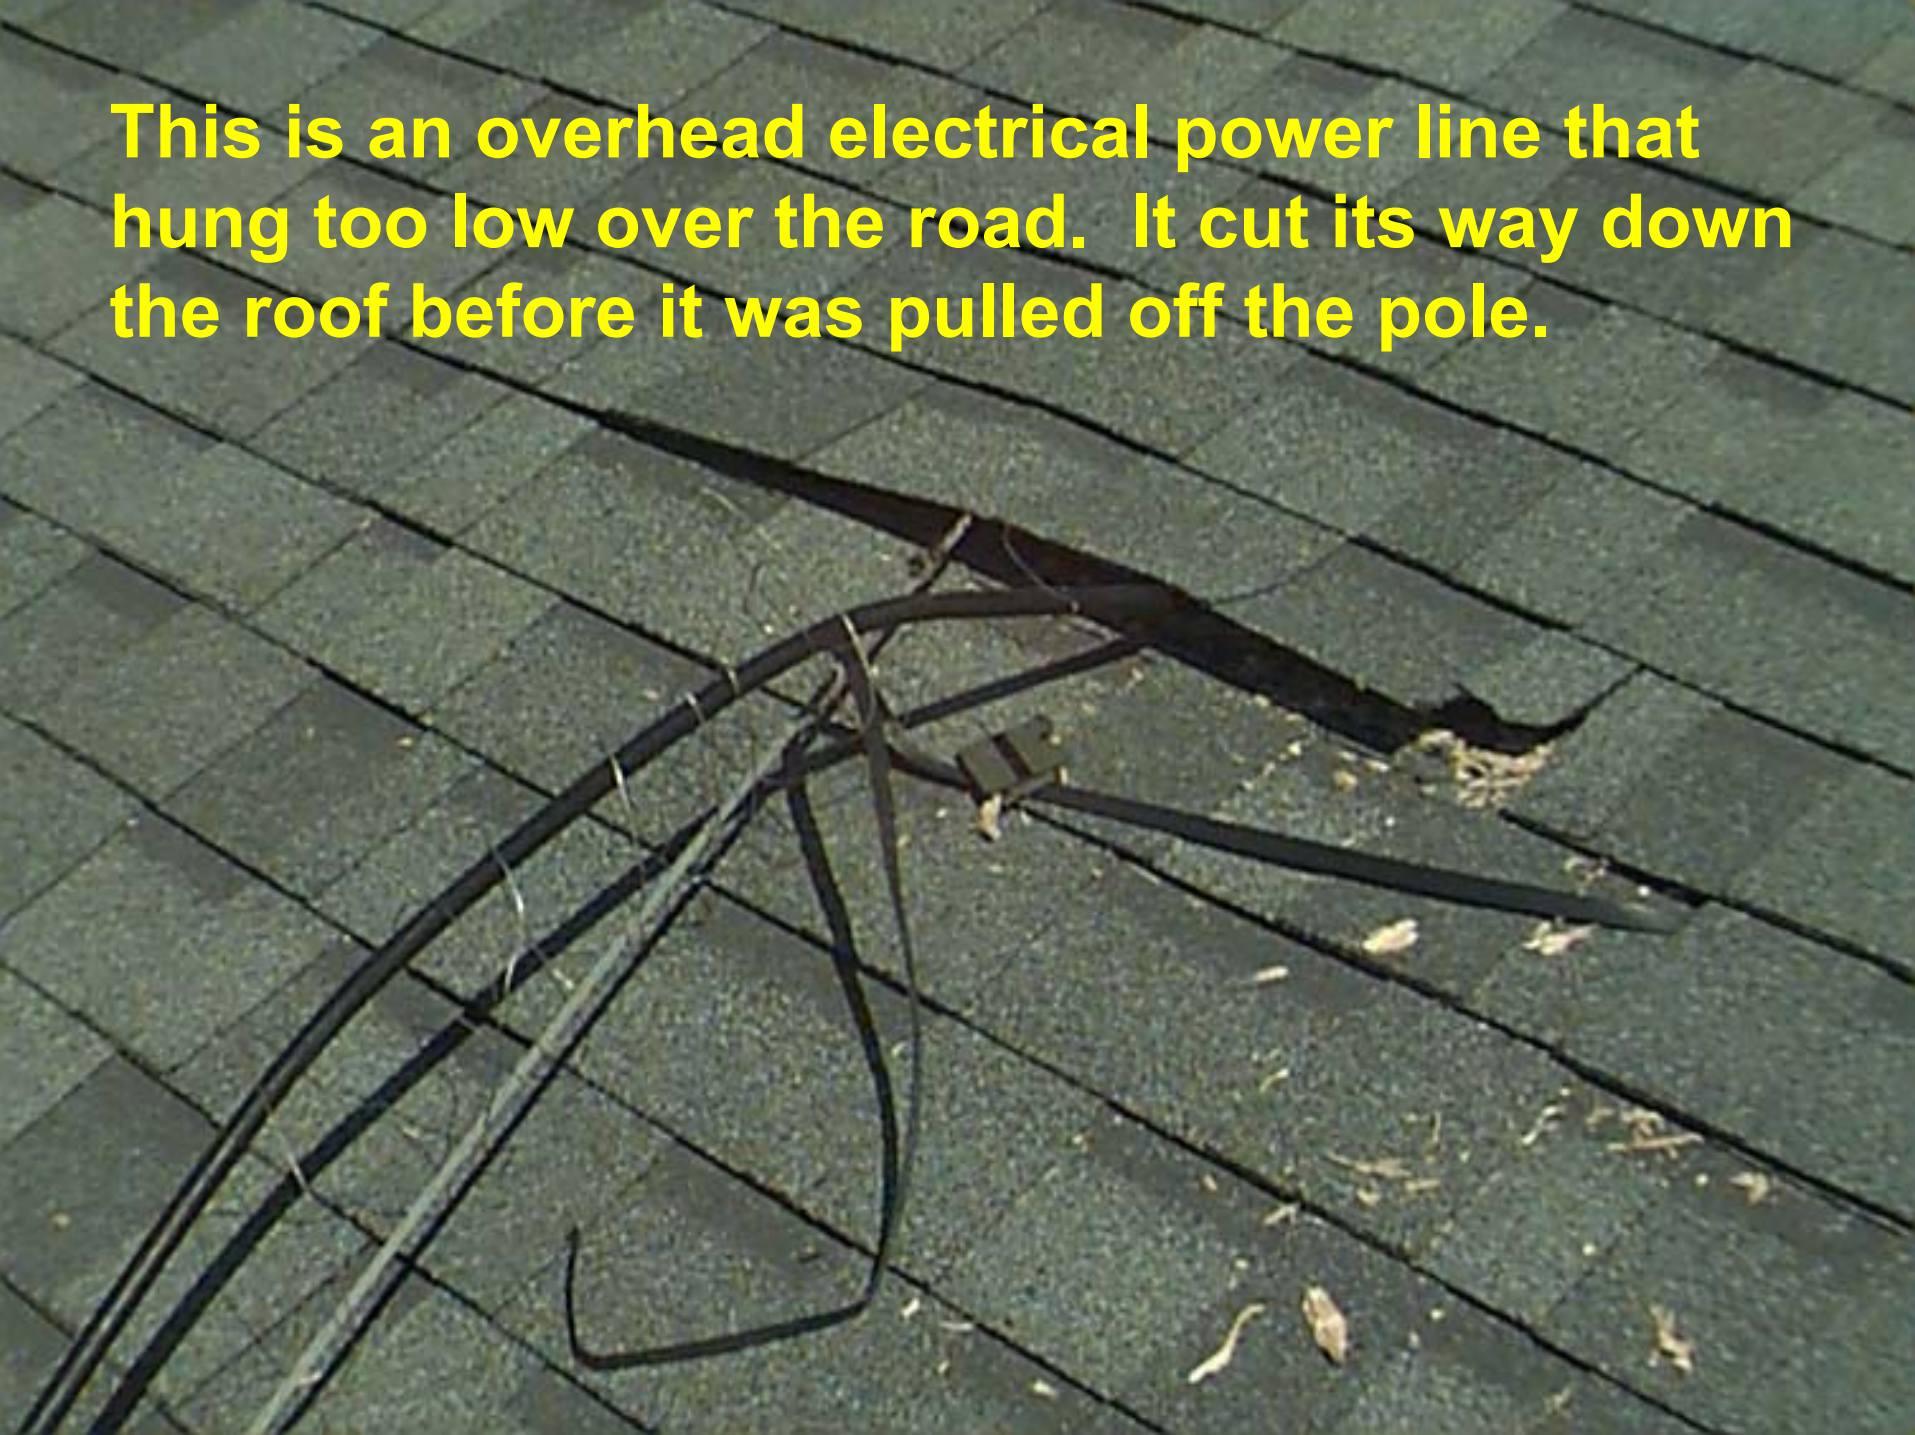
**This is an overhead electrical power line that hung too low over the road. It cut its way down the roof before it was pulled off the pole.**

**This is what the wire did to the trusses.**

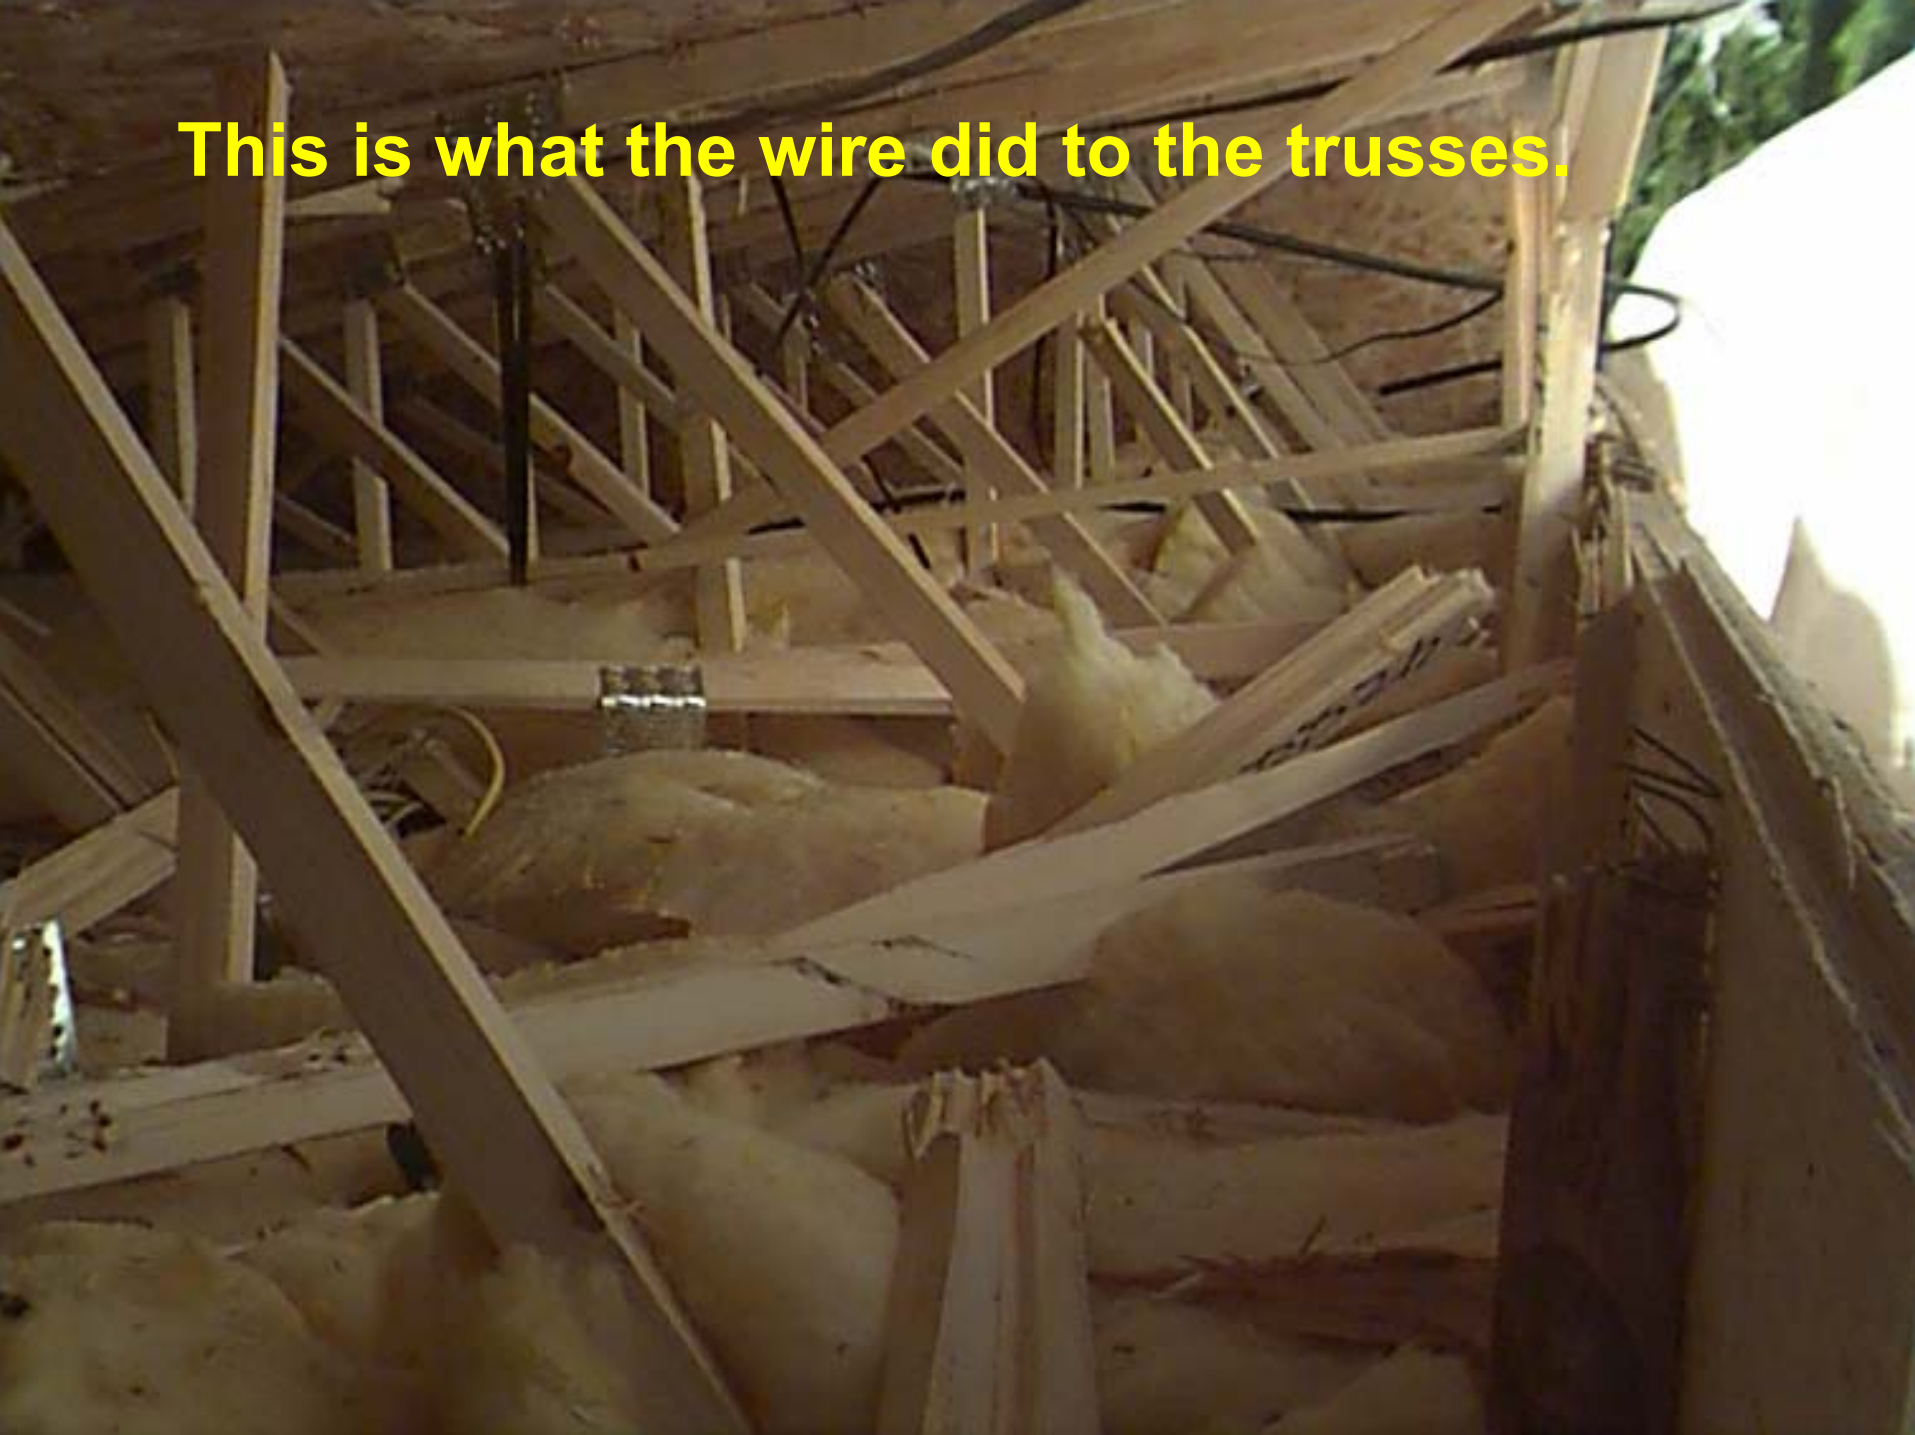
**Another view of the wire cutting through the roof and trusses.**

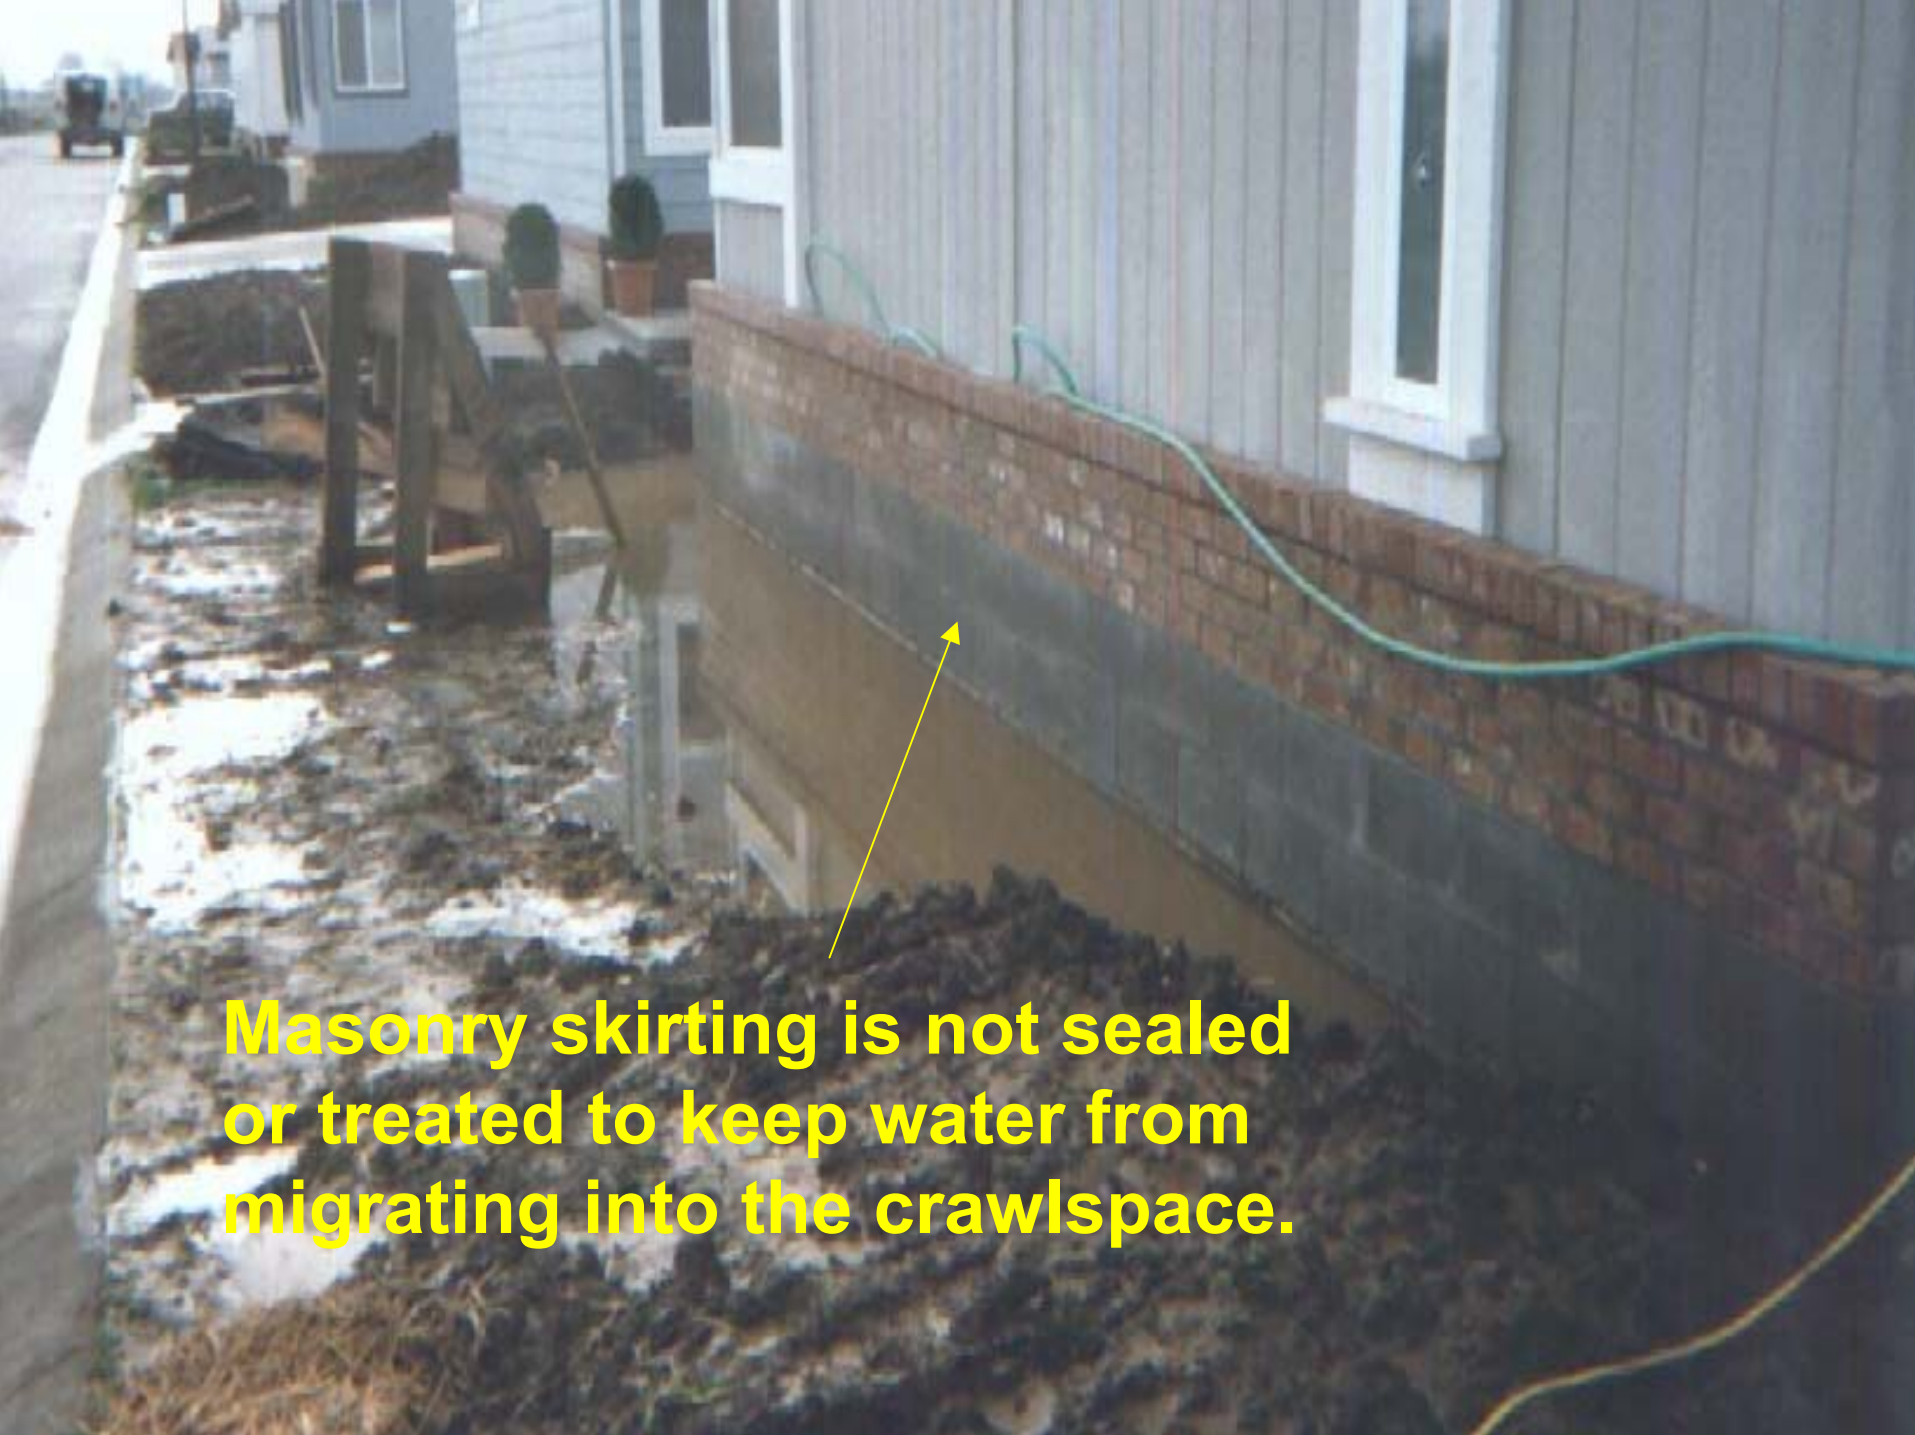
**Masonry skirting is not sealed or treated to keep water from migrating into the crawlspace.**

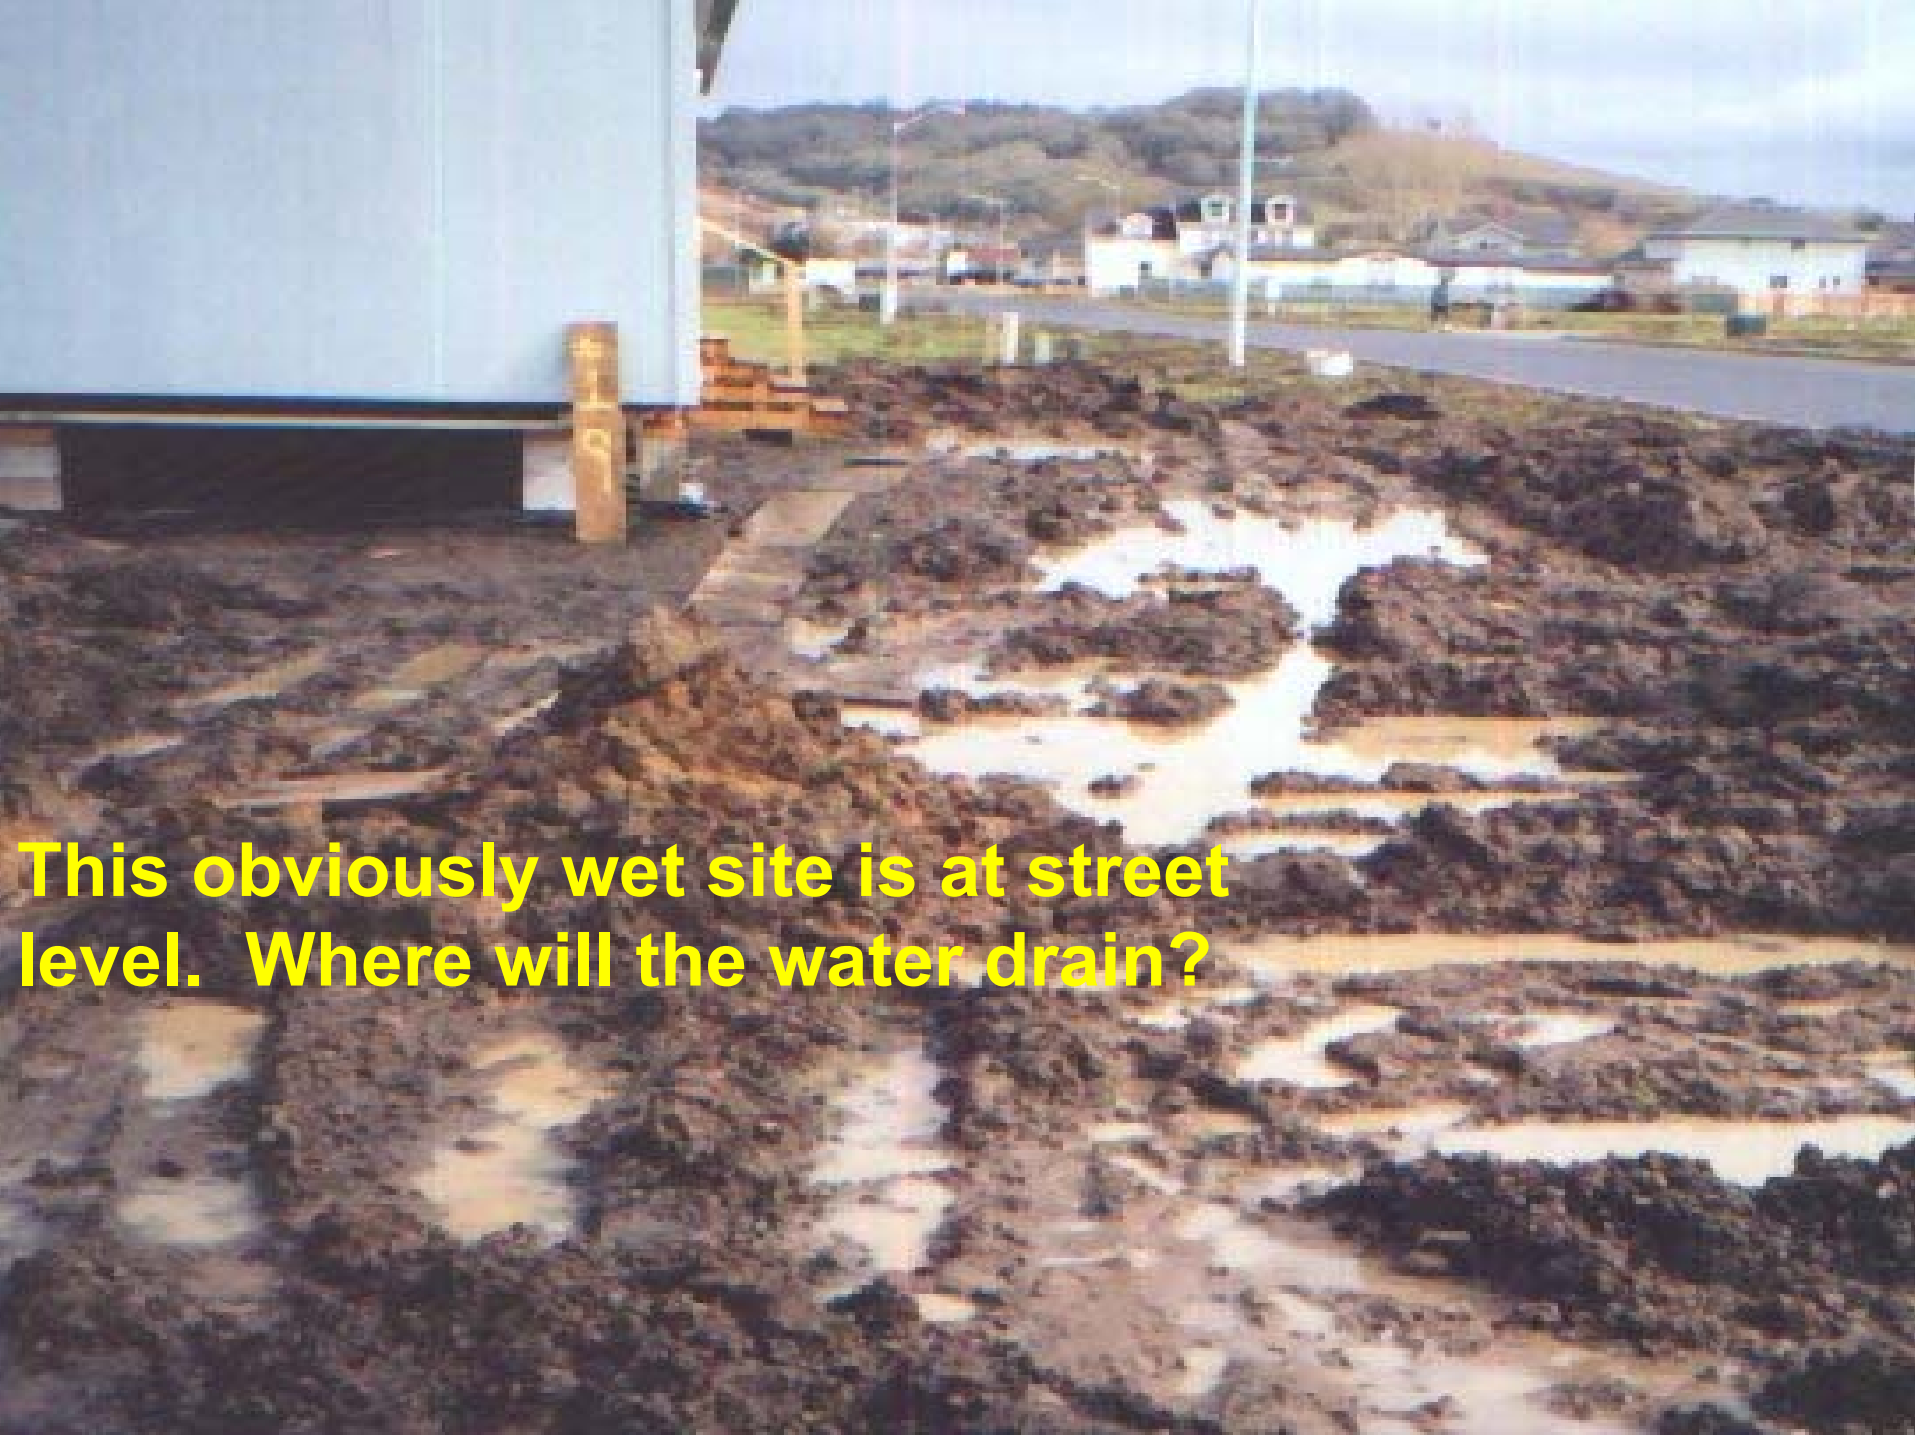
**This obviously wet site is at street level. Where will the water drain?**

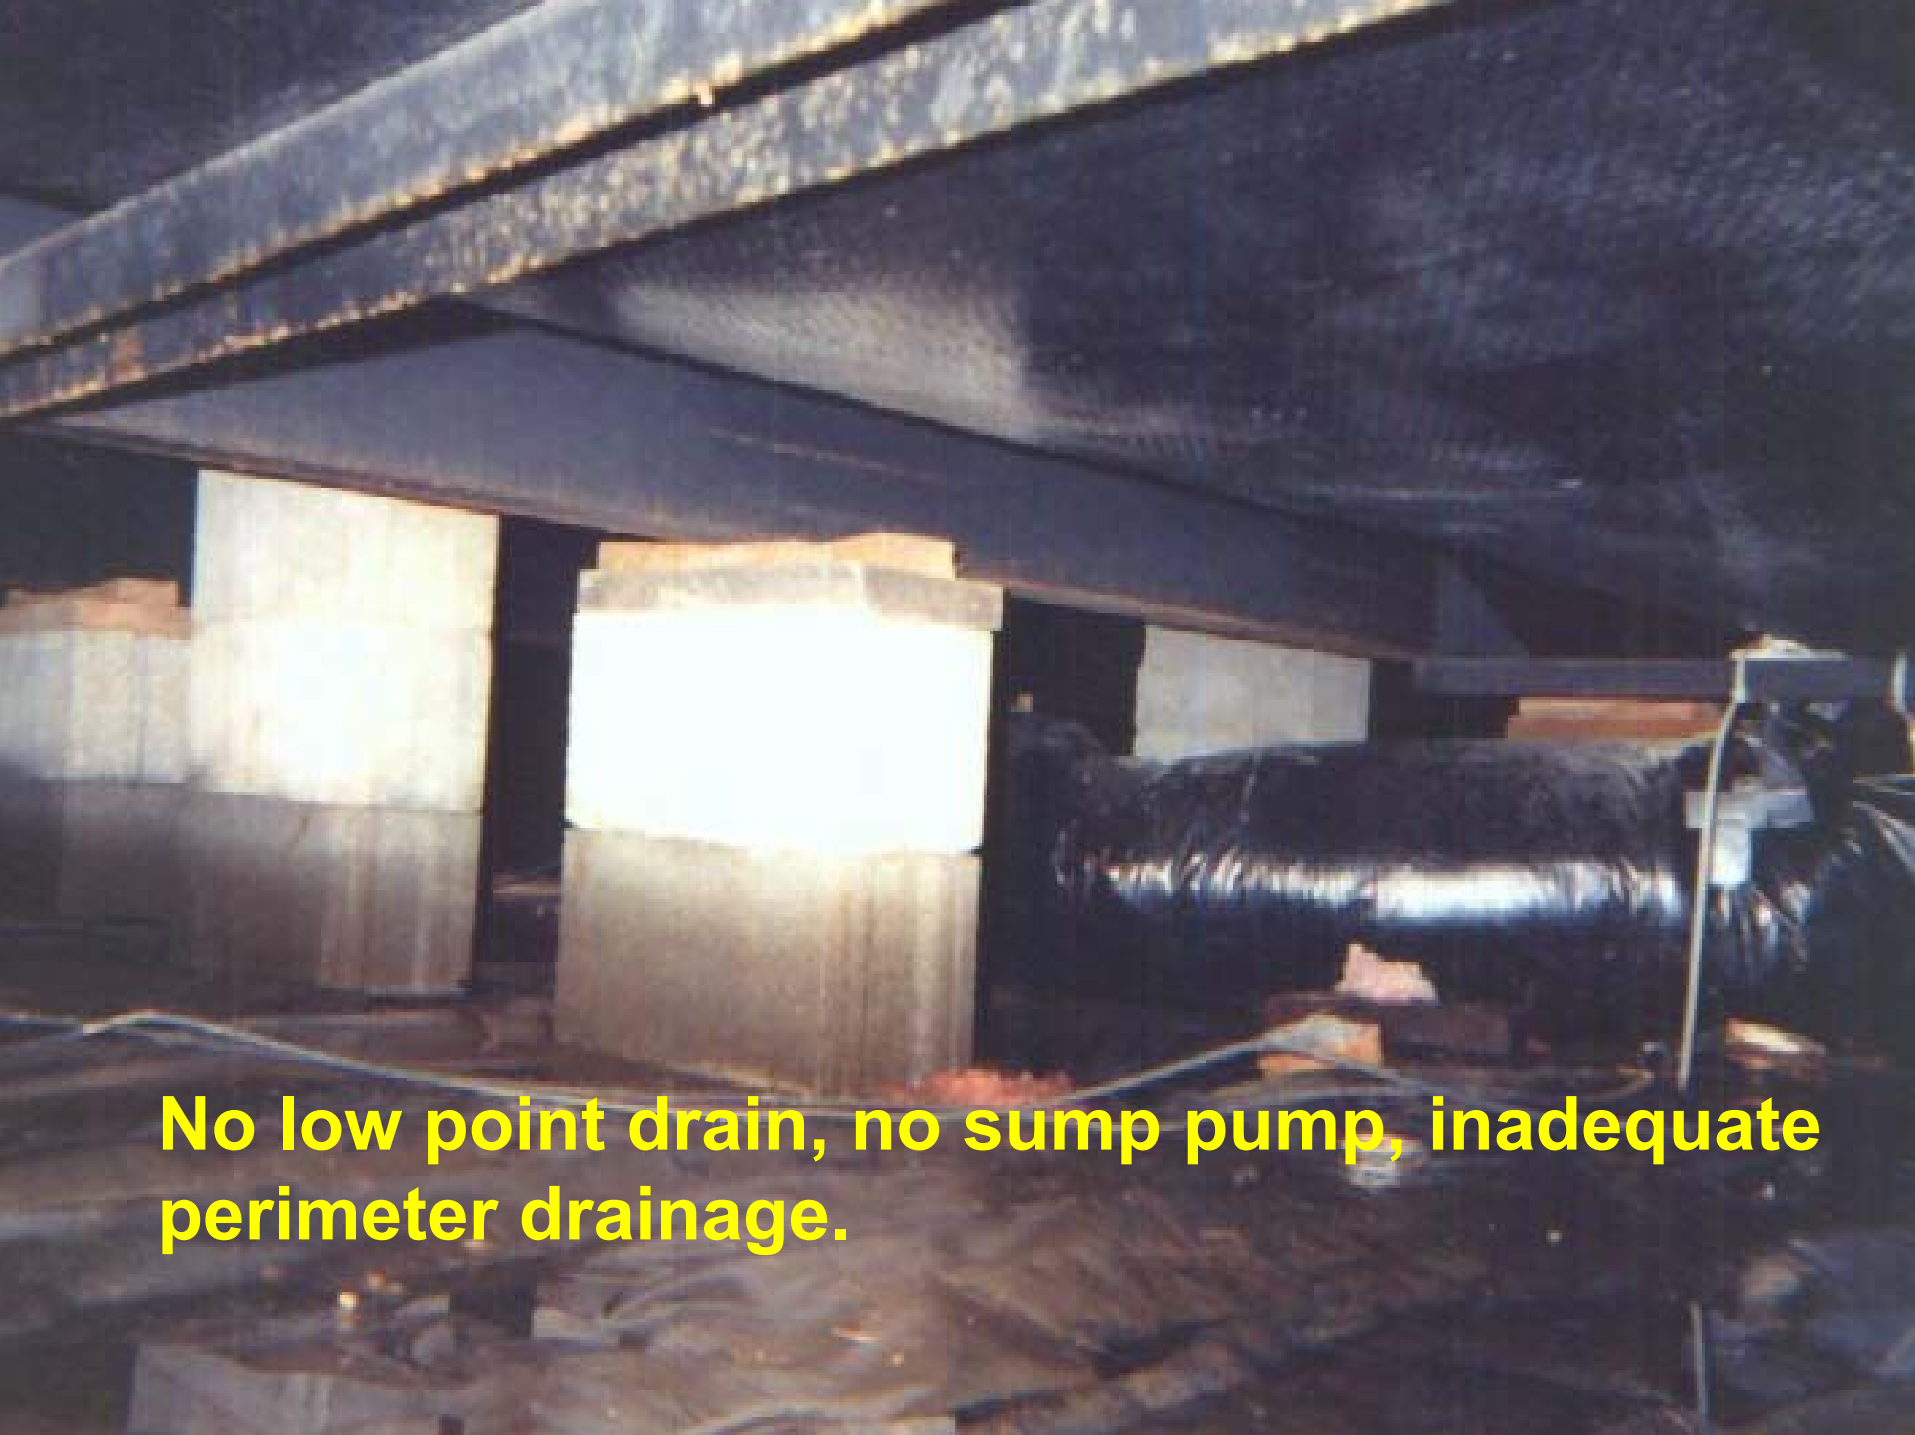
**No low point drain, no sump pump, inadequate perimeter drainage.**
