**TRANSPORTATION  
AND OTHER  
DAMAGE**

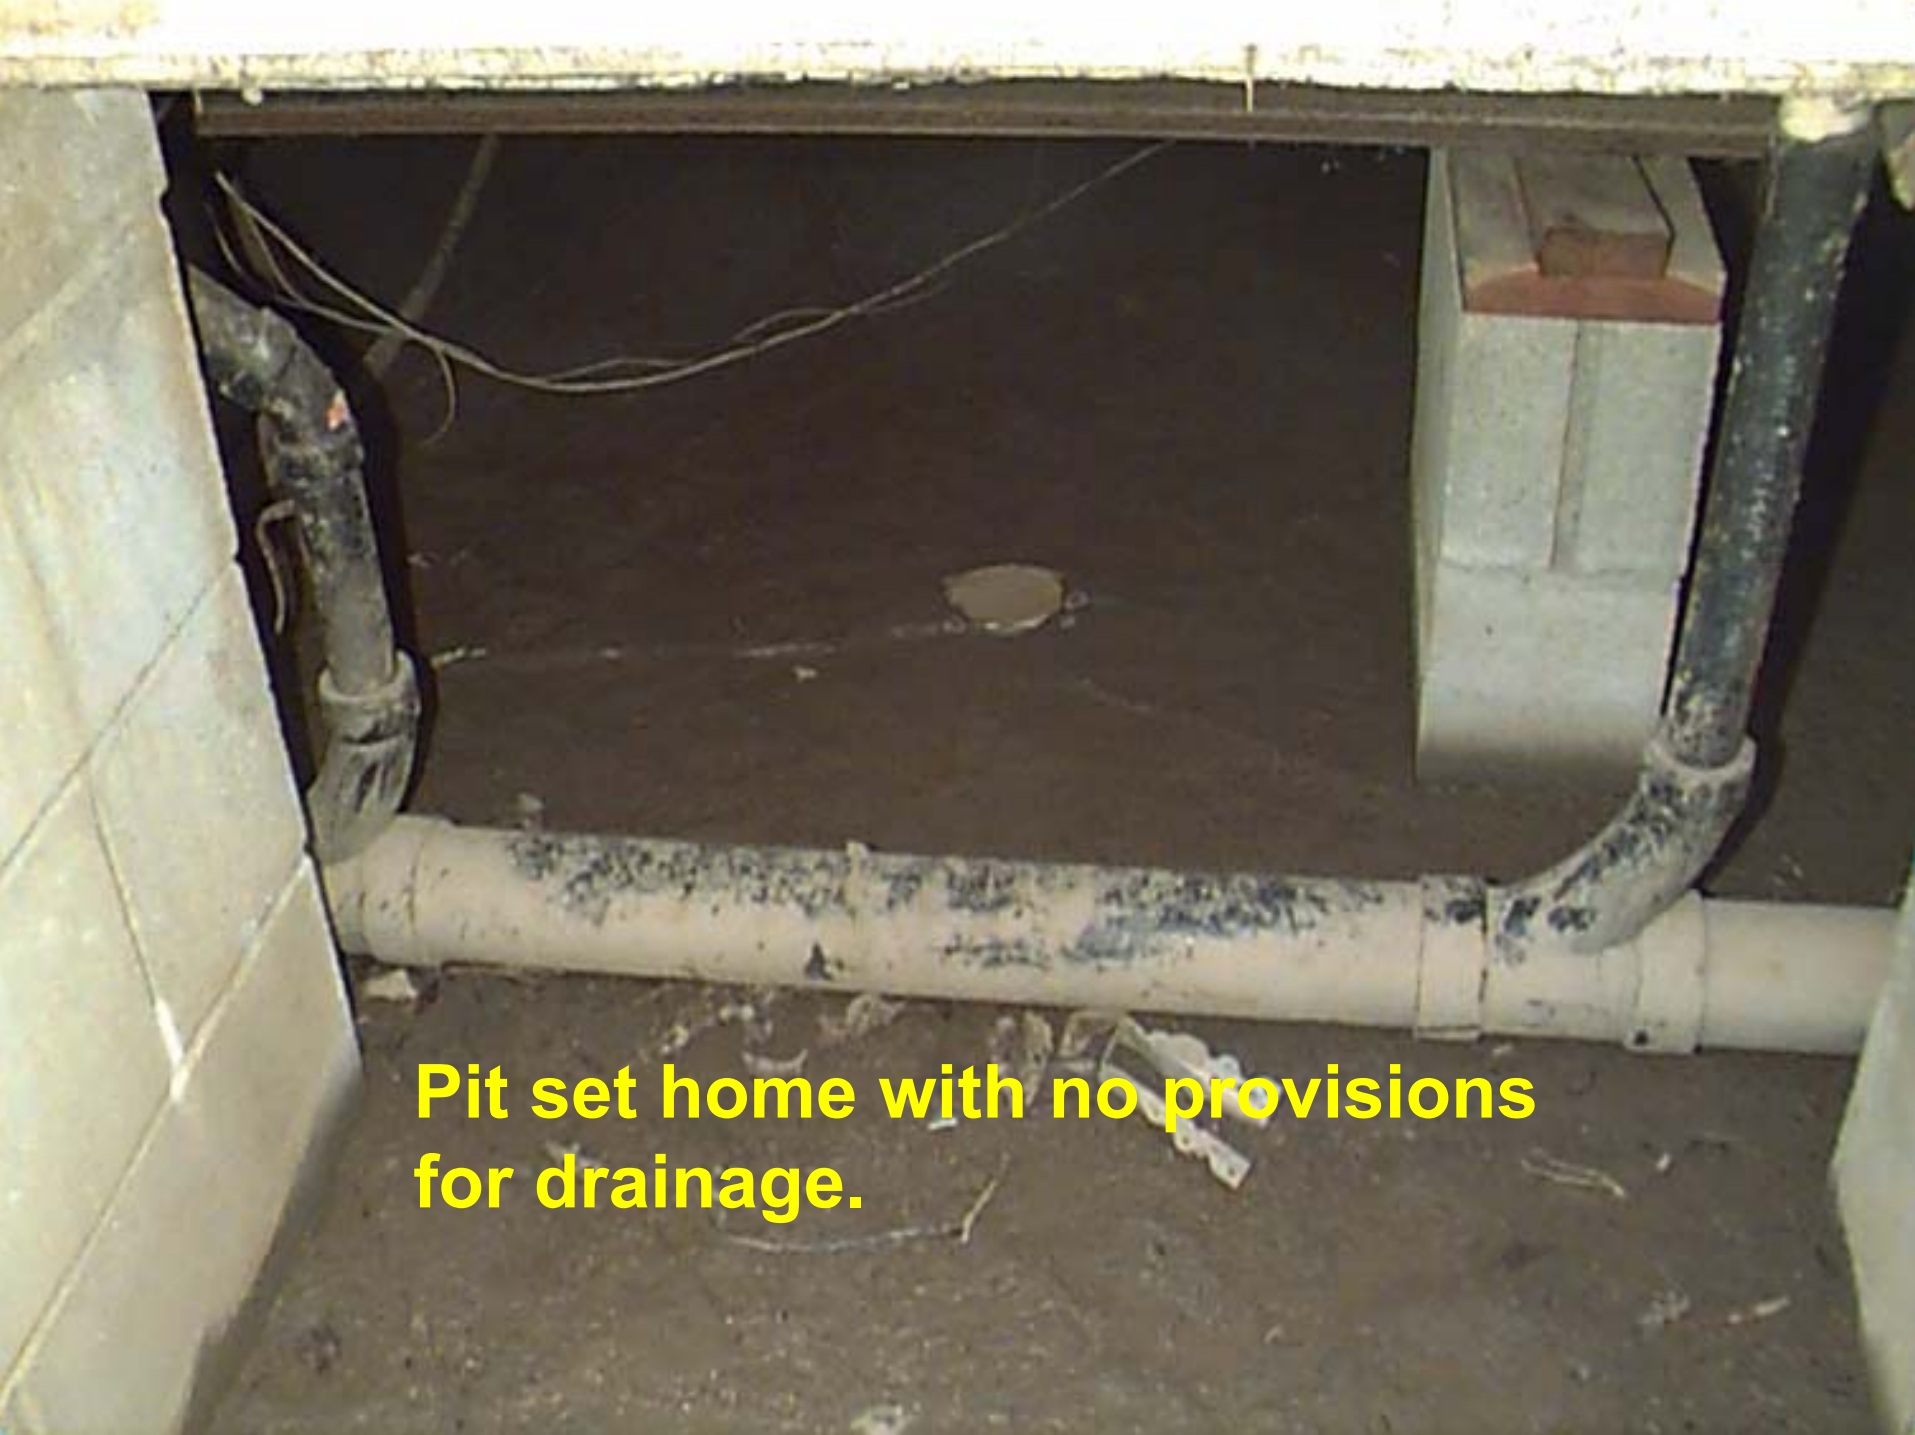
**Pit set home with no provisions for drainage.**

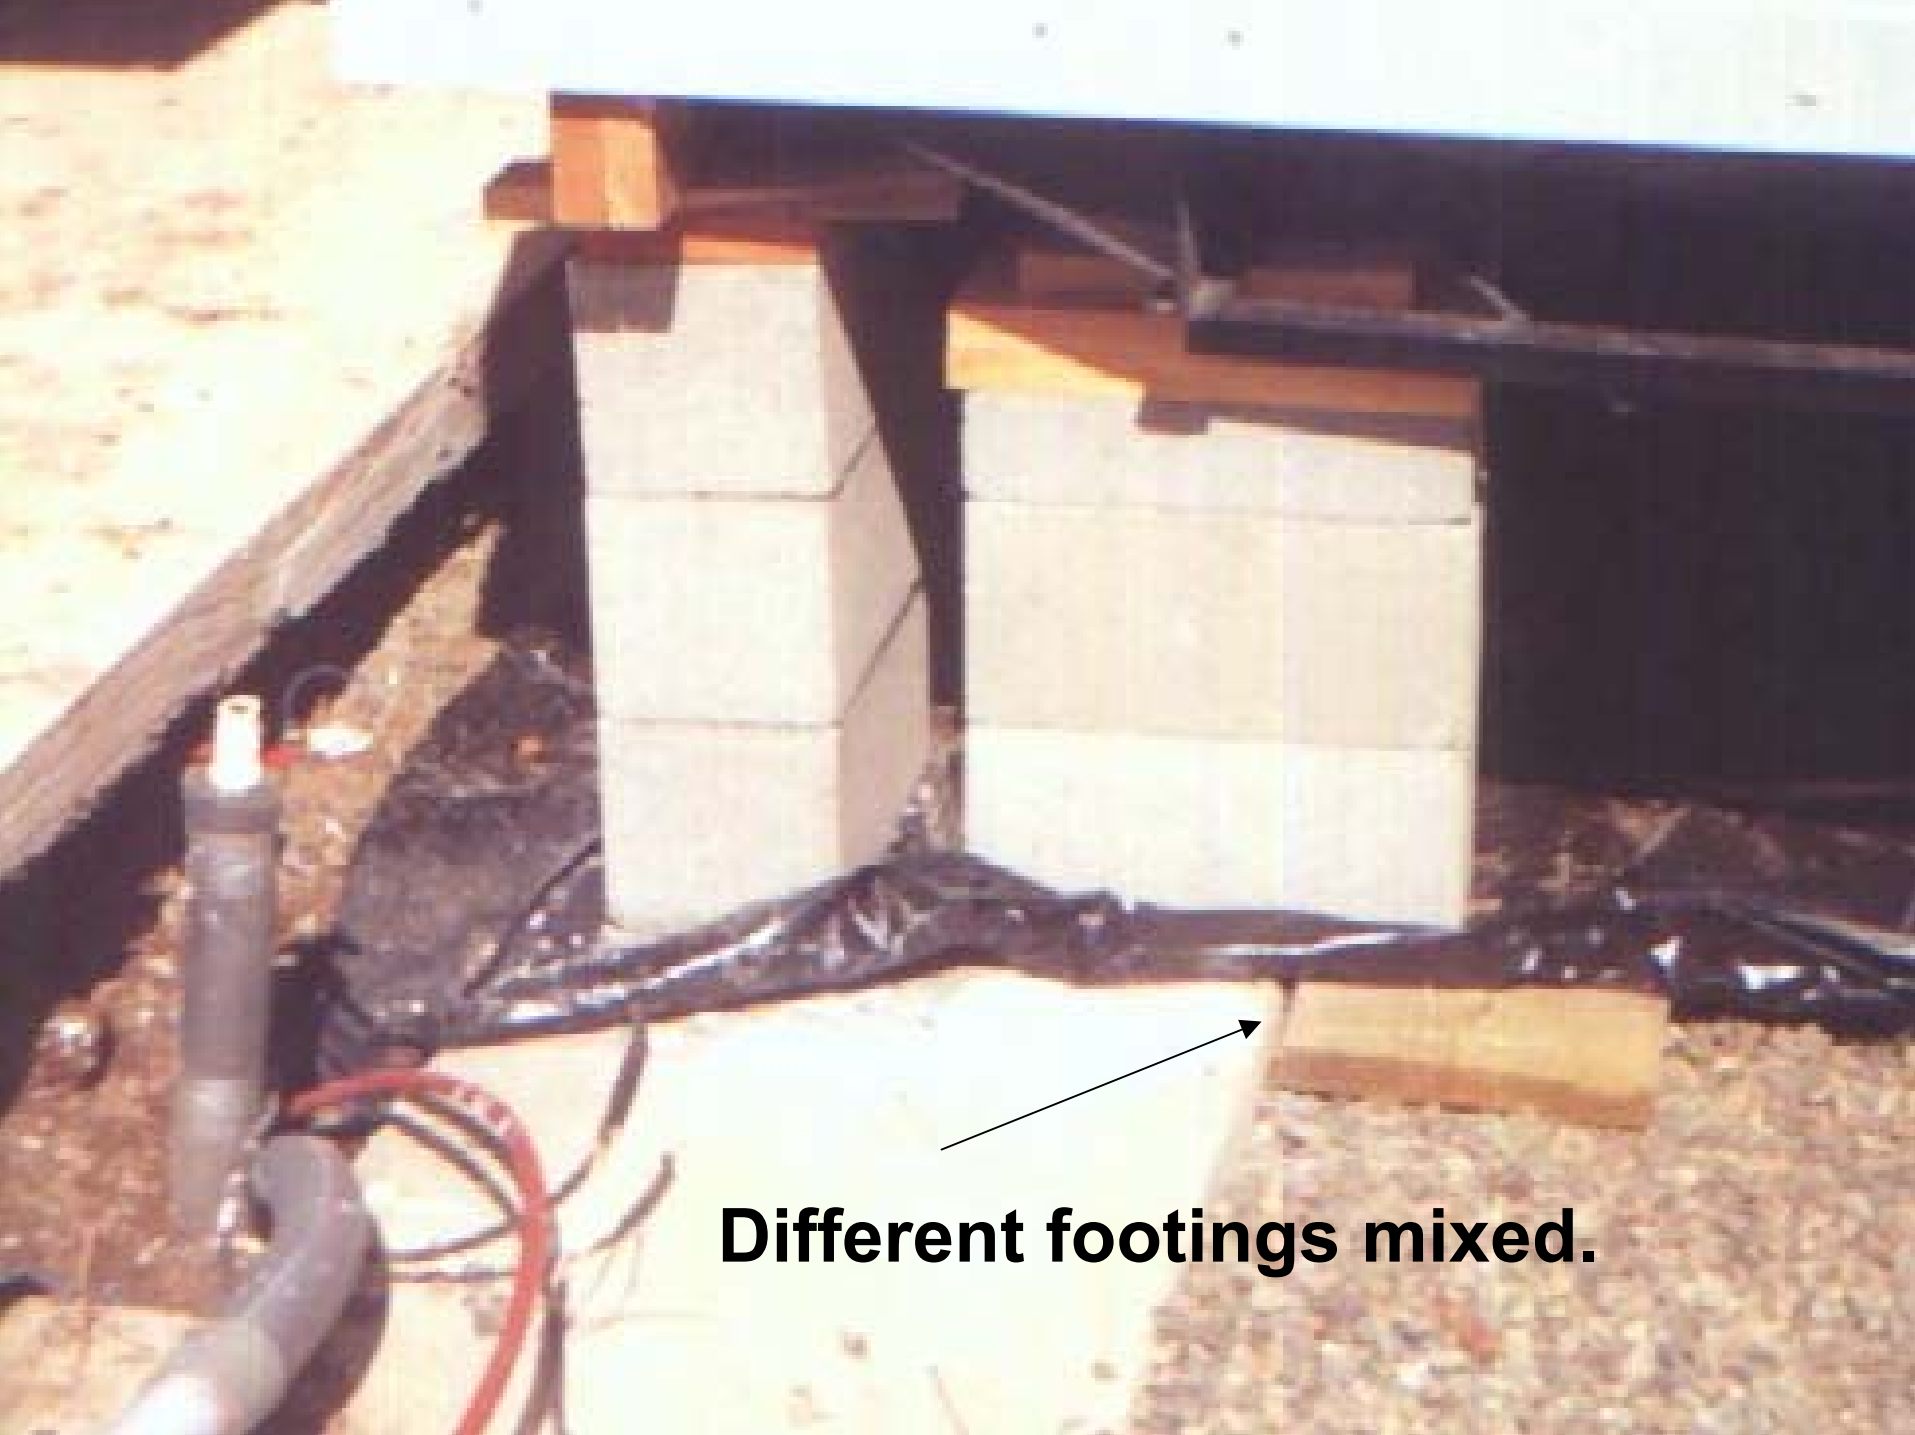
**Different footings mixed.**

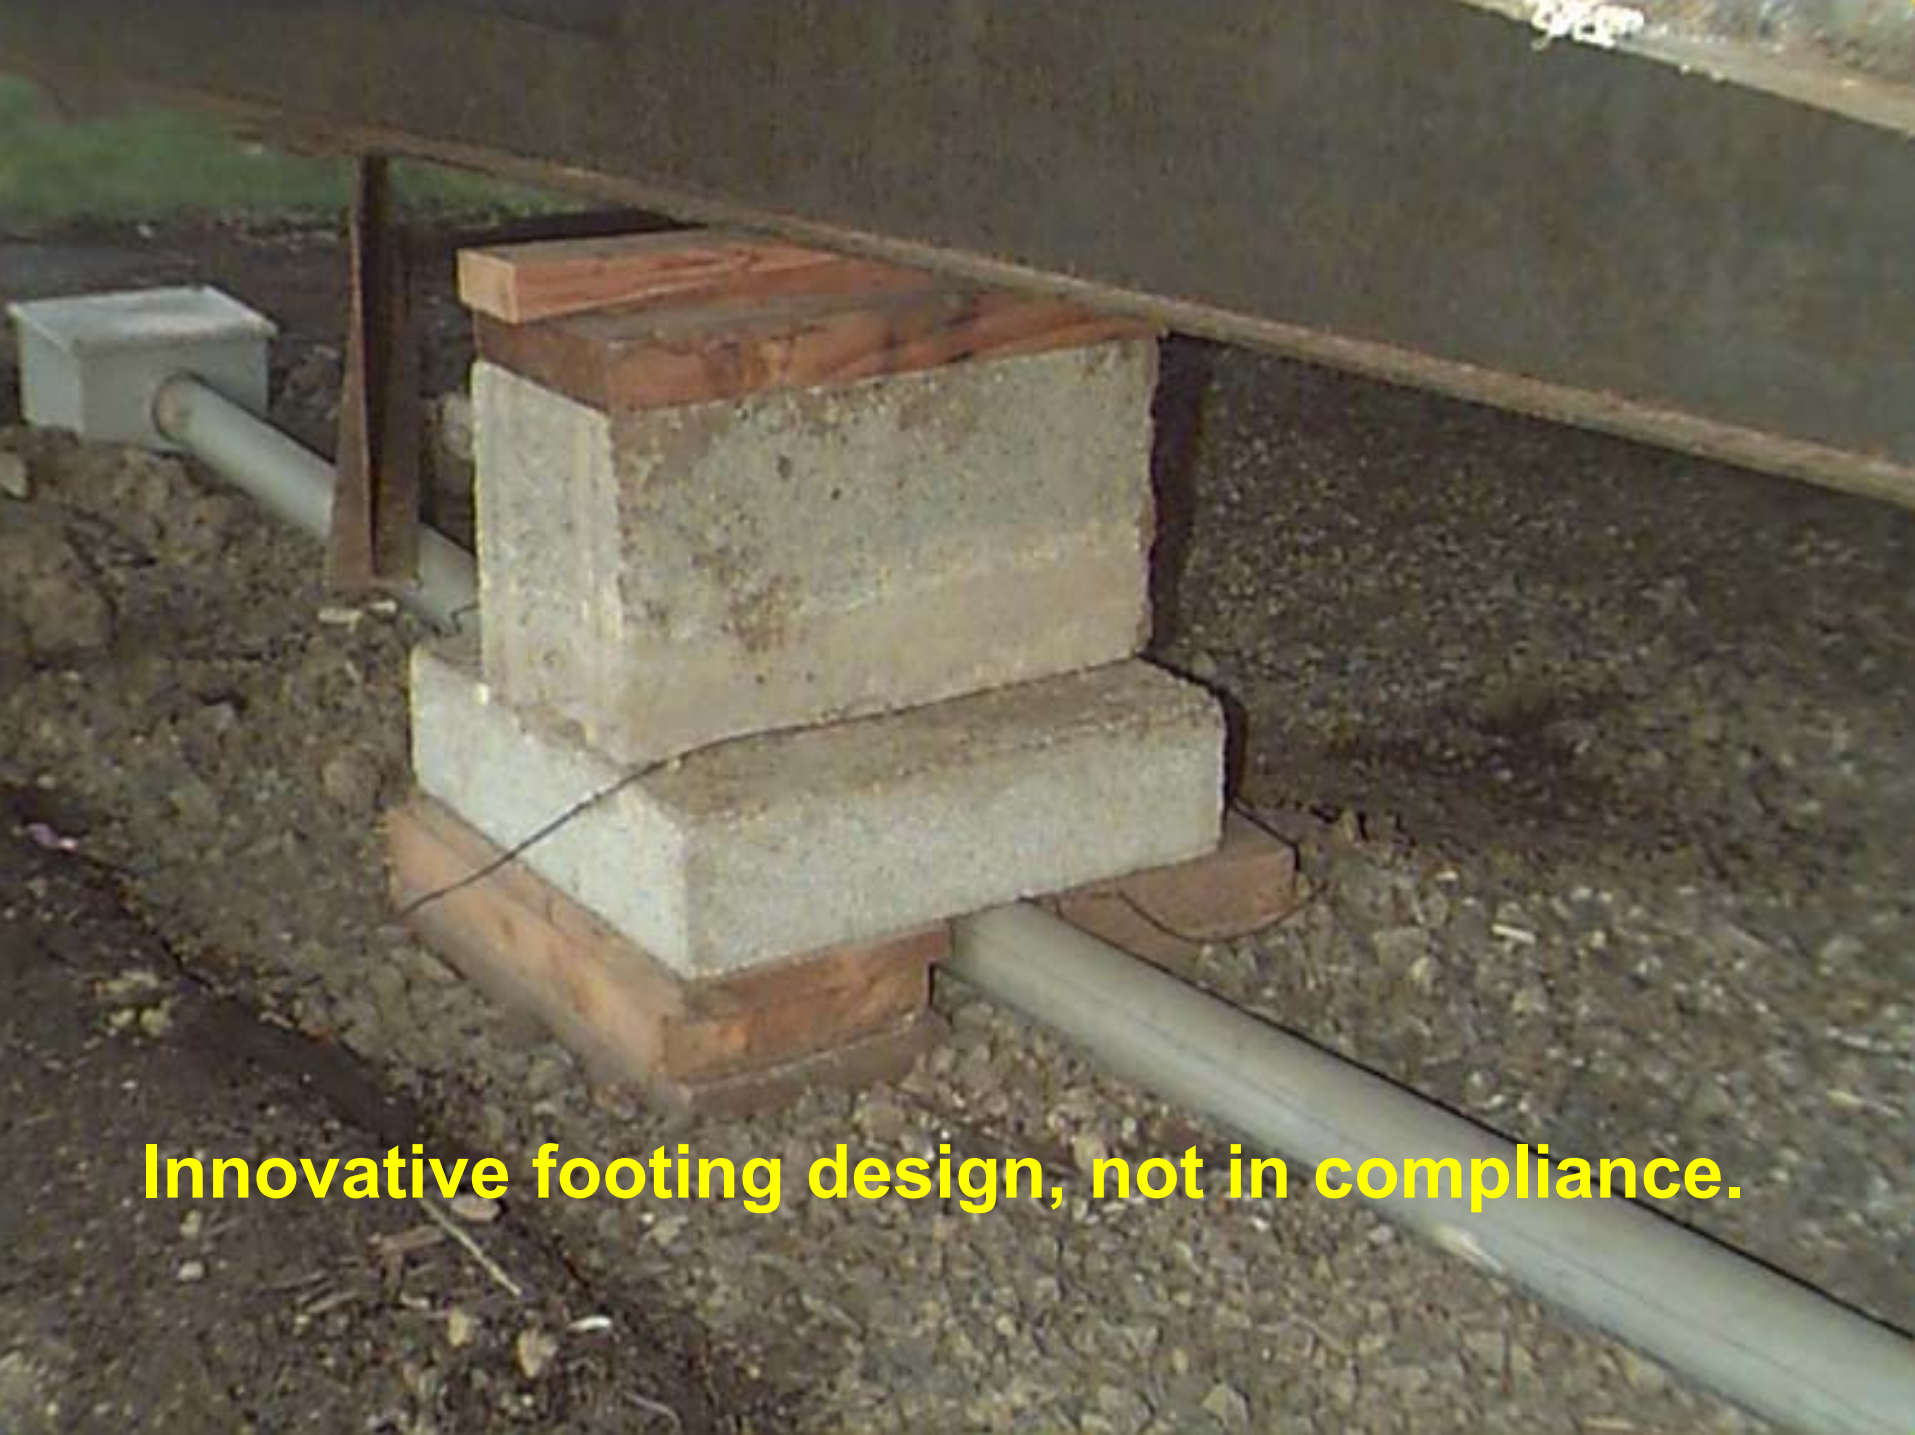
**Innovative footing design, not in compliance.**

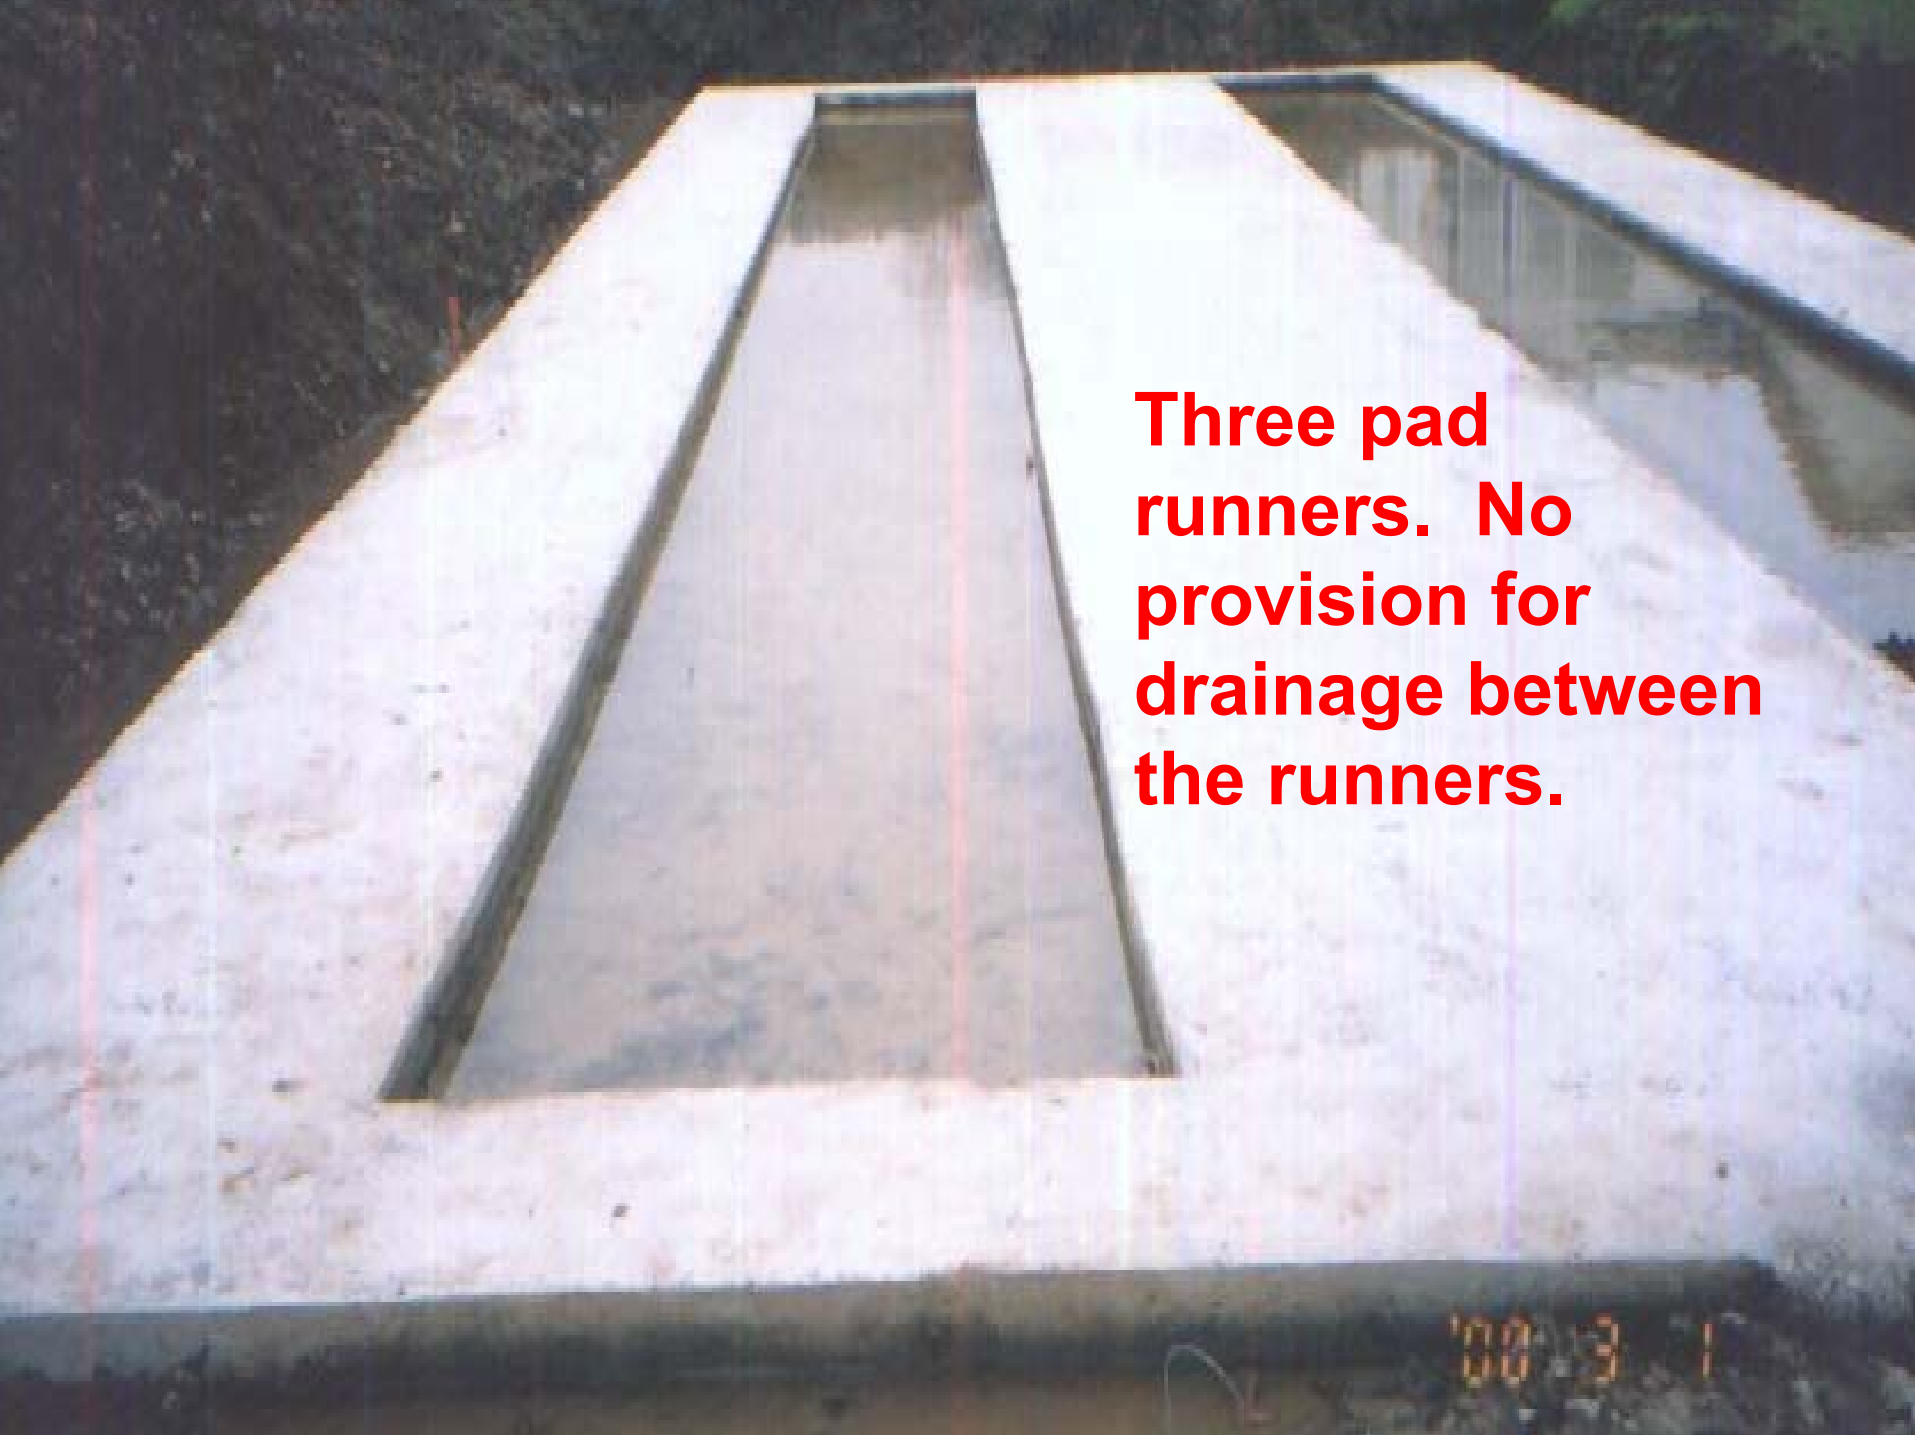
**Three pad  
runners. No  
provision for  
drainage between  
the runners.**

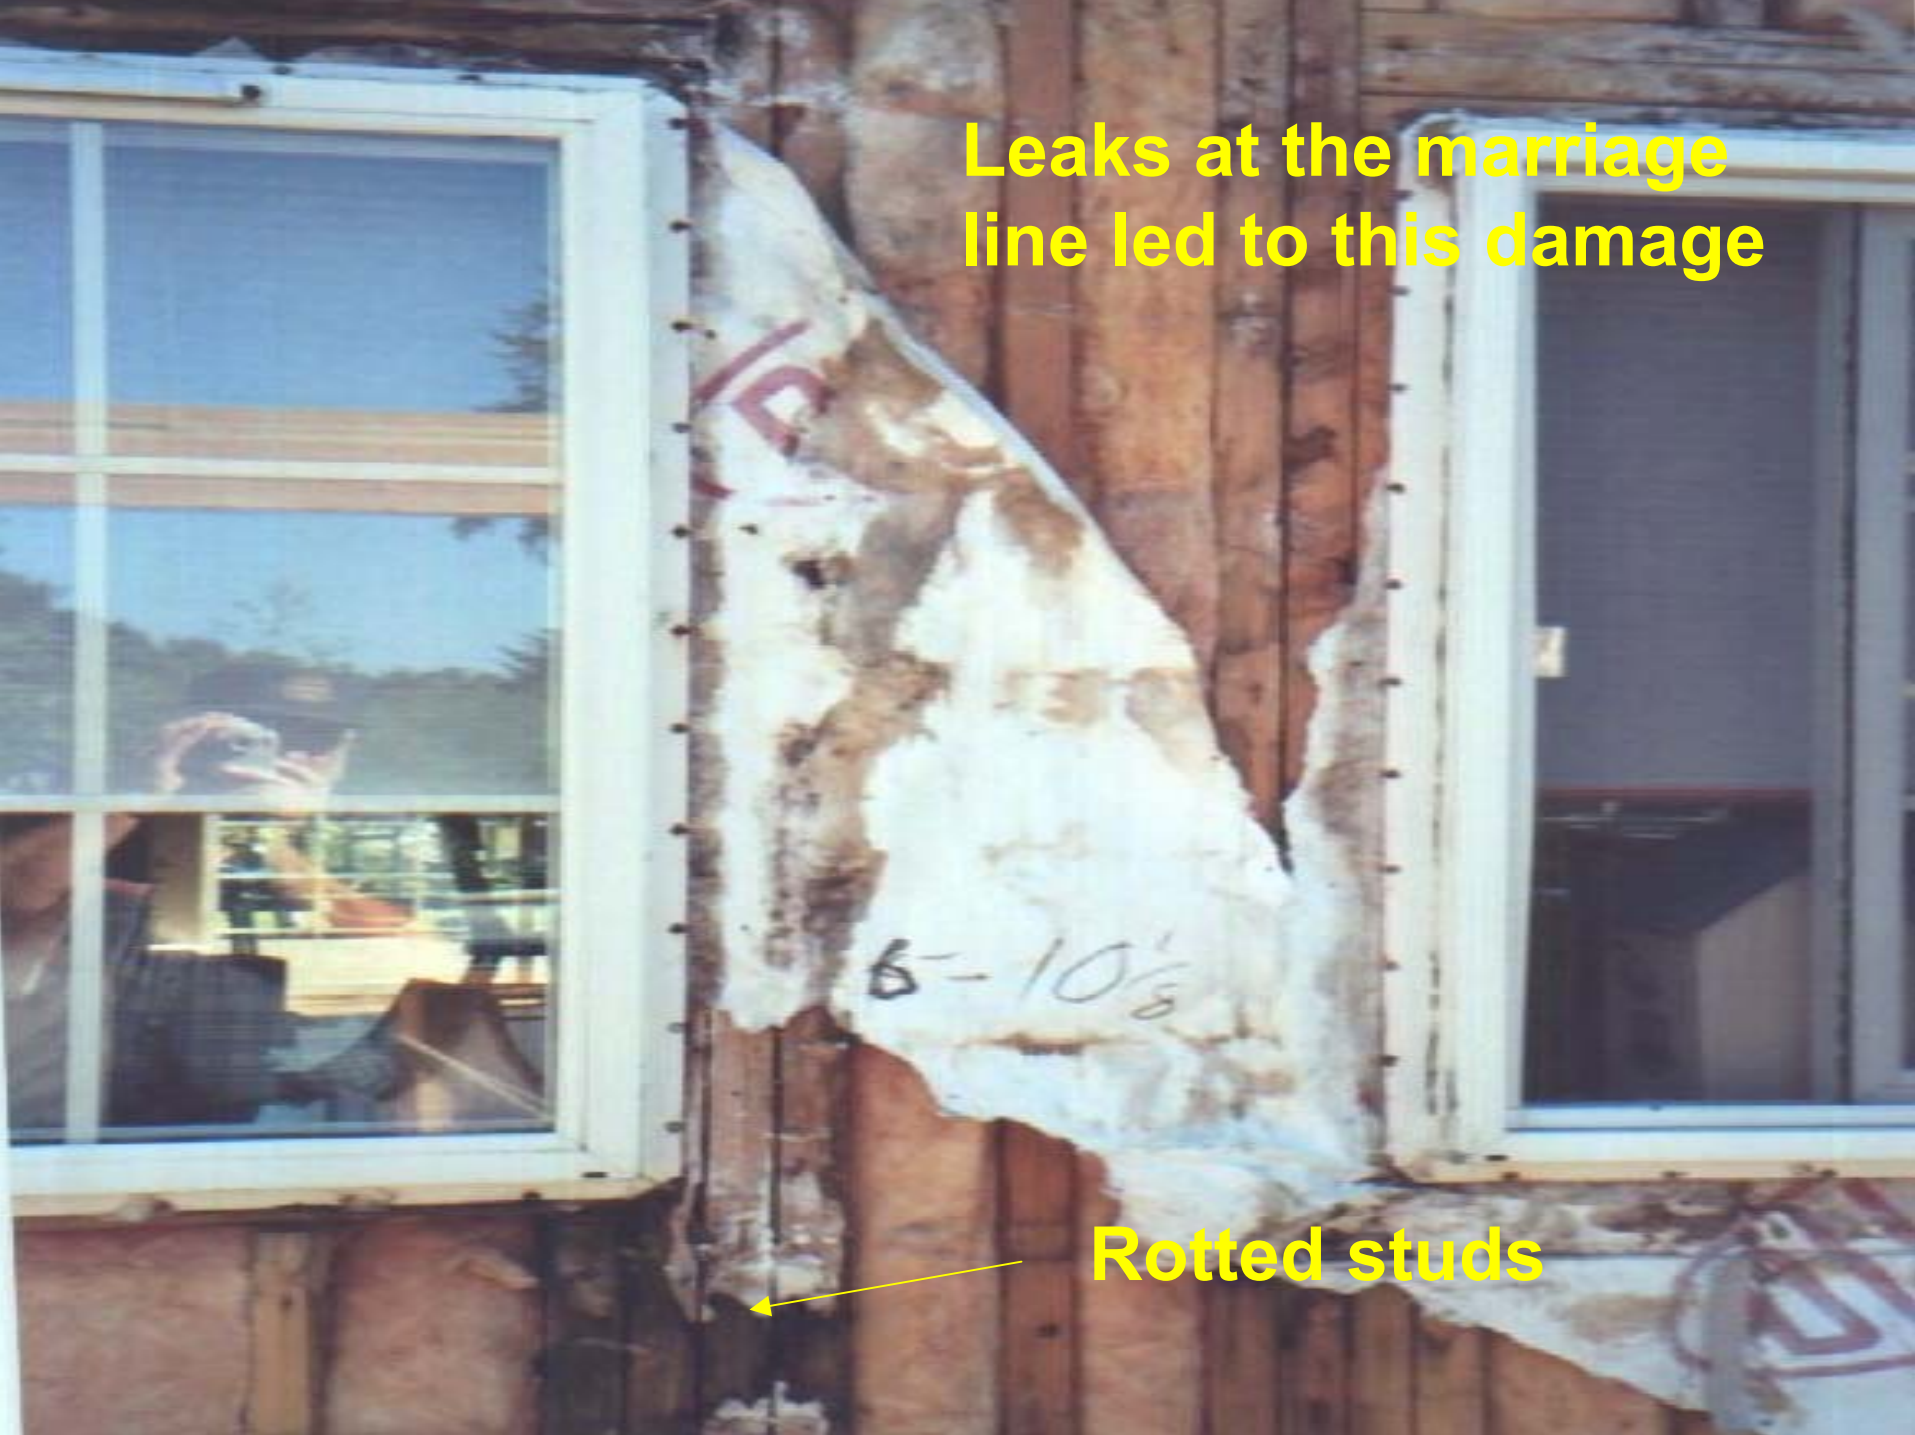
Rotted studs

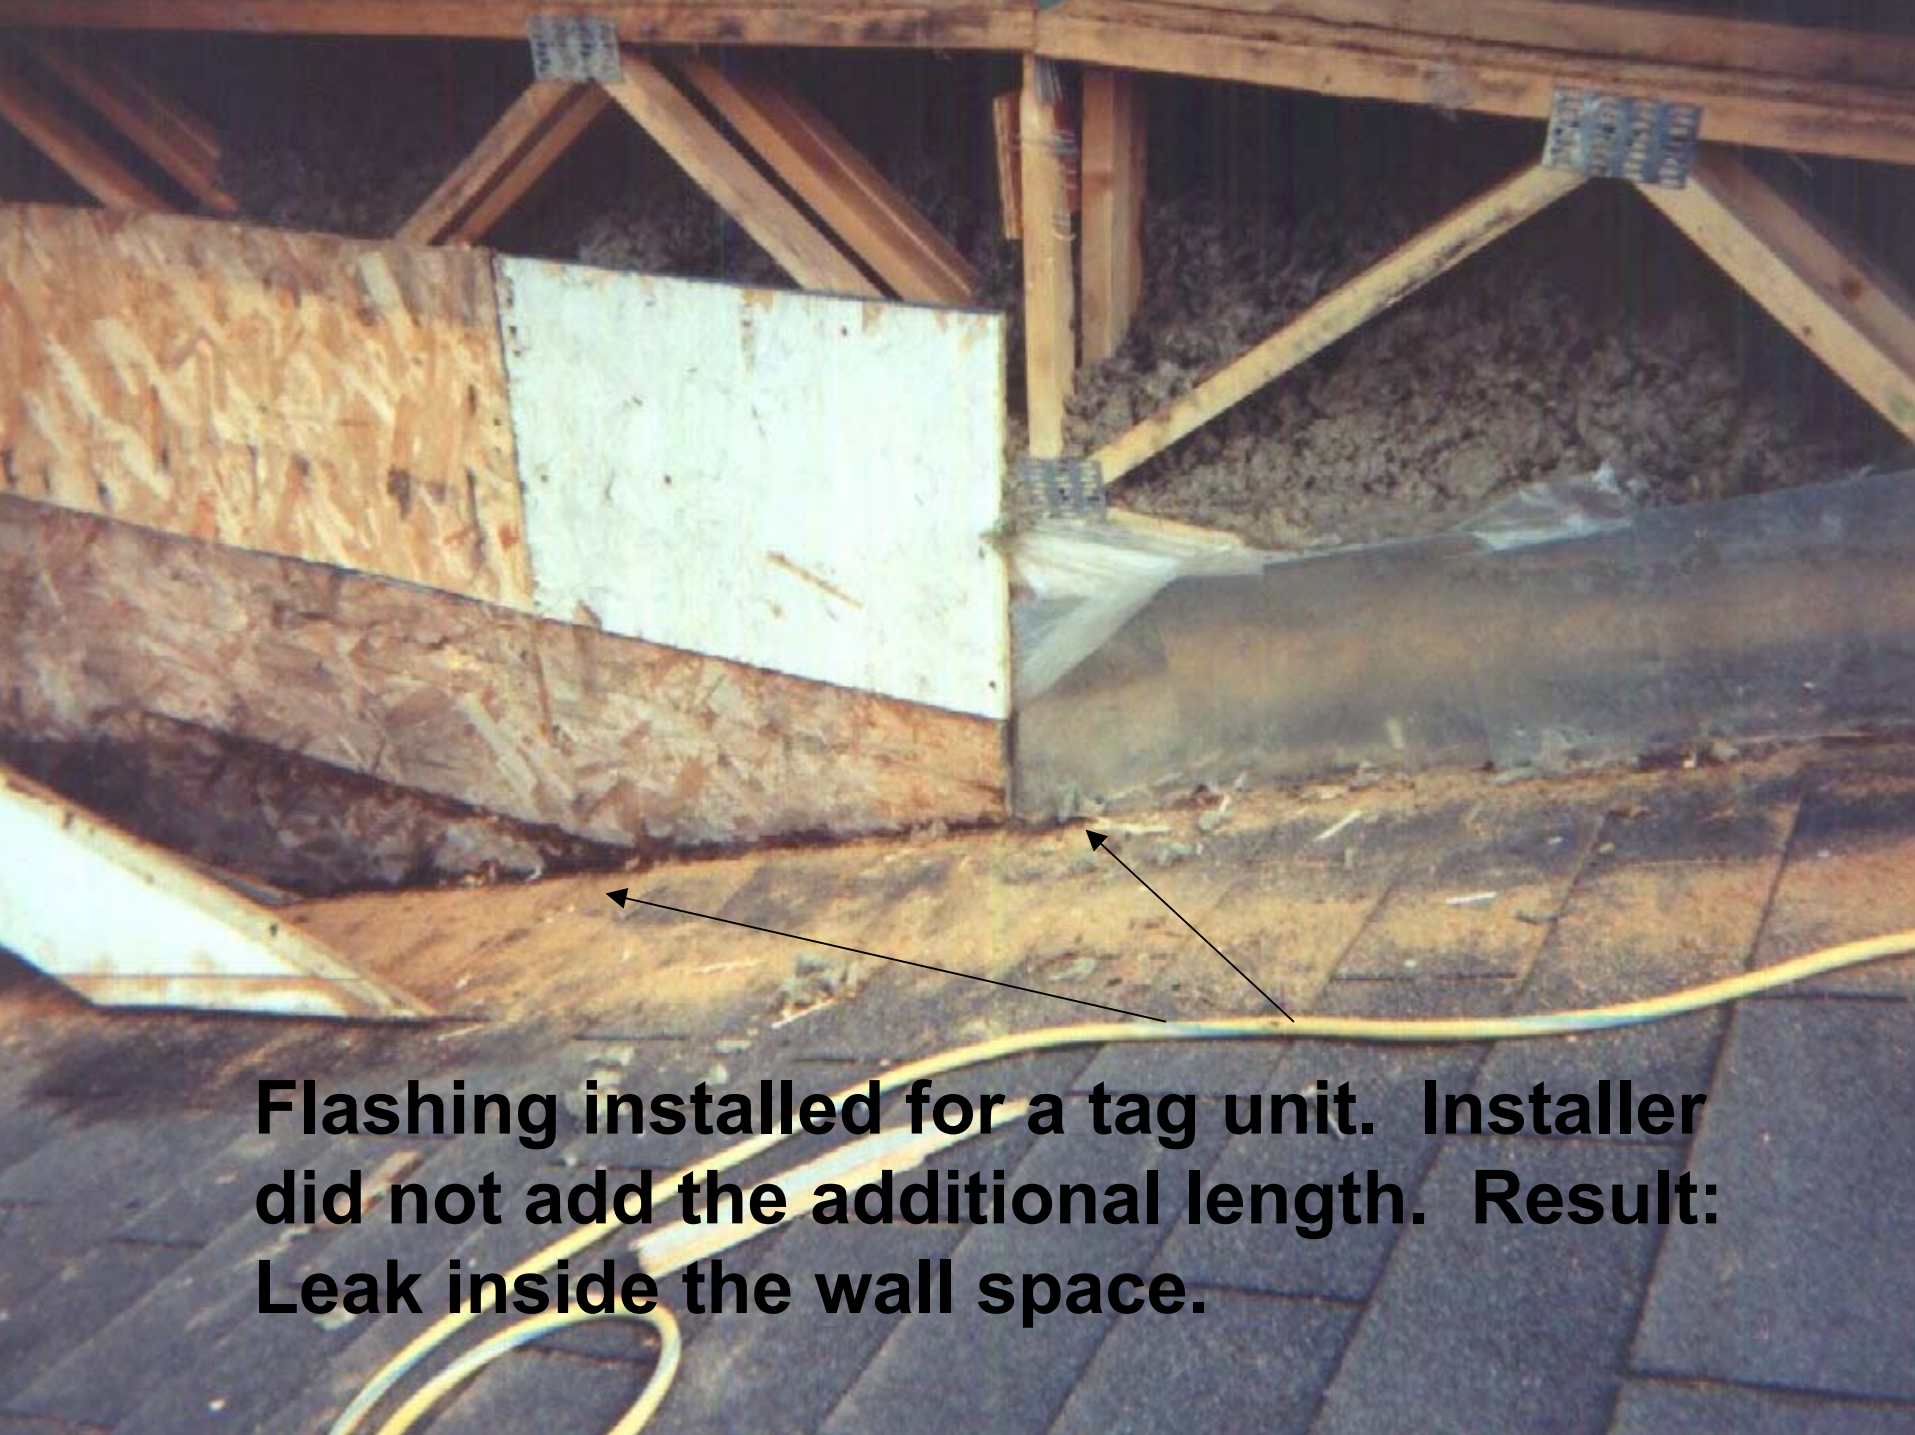
**Flashing installed for a tag unit. Installer did not add the additional length. Result: Leak inside the wall space.**

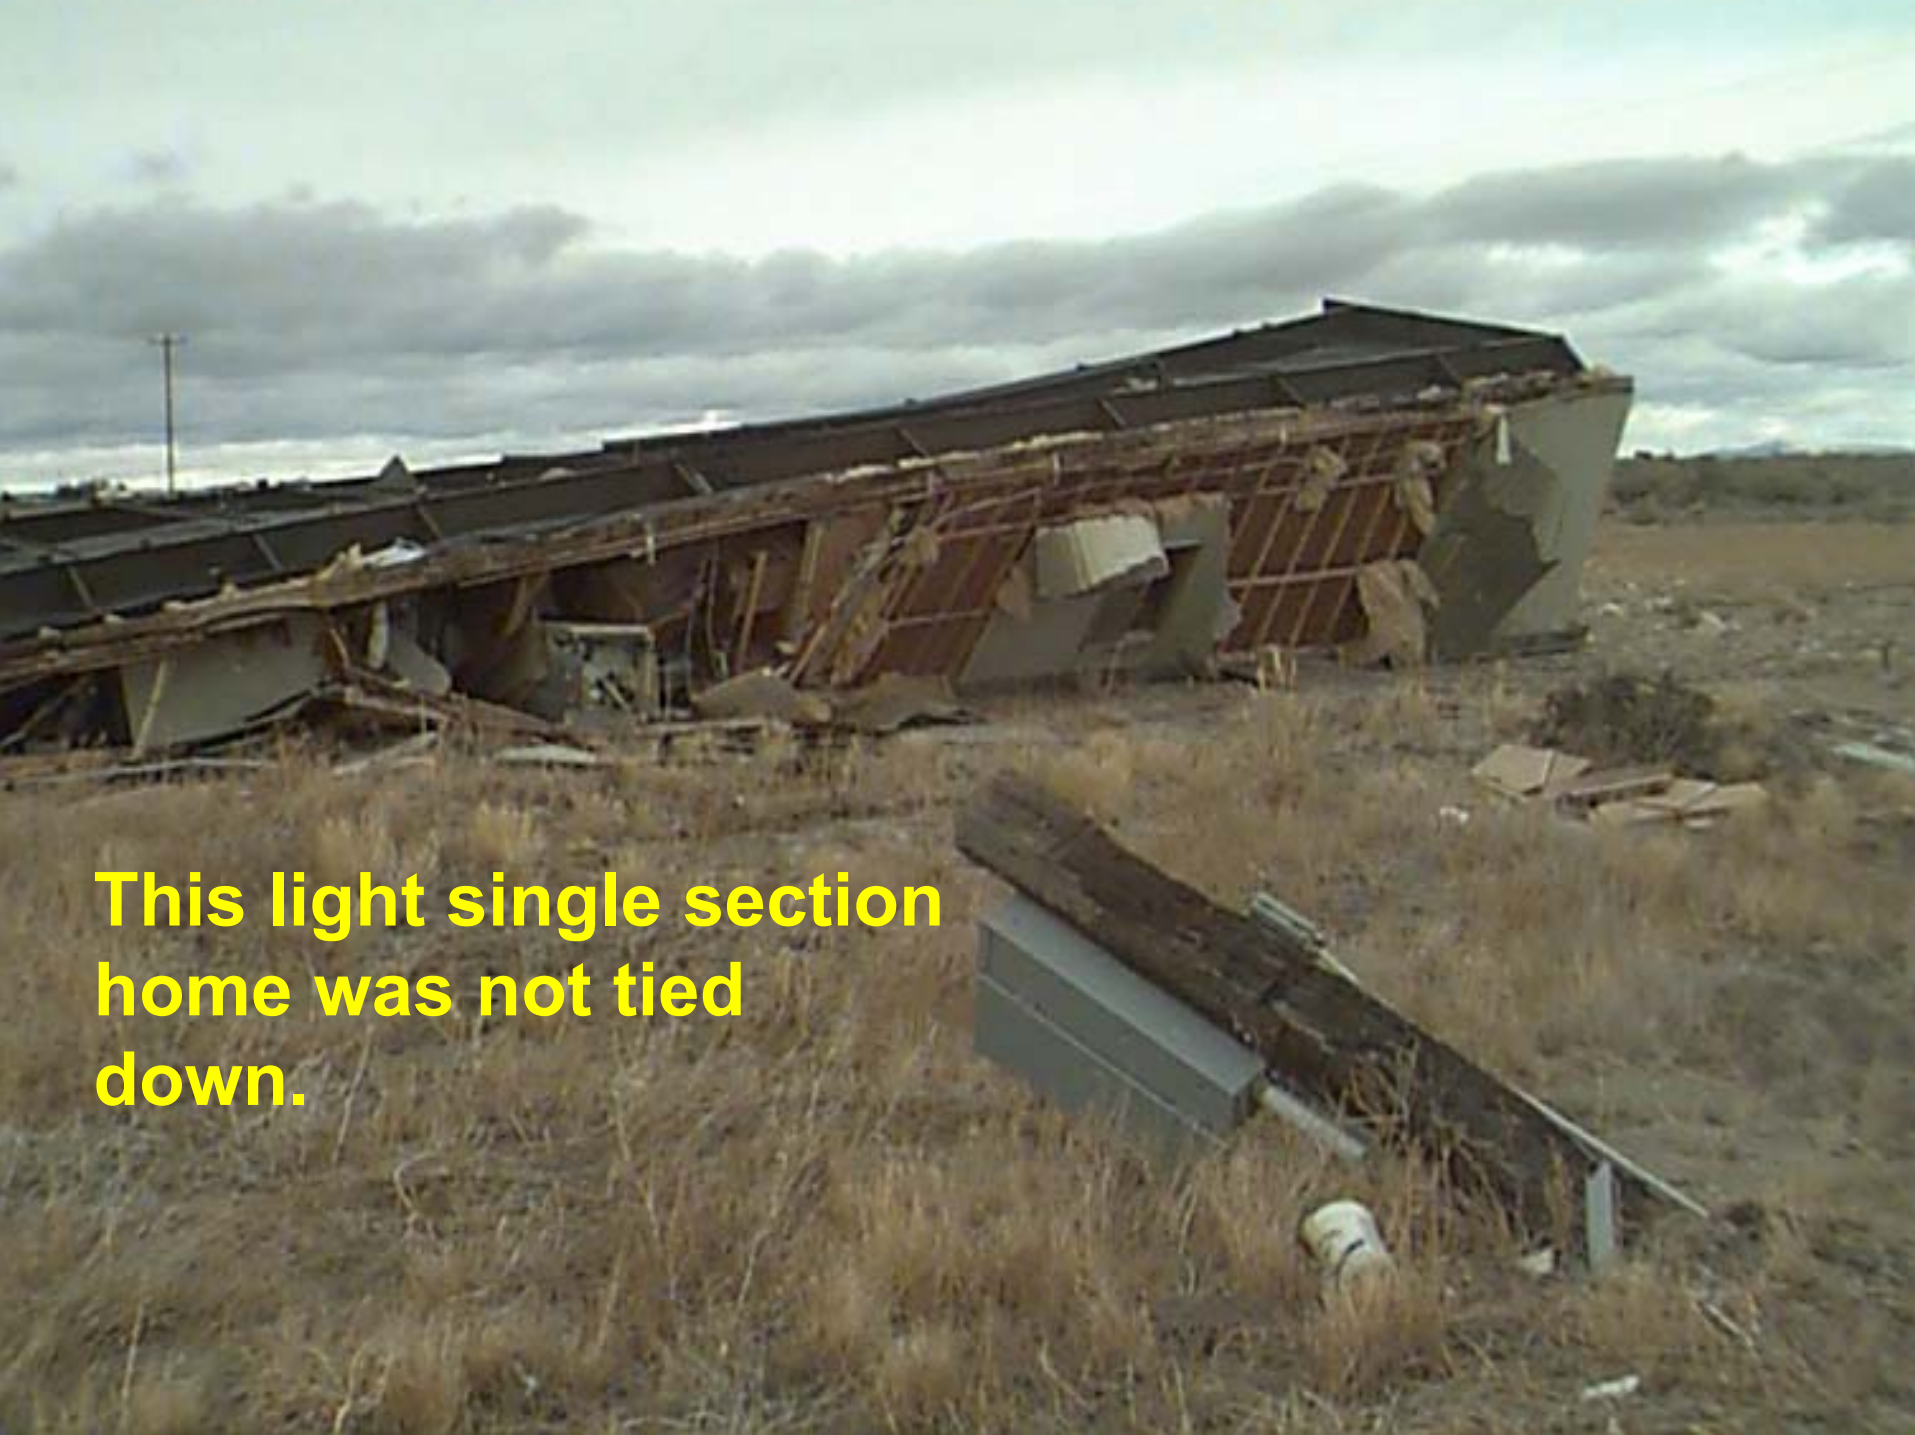
**This light single section home was not tied down.**

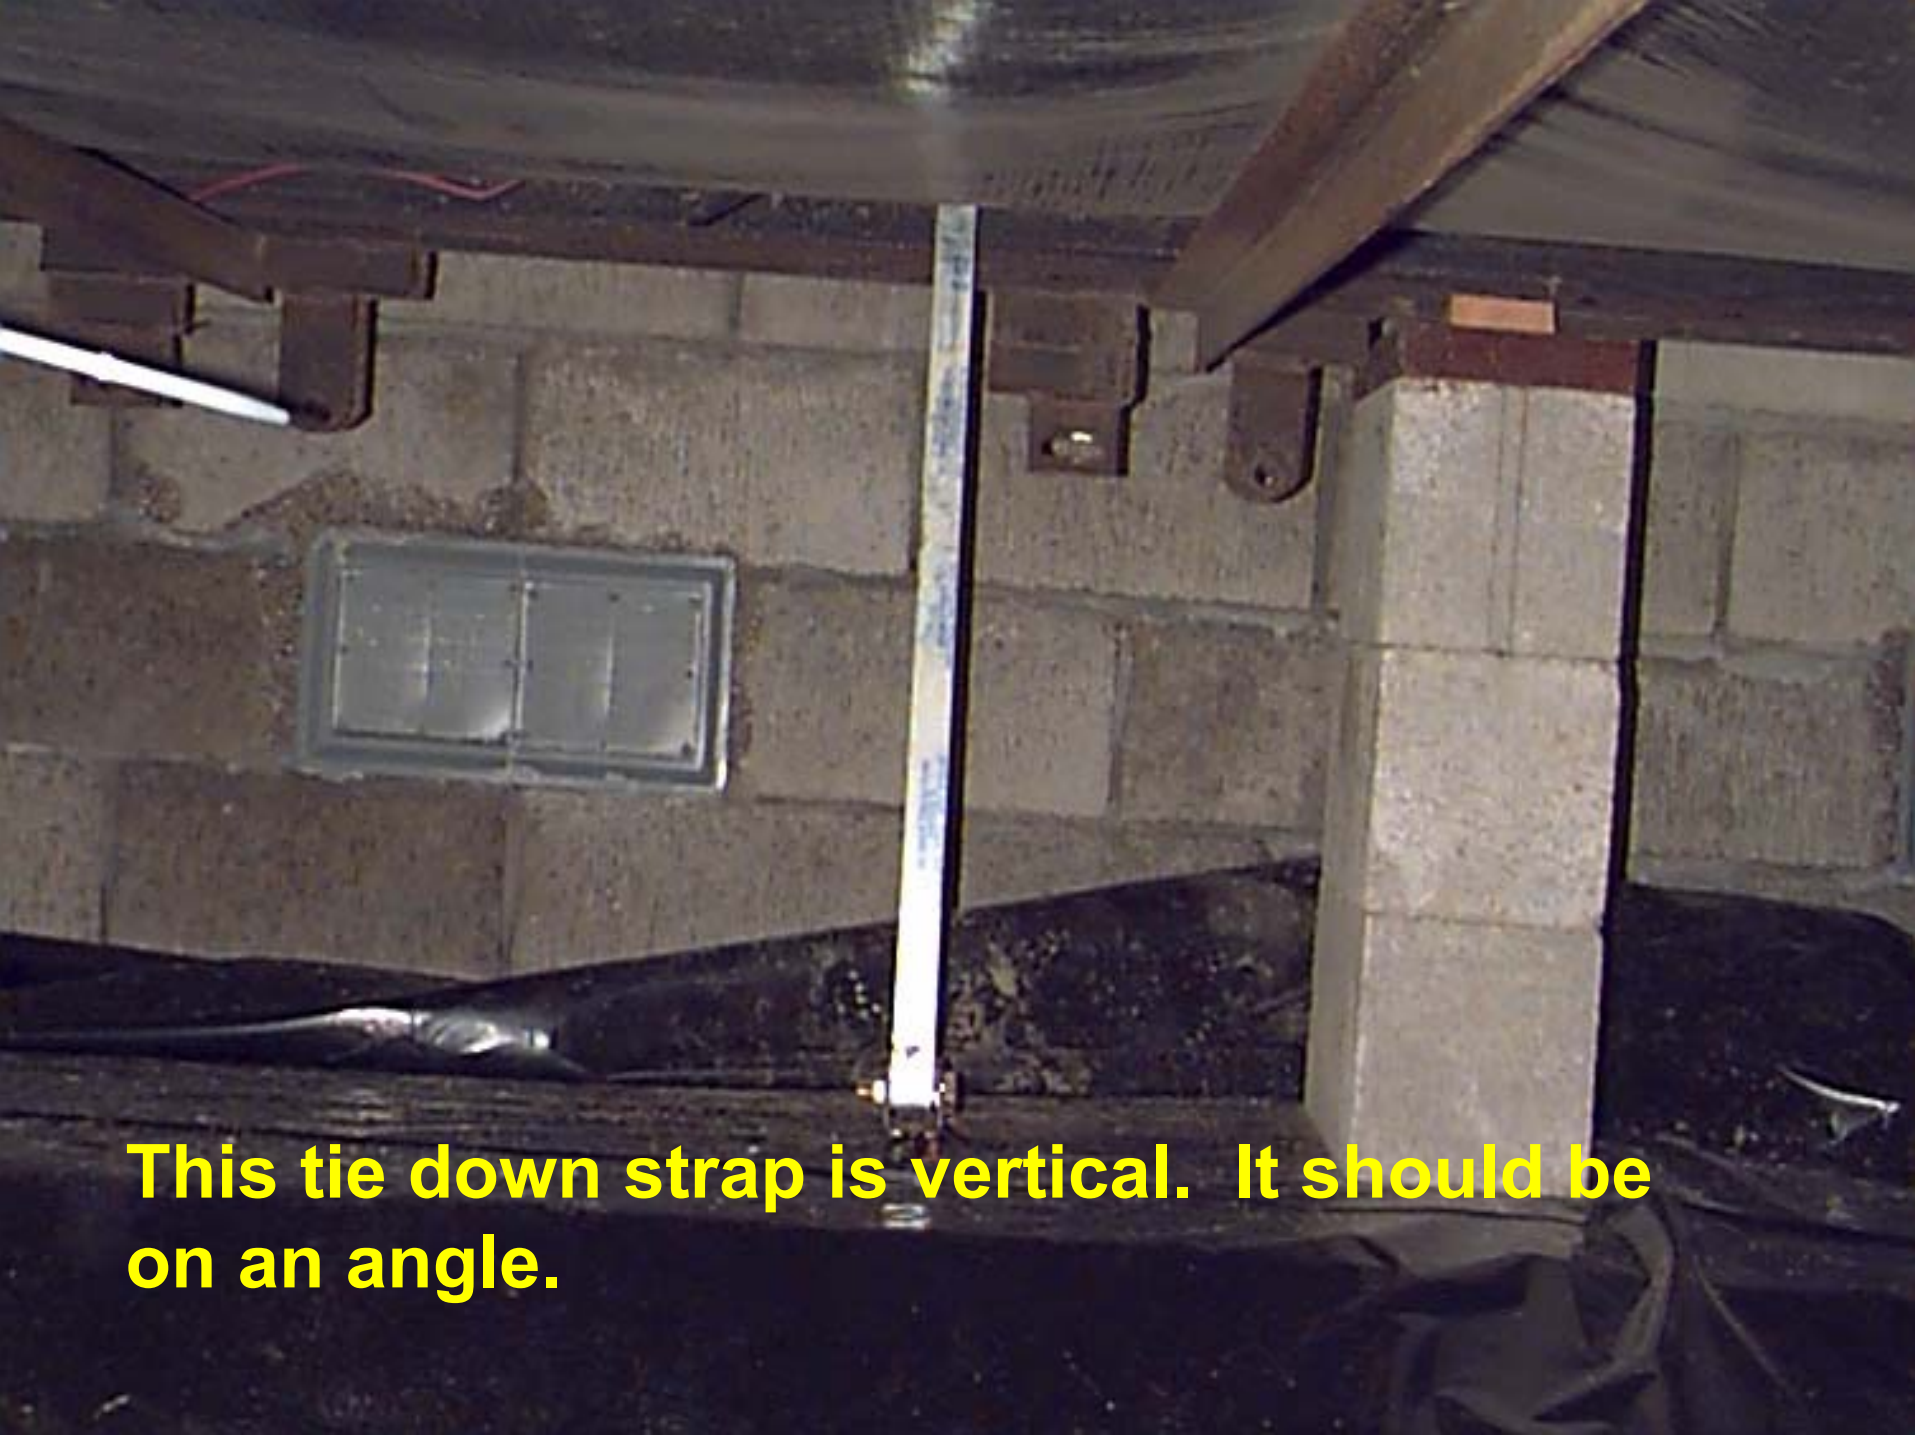
**This tie down strap is vertical. It should be on an angle.**

**Notice the absence of the required perimeter piers.**
