**TRANSPORTATION  
AND OTHER  
DAMAGE**

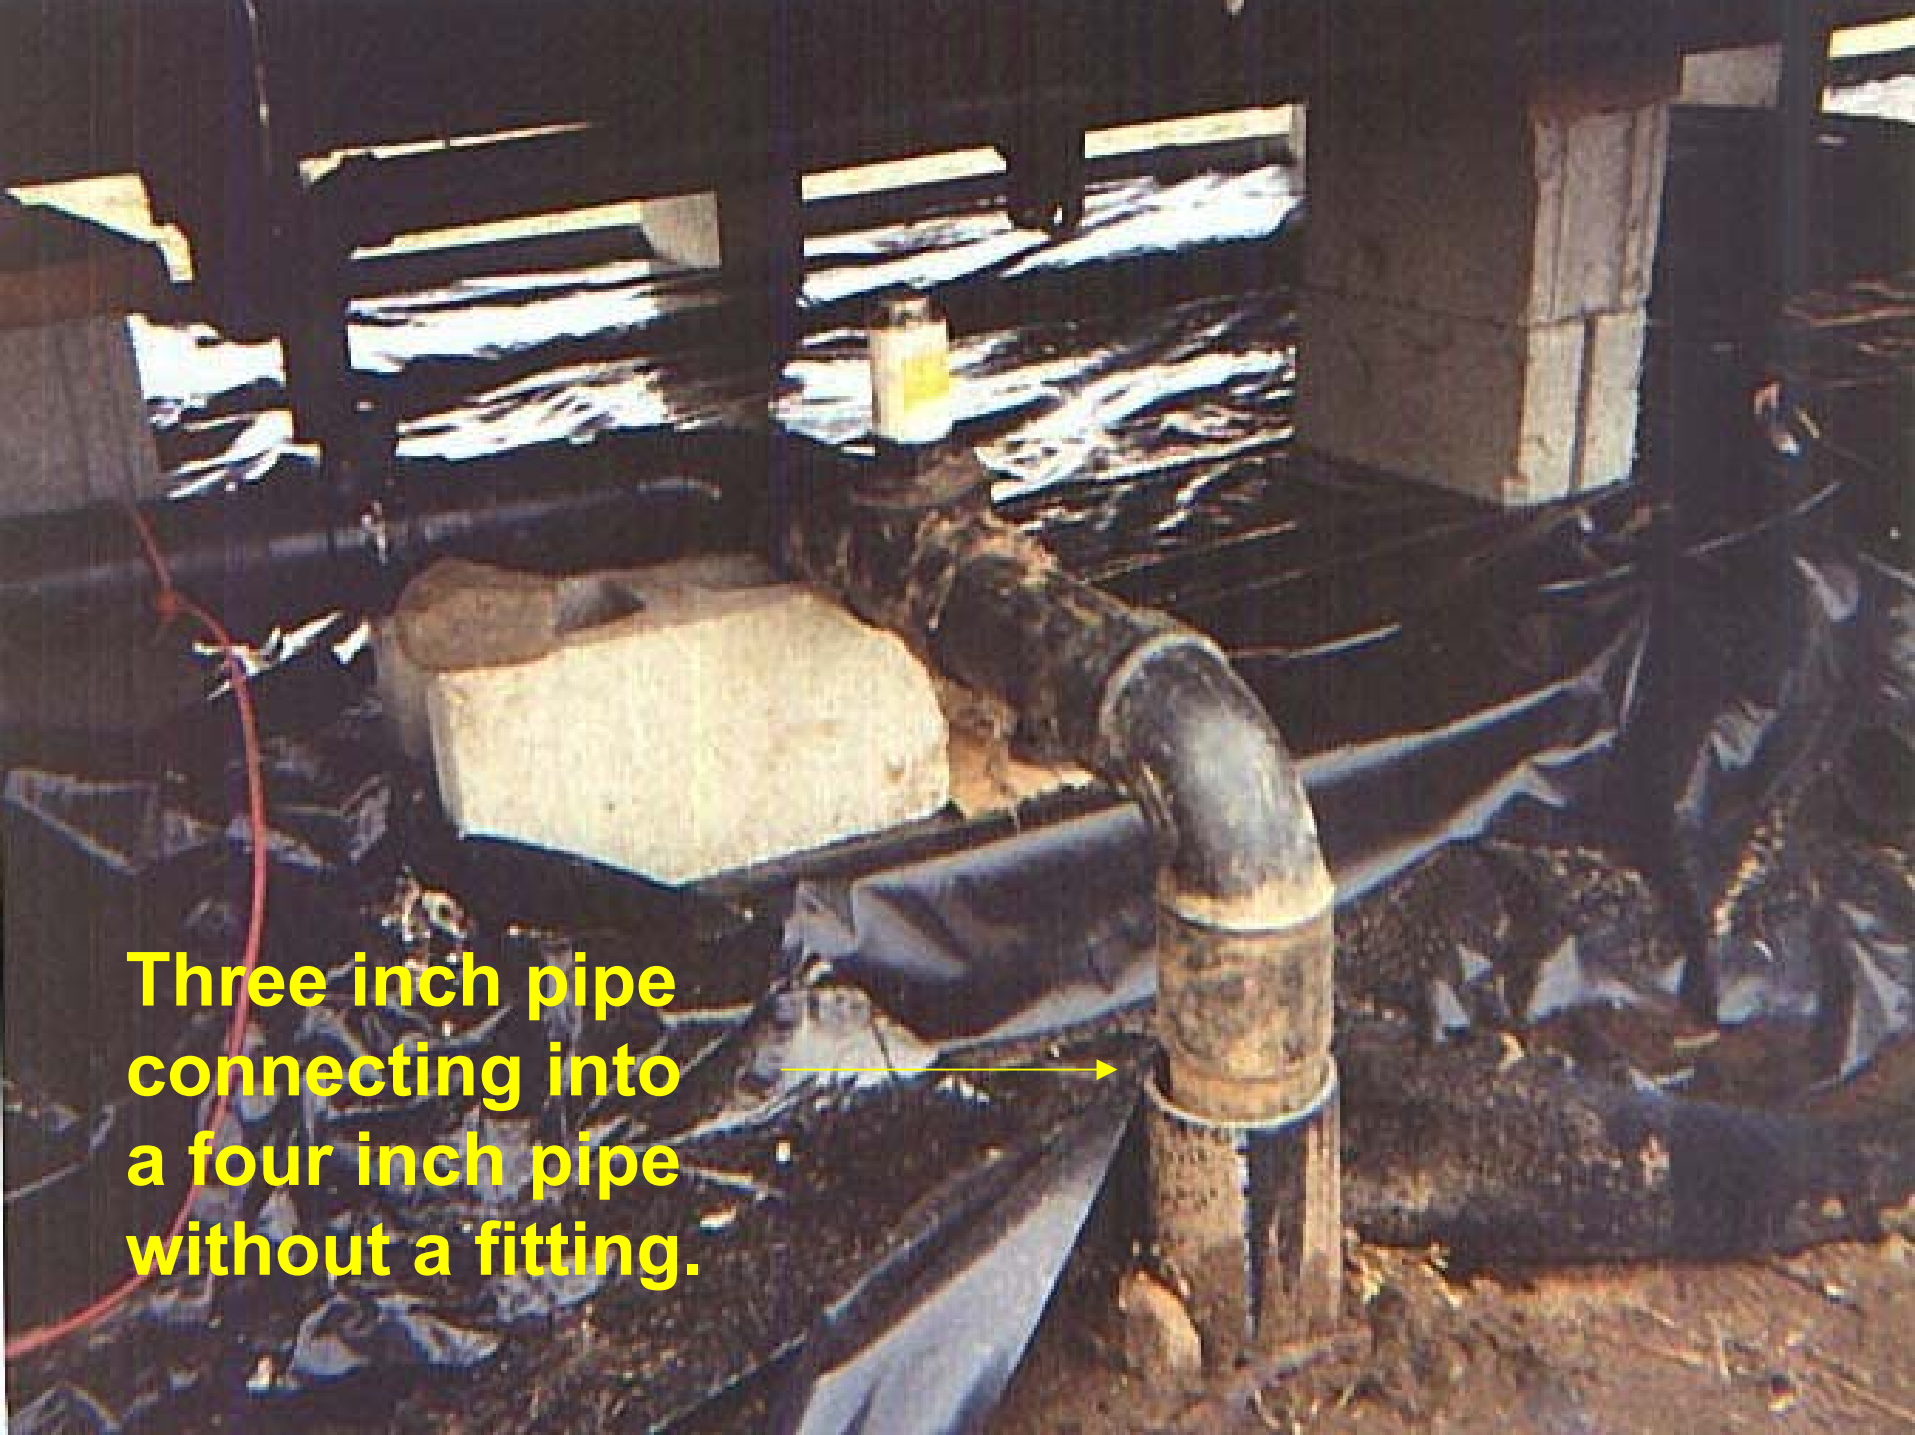
Three inch pipe connecting into a four inch pipe without a fitting.

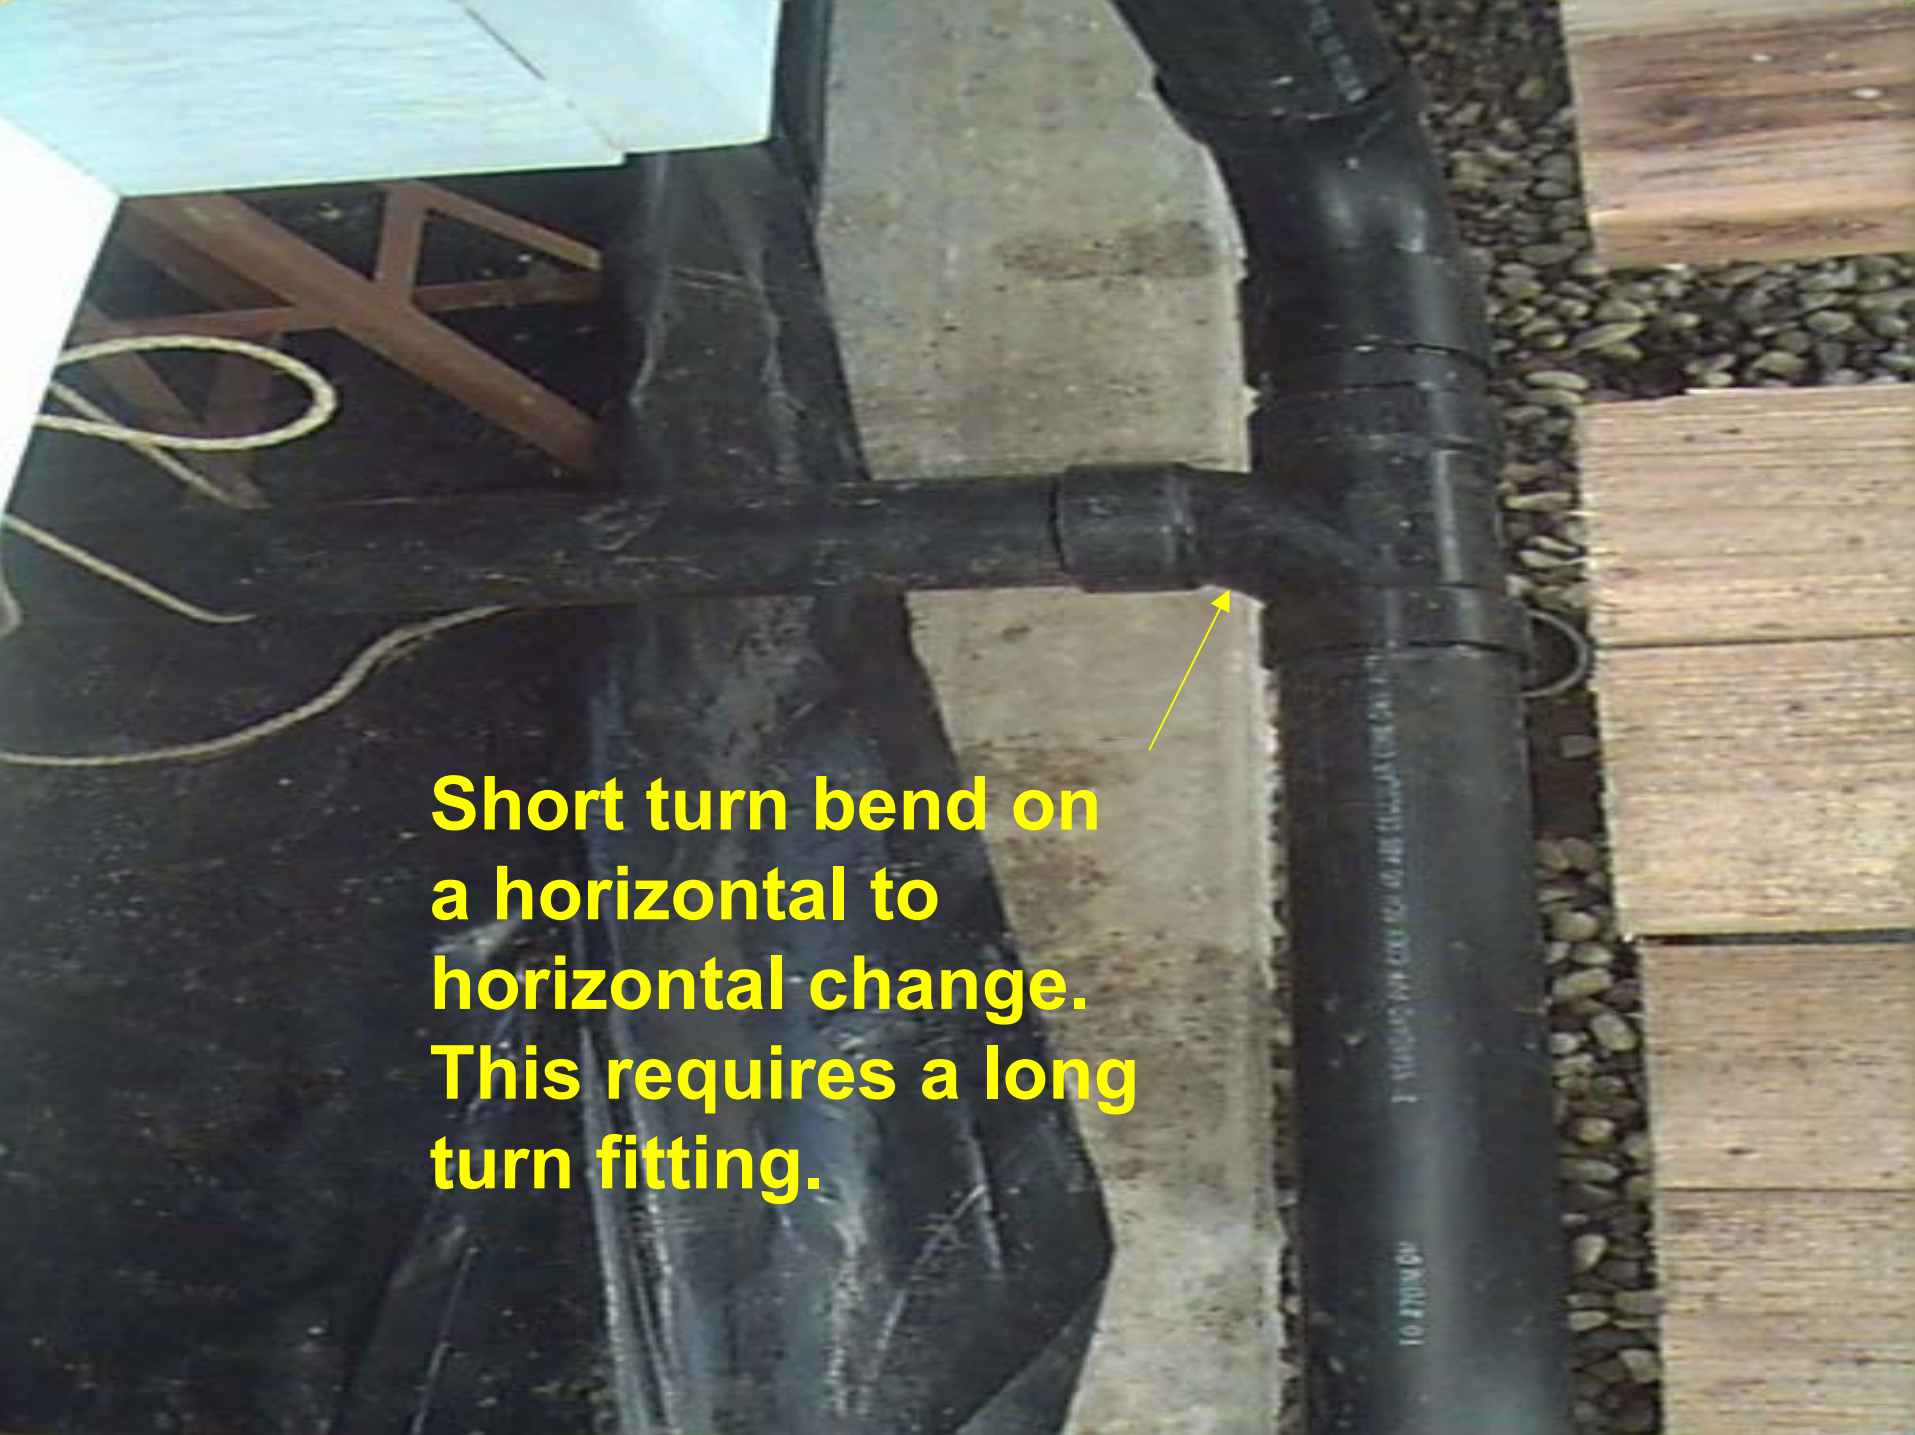
**Short turn bend on  
a horizontal to  
horizontal change.  
This requires a long  
turn fitting.**

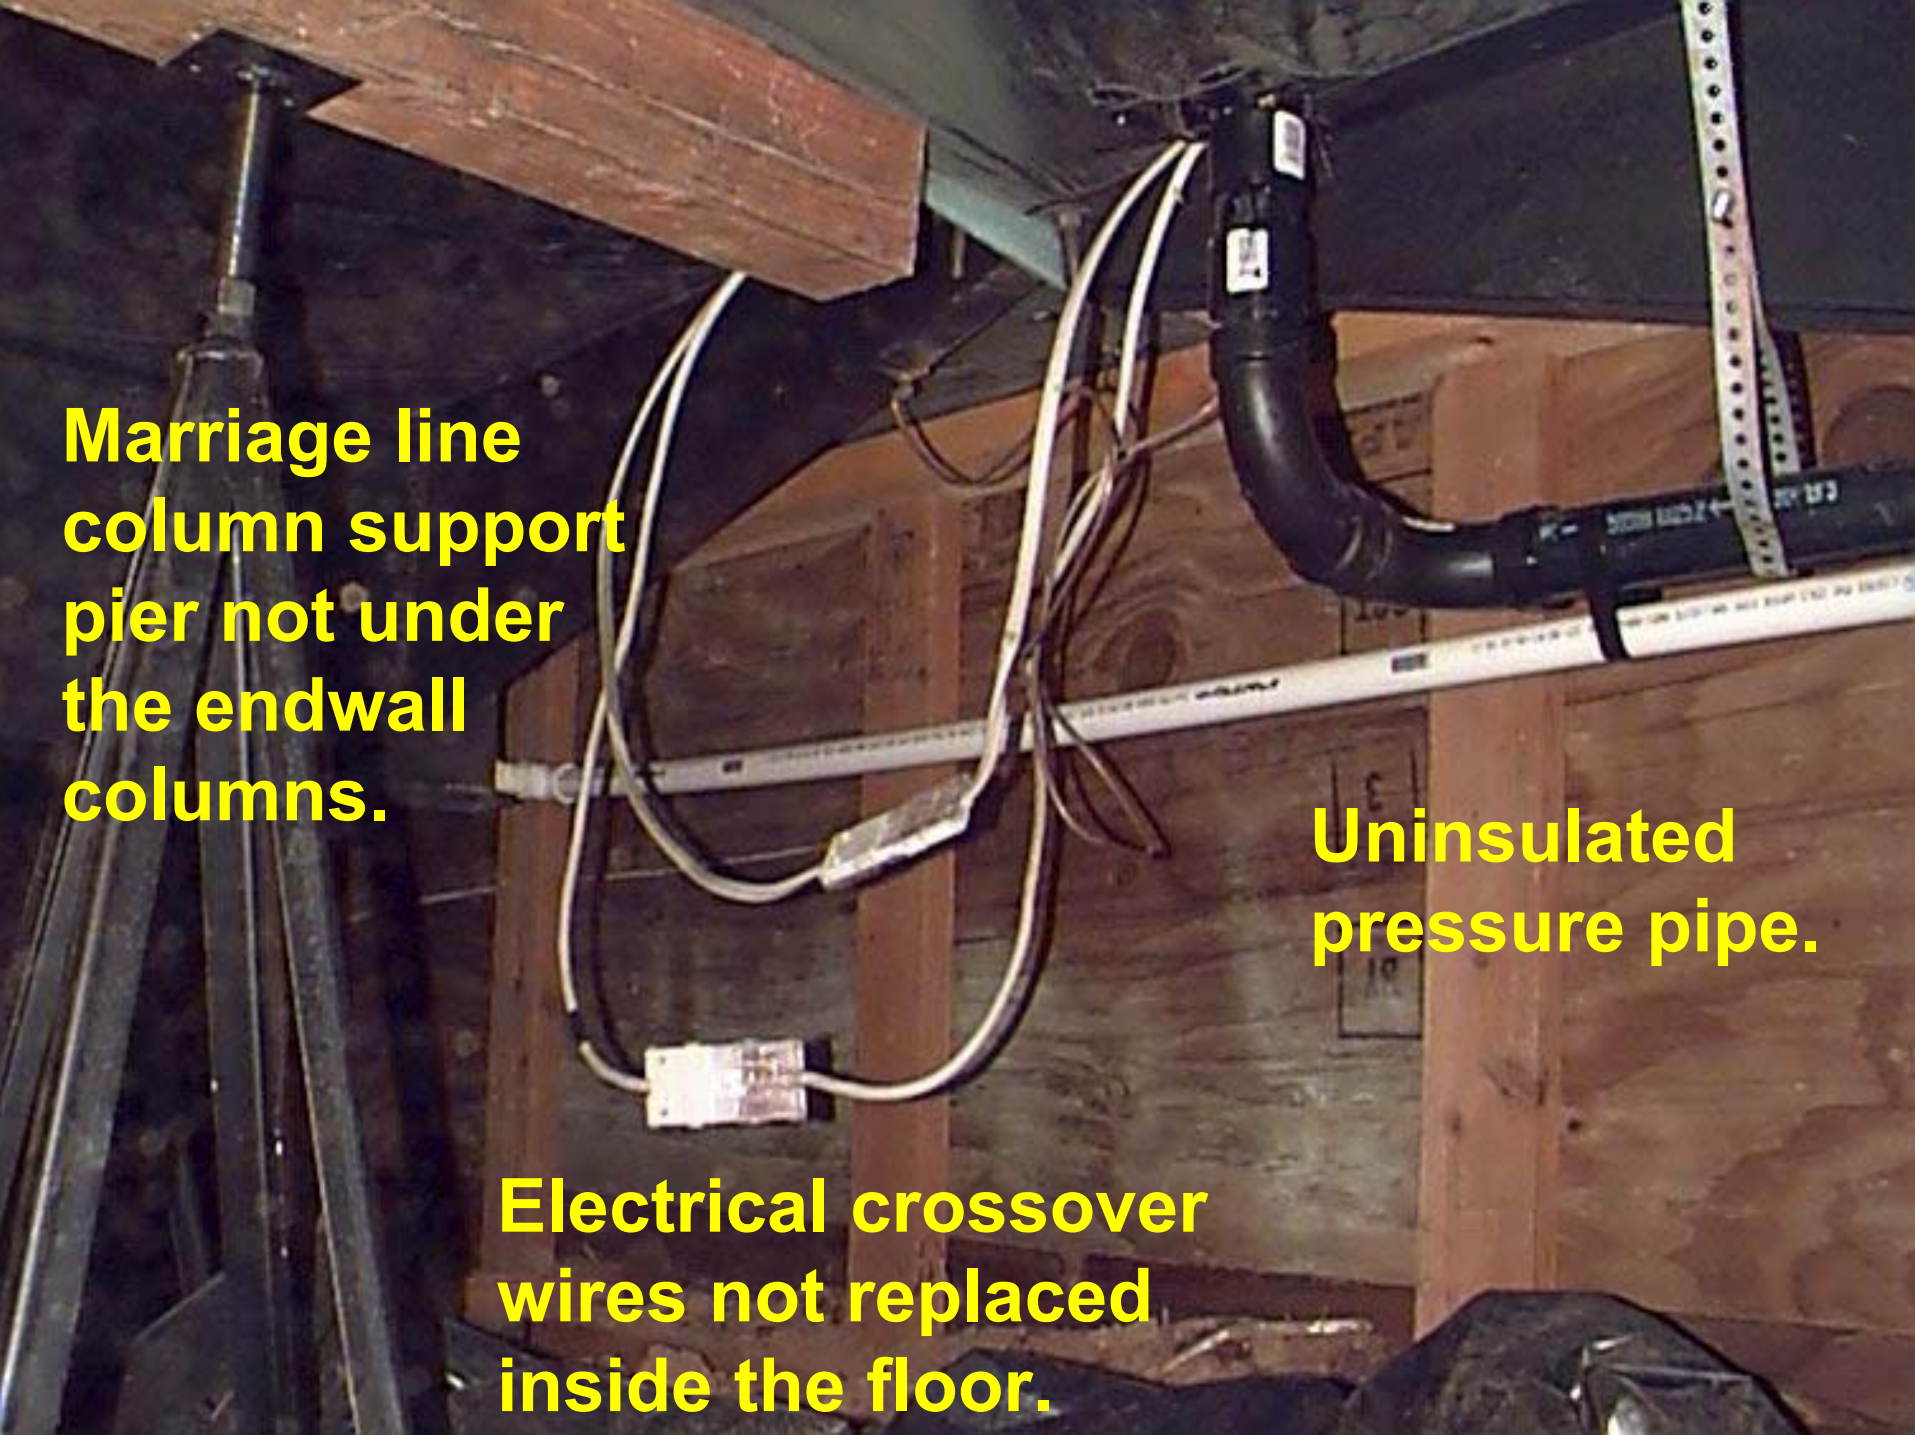
**Marriage line  
column support  
pier not under  
the endwall  
columns.**

**Uninsulated  
pressure pipe.**

**Electrical crossover  
wires not replaced  
inside the floor.**

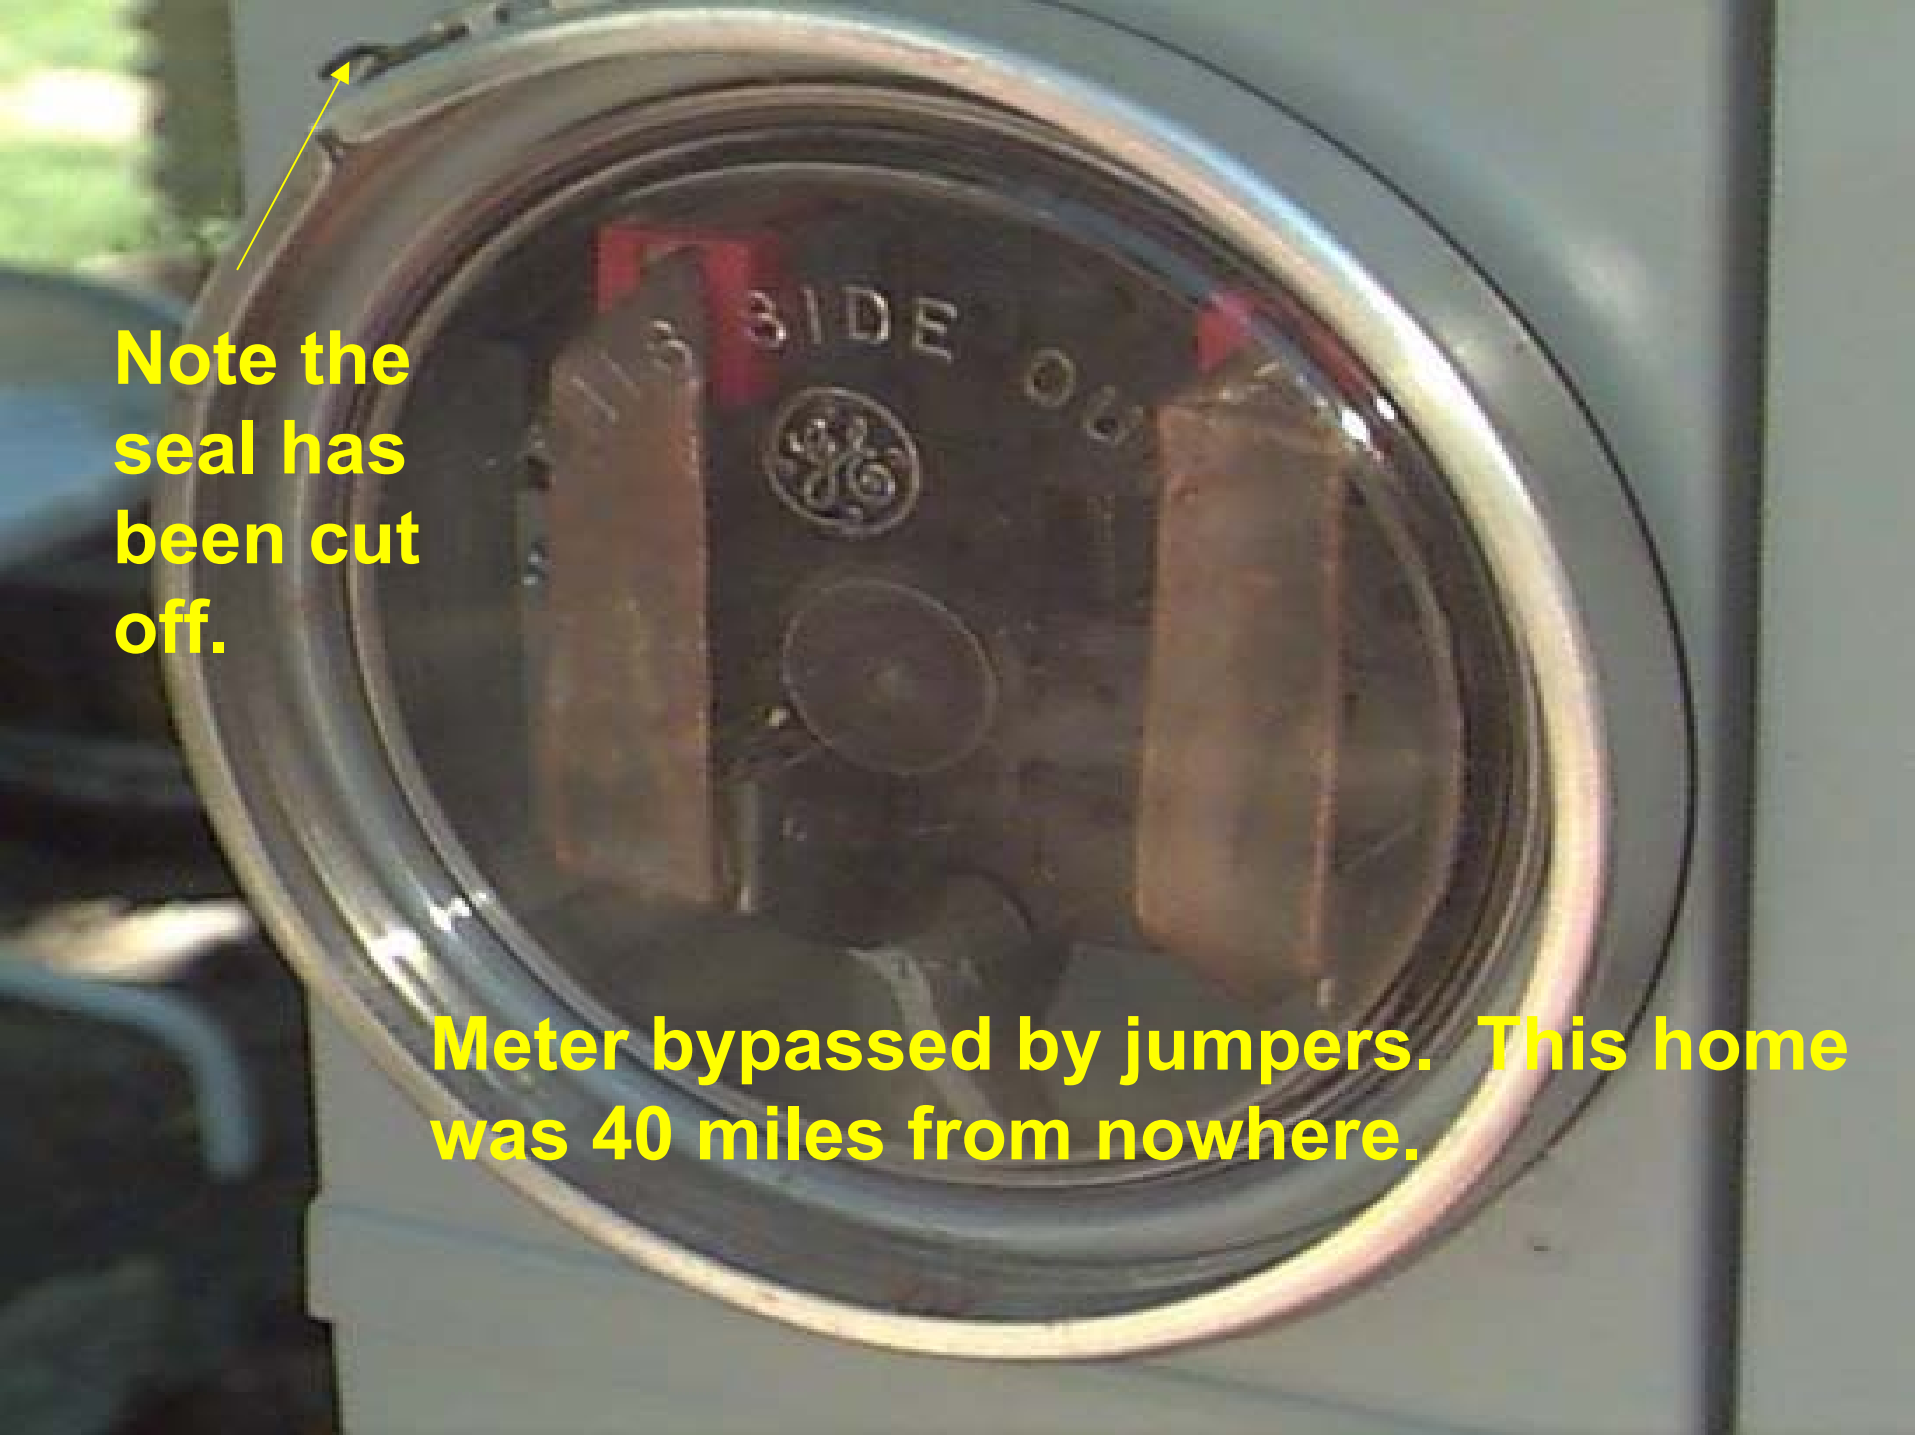
**Note the seal has been cut off.**

**Meter bypassed by jumpers. This home was 40 miles from nowhere.**

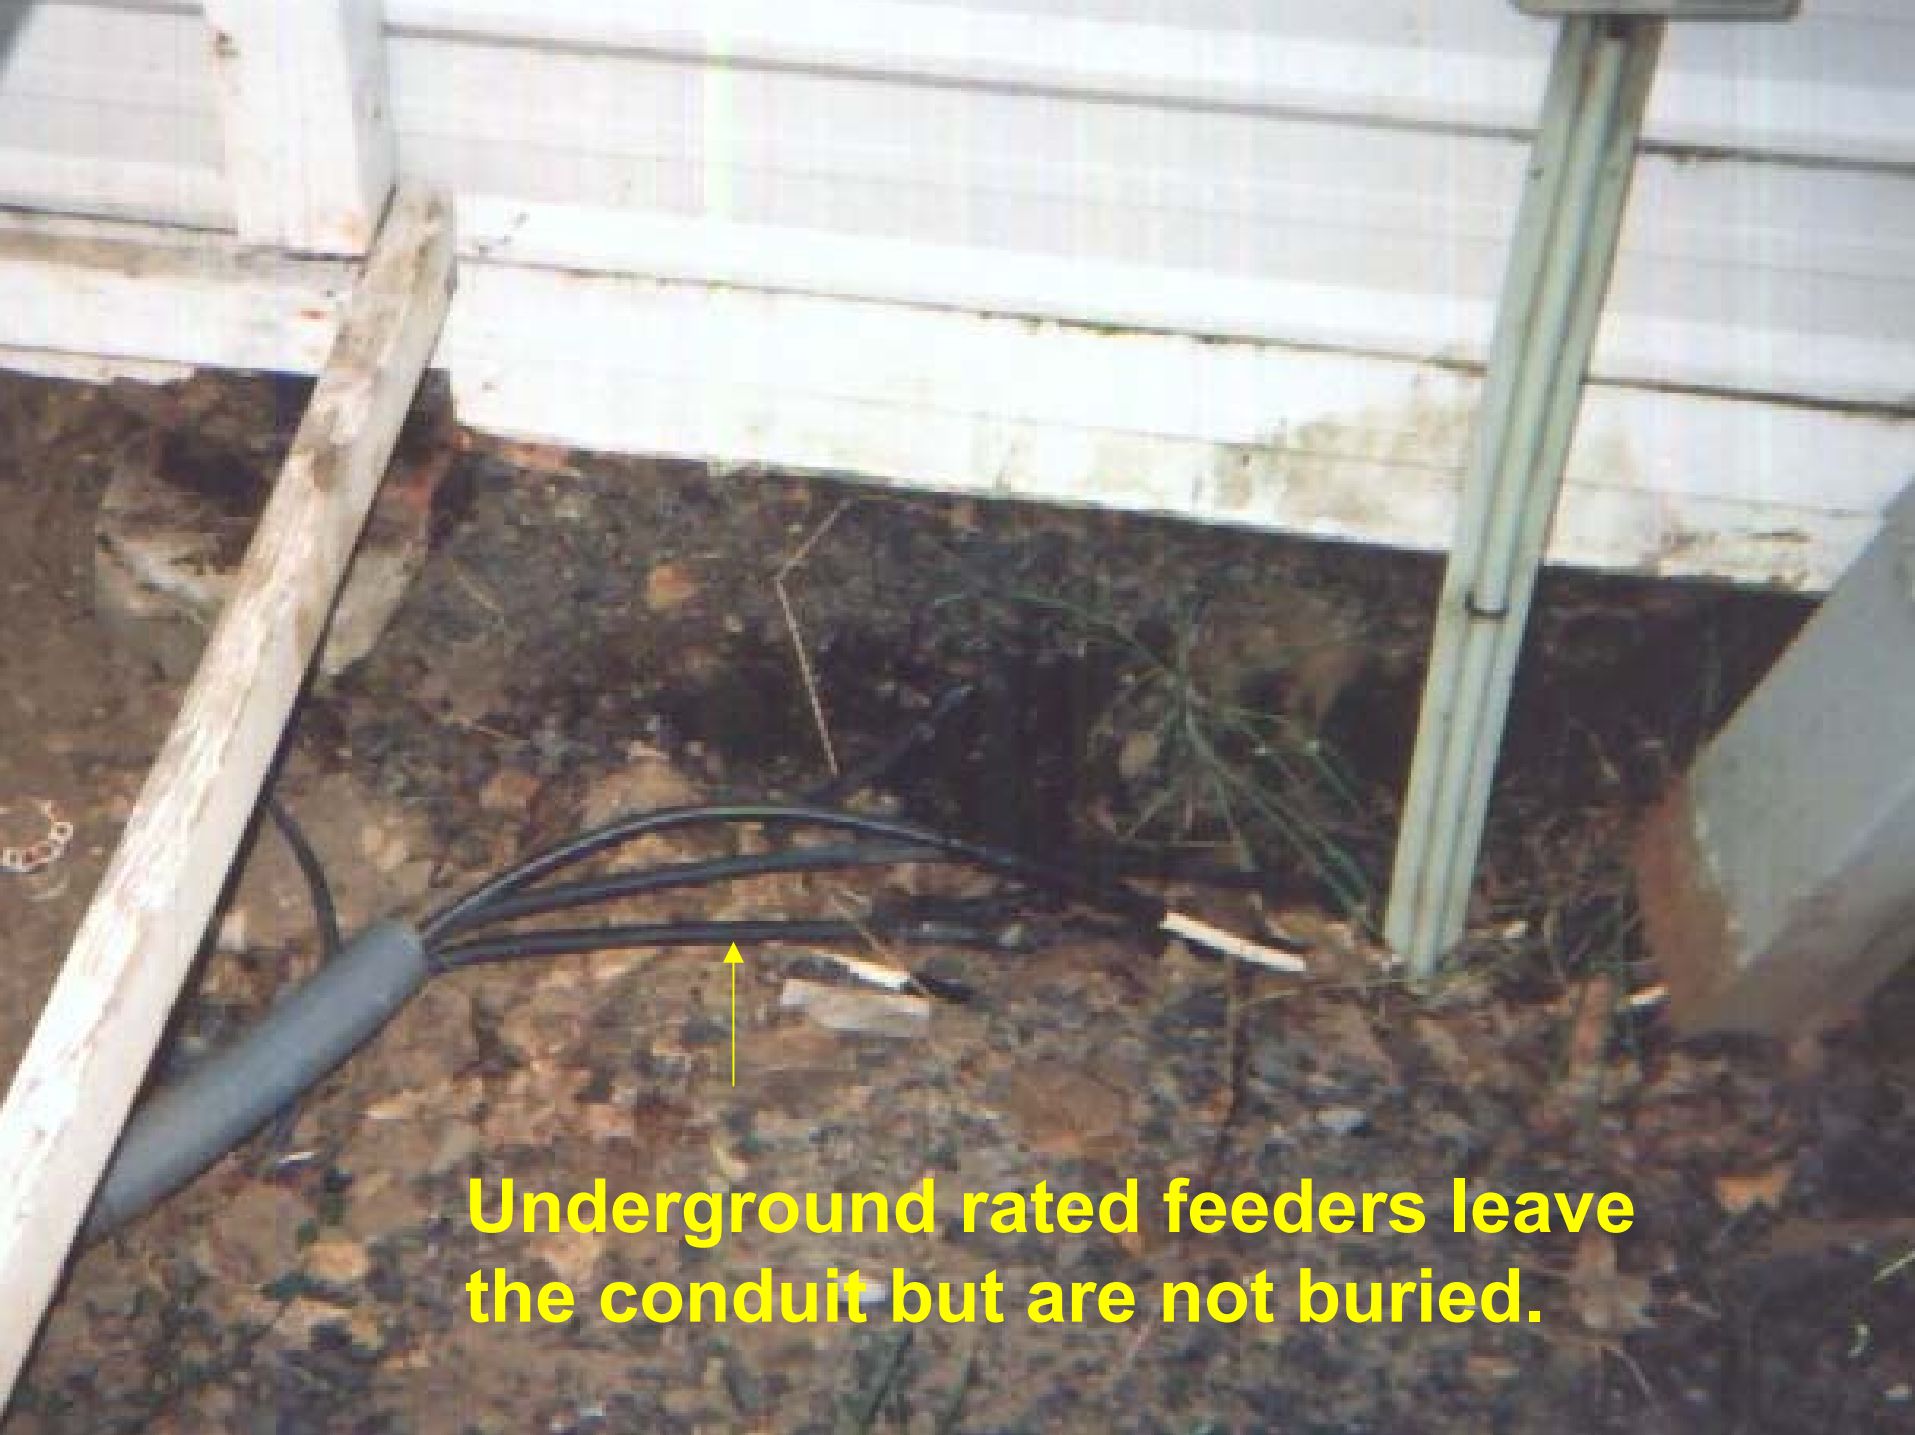
**Underground rated feeders leave the conduit but are not buried.**

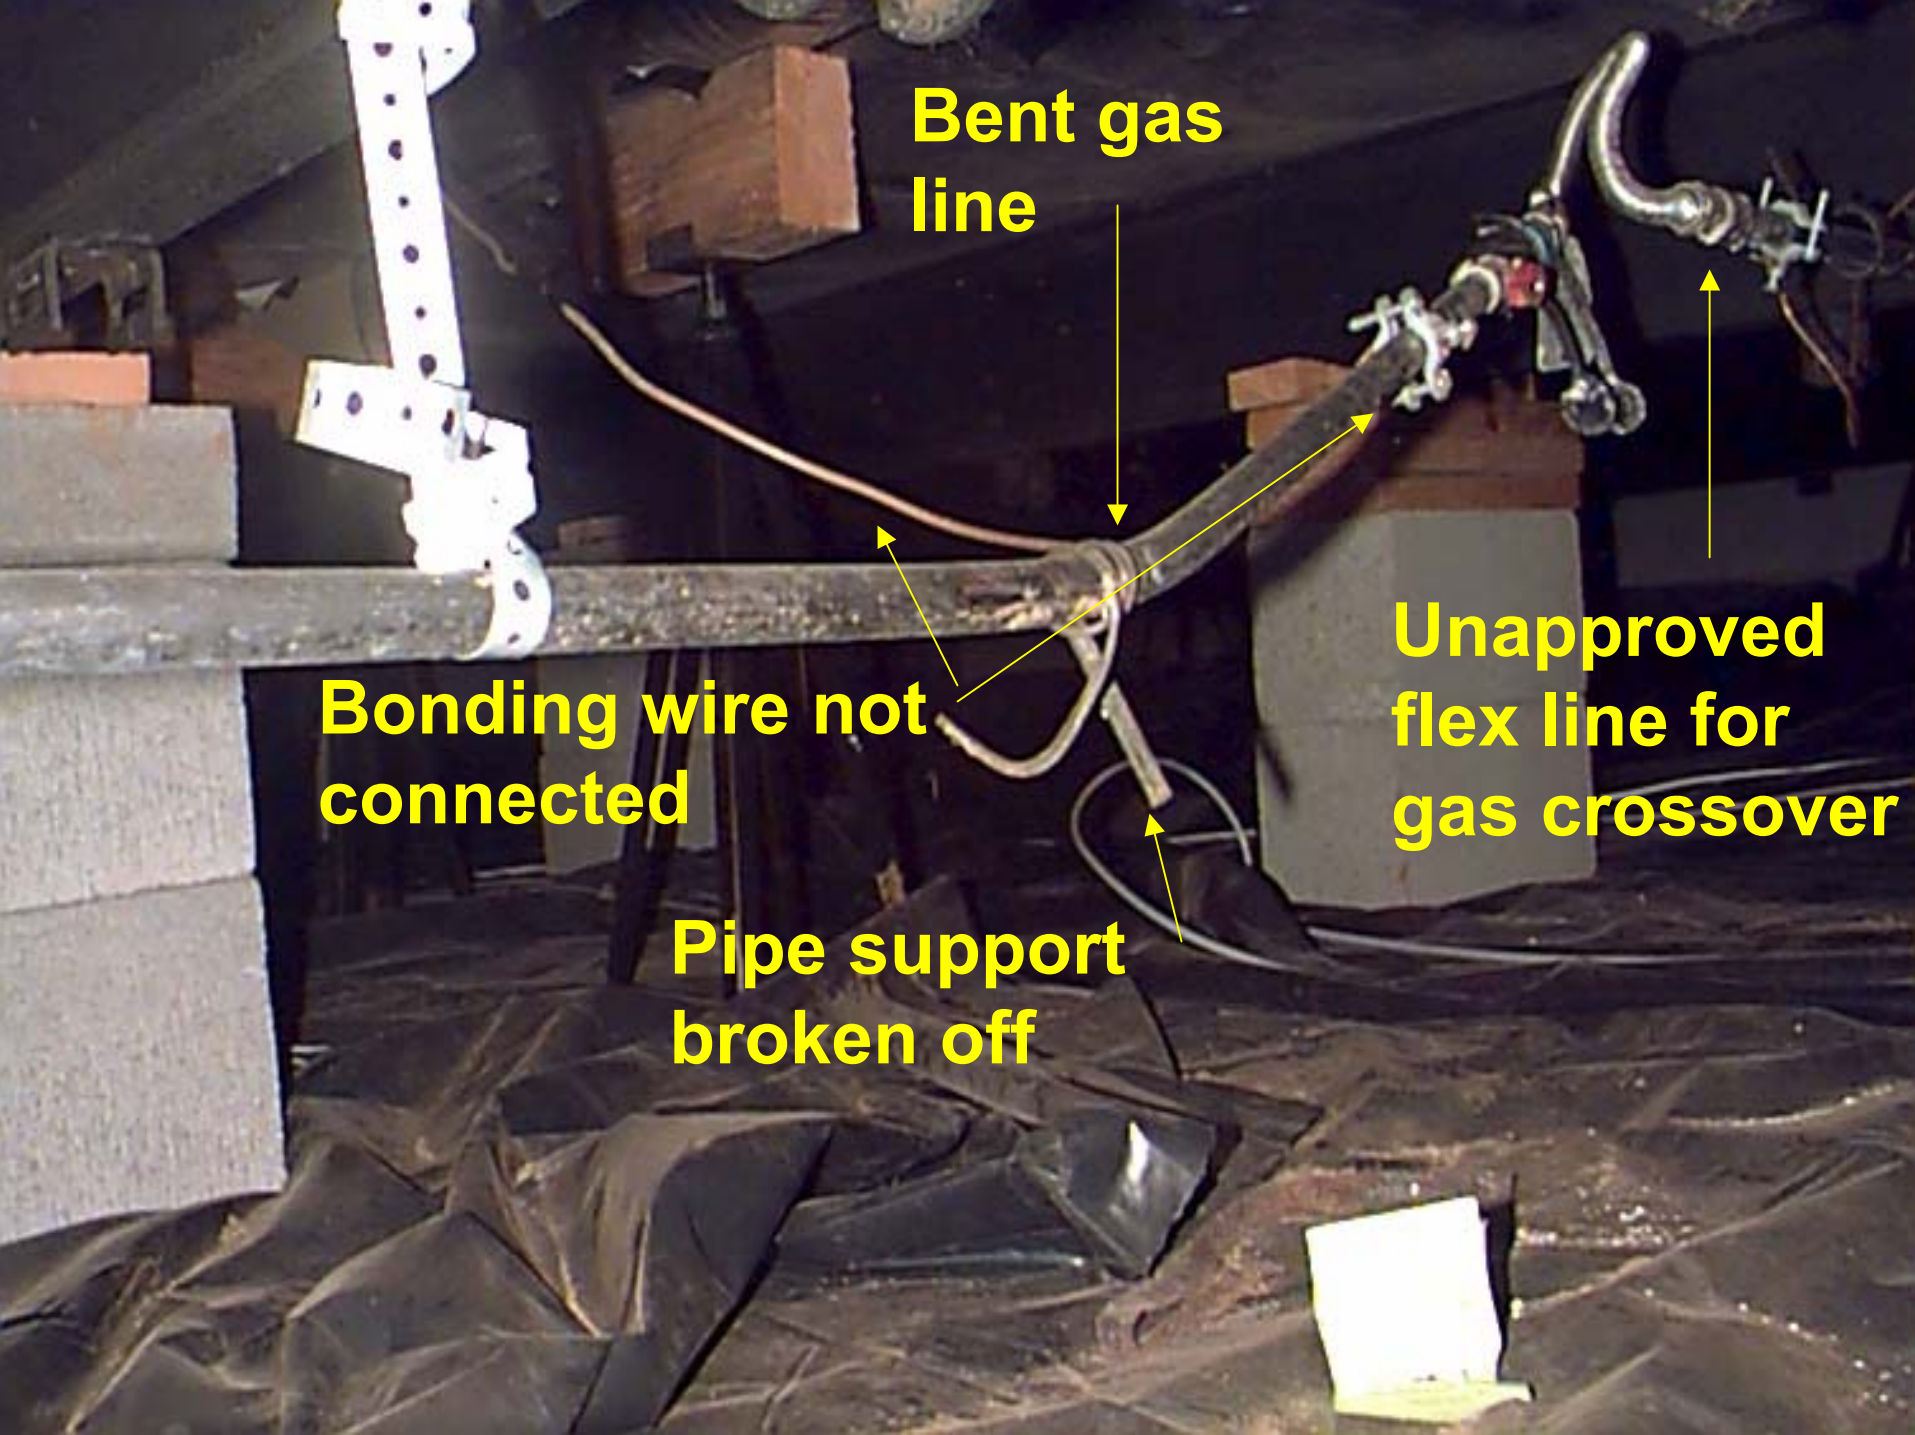
**Bent gas line**

**Bonding wire not connected**

**Pipe support broken off**

**Unapproved flex line for gas crossover**

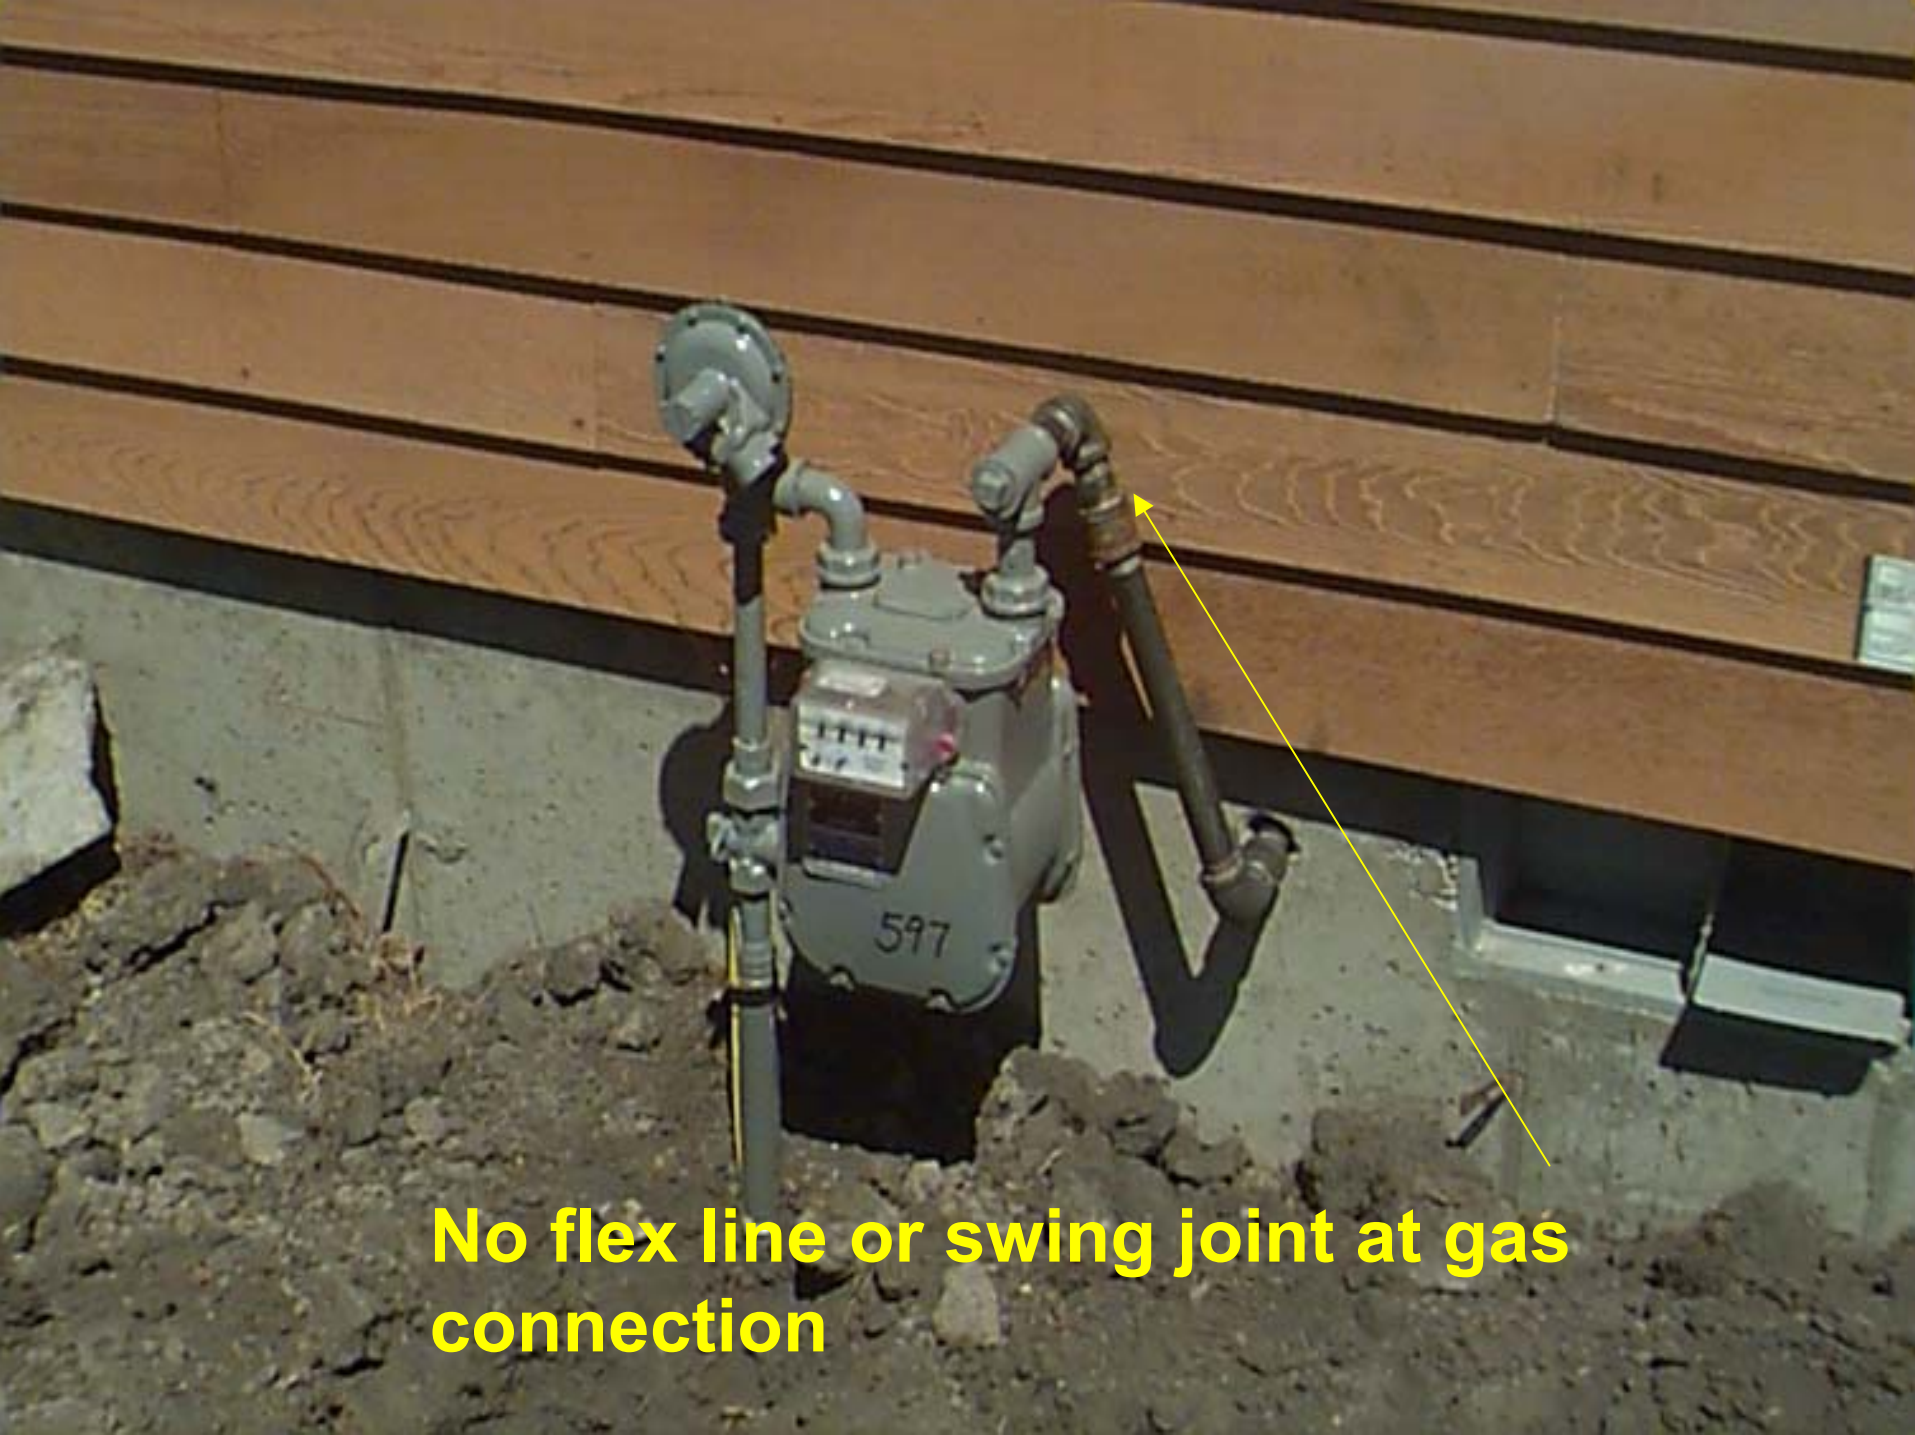
**No flex line or swing joint at gas connection**

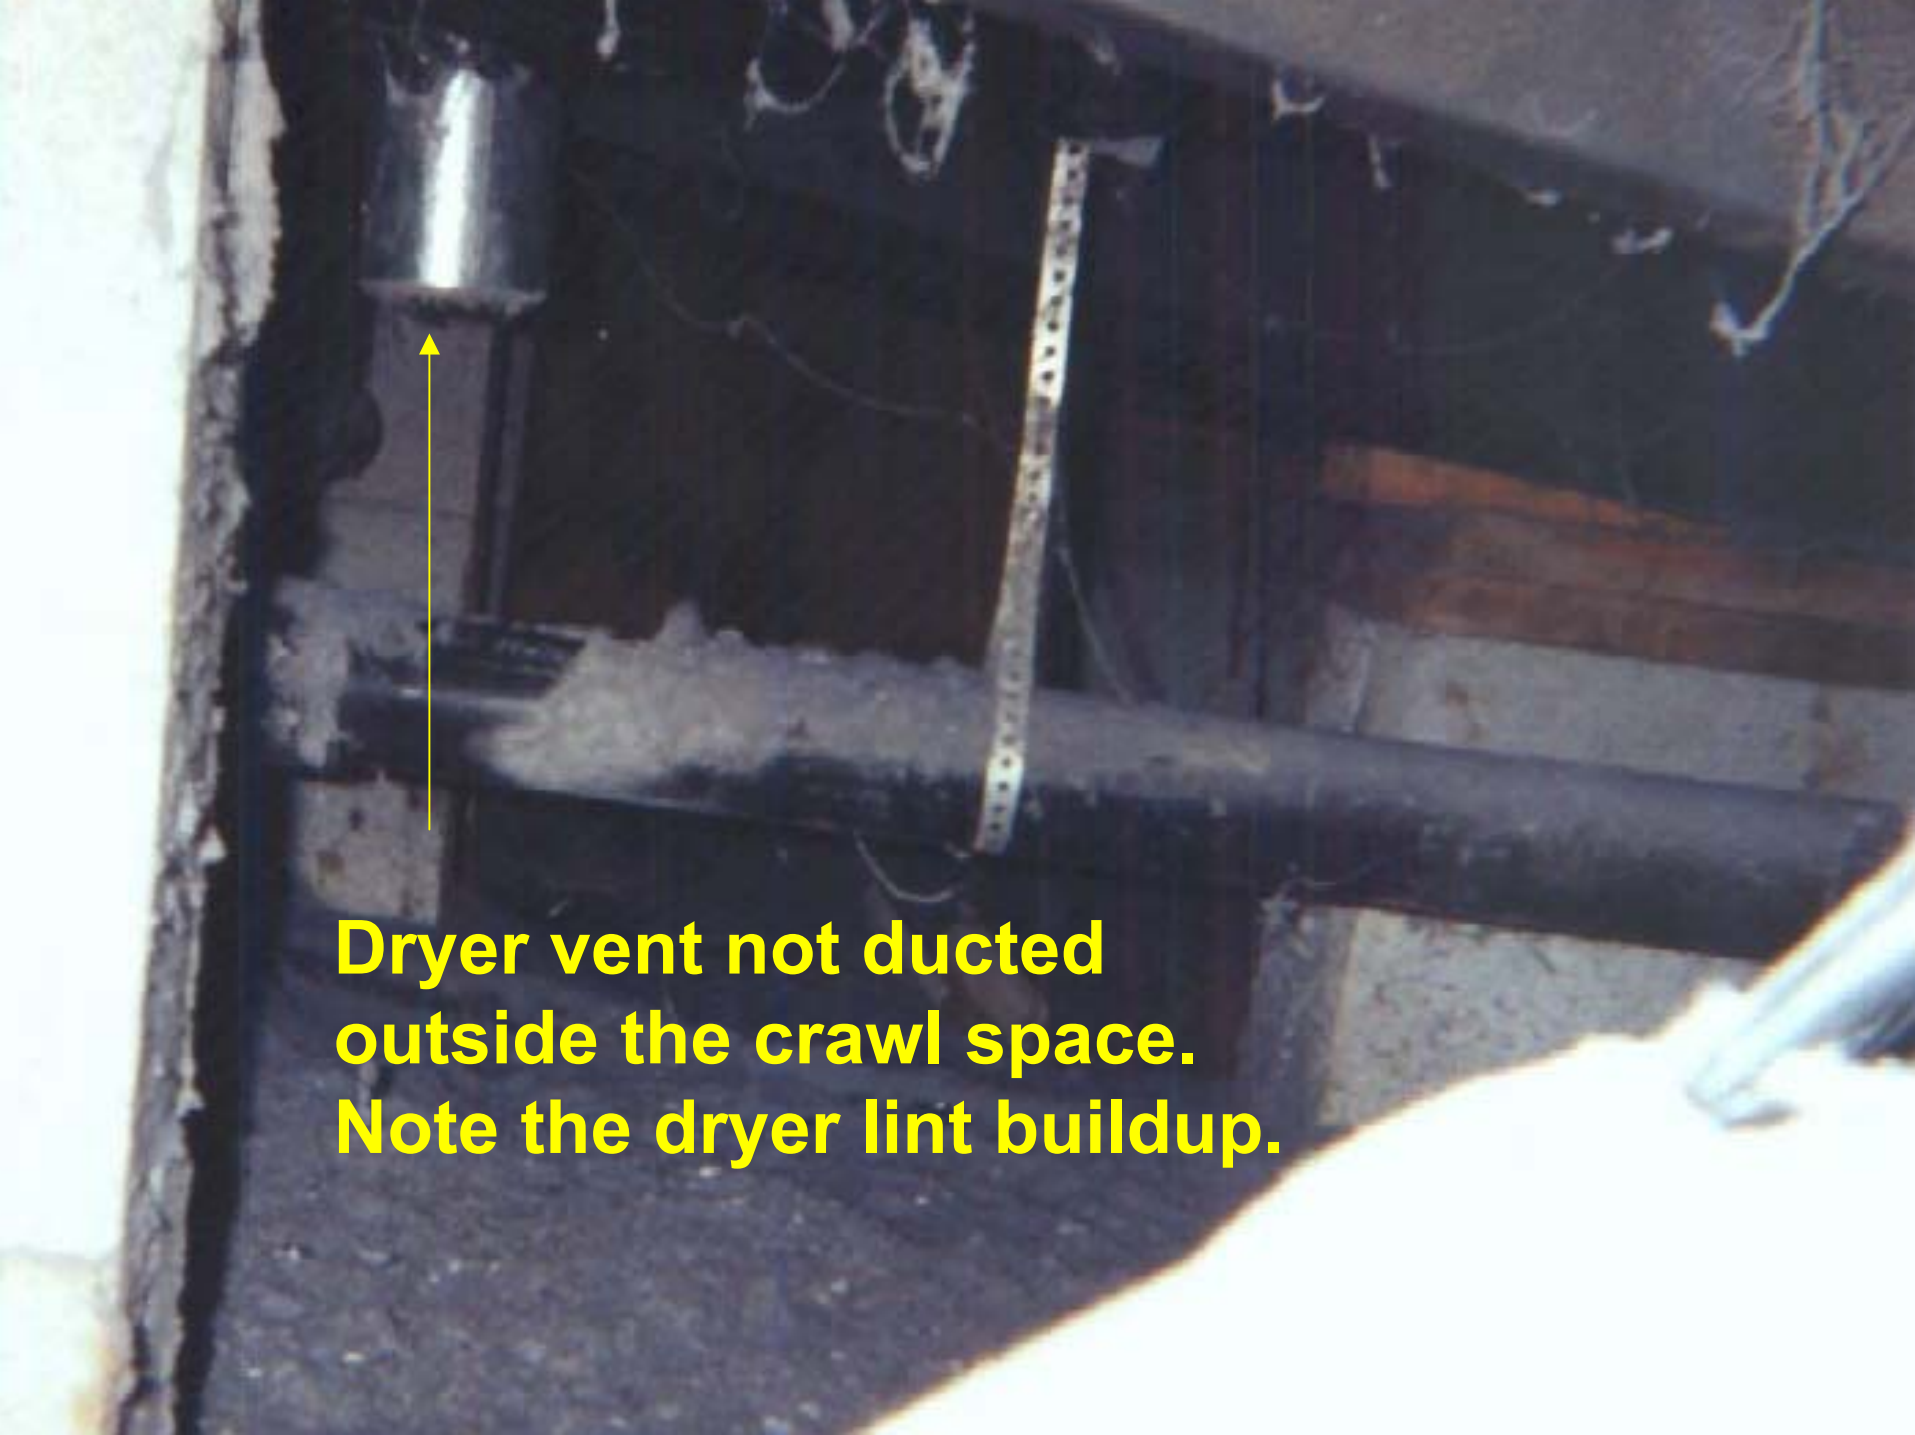
**Dryer vent not ducted  
outside the crawl space.  
Note the dryer lint buildup.**
