**TRANSPORTATION  
AND OTHER  
DAMAGE**

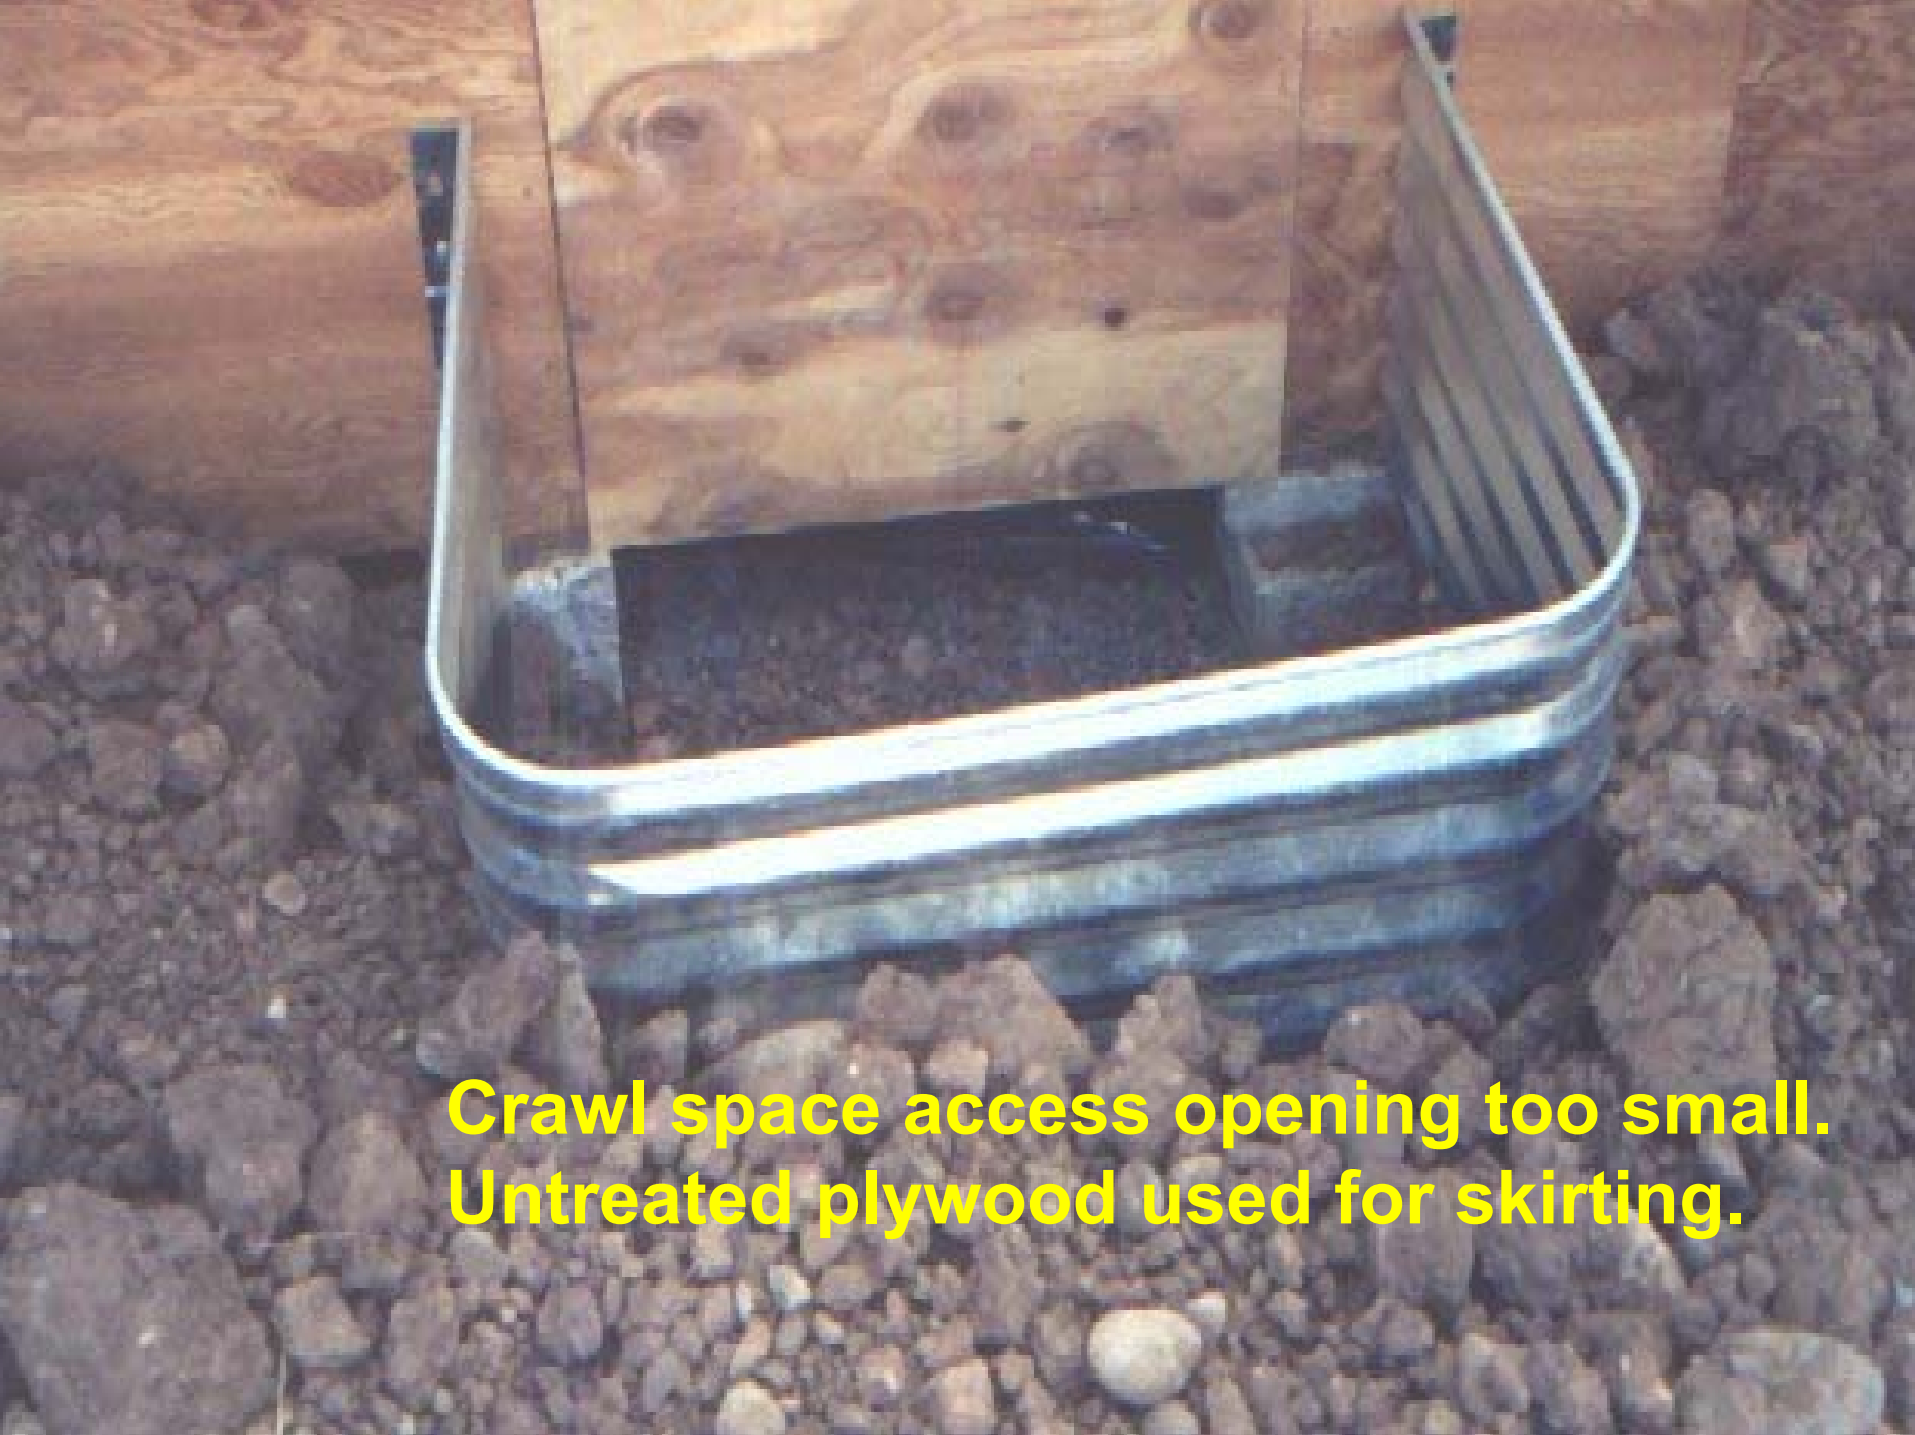
**Crawl space access opening too small.  
Untreated plywood used for skirting.**

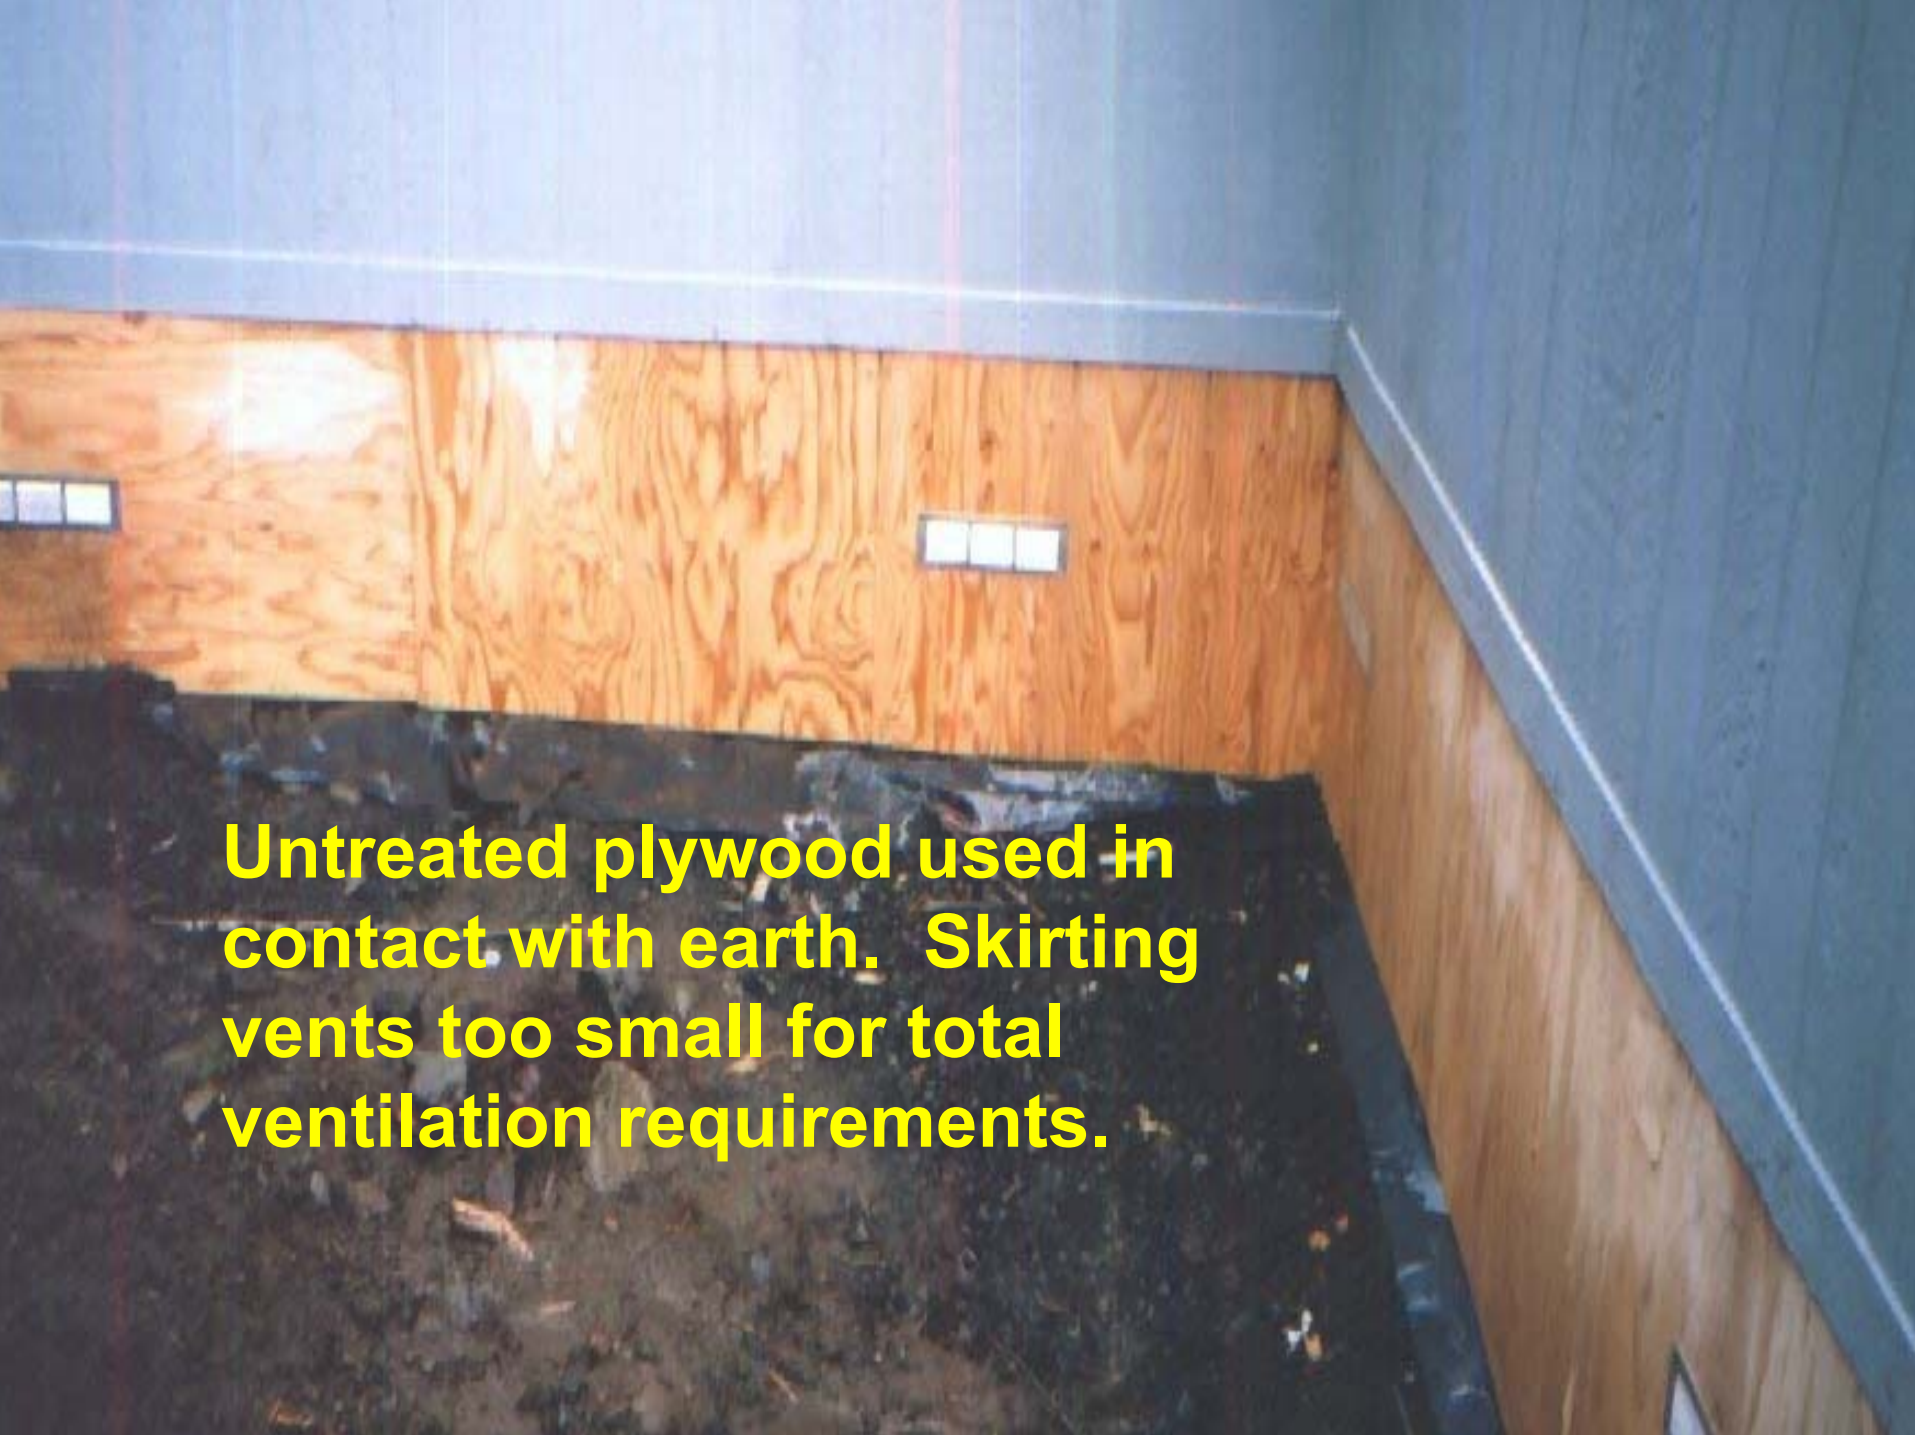
**Untreated plywood used in contact with earth. Skirting vents too small for total ventilation requirements.**

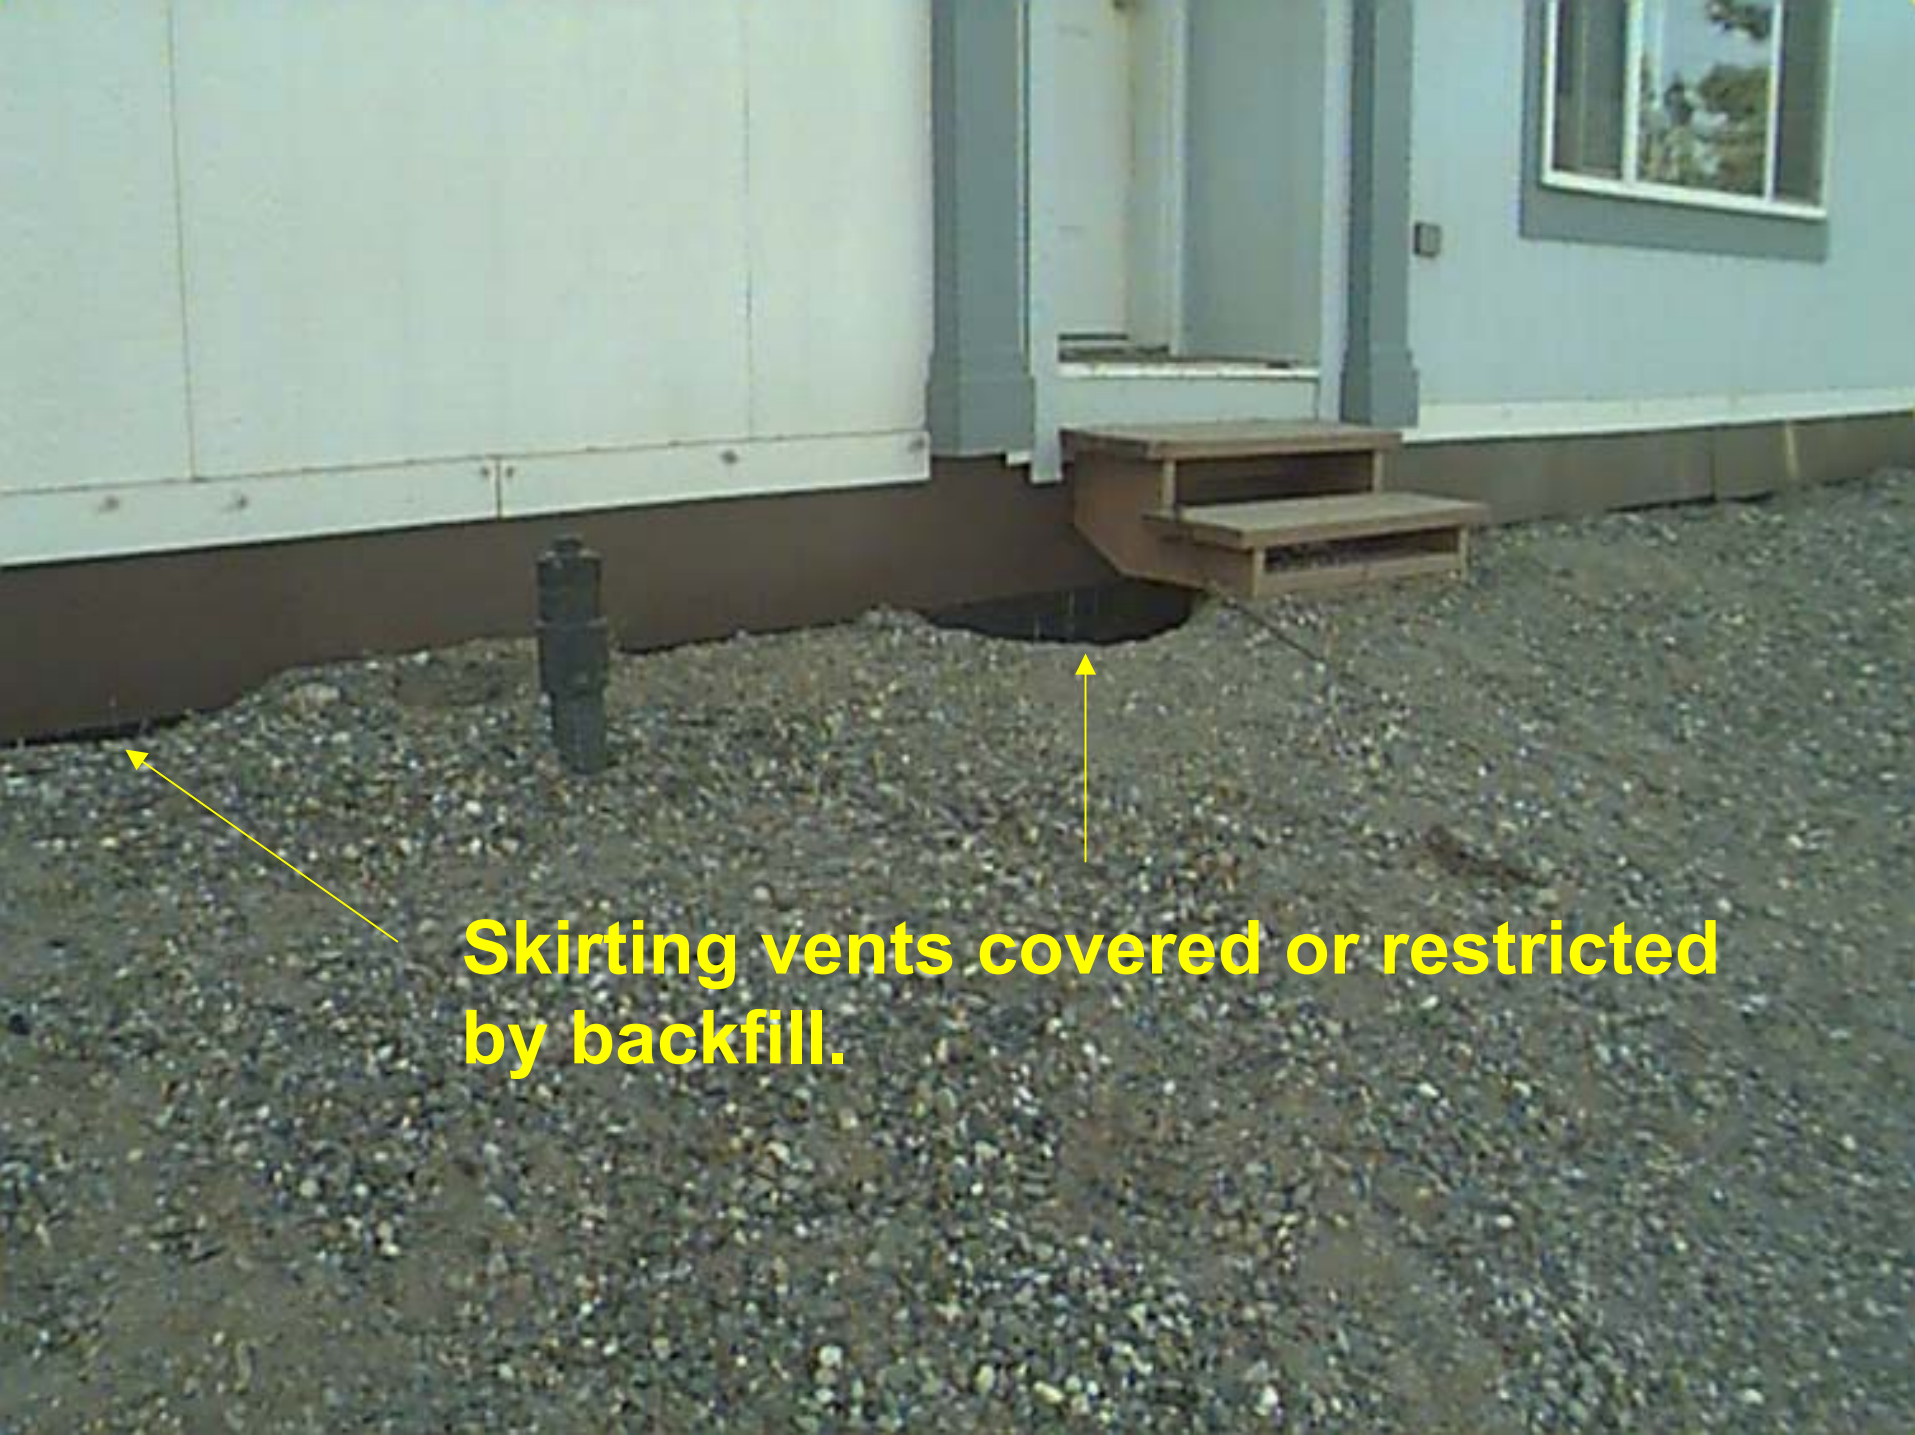
**Skirting vents covered or restricted by backfill.**

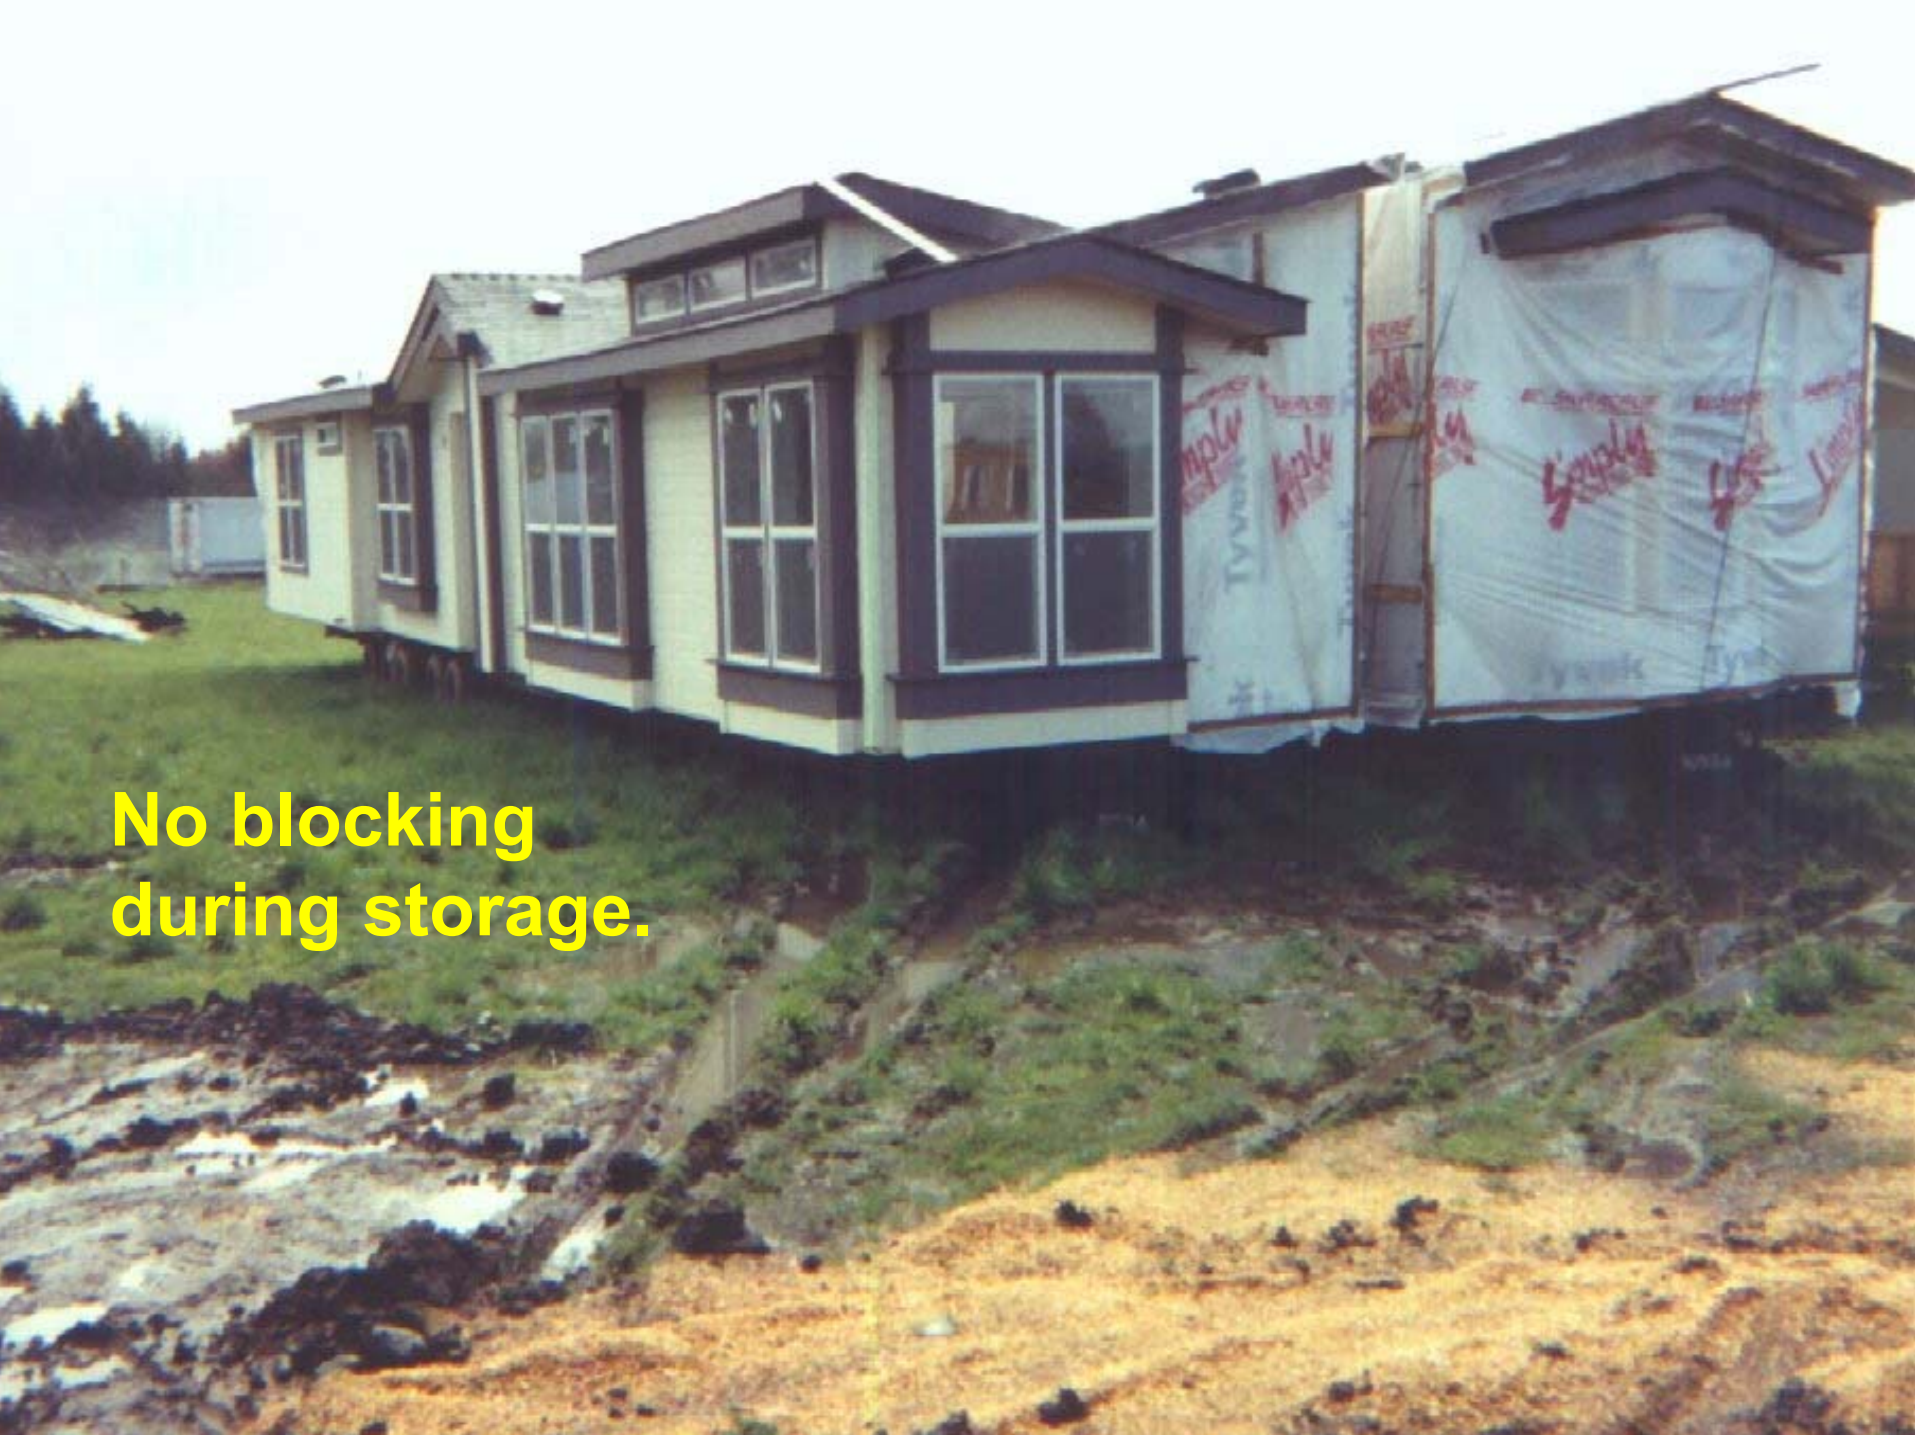
**No blocking  
during storage.**

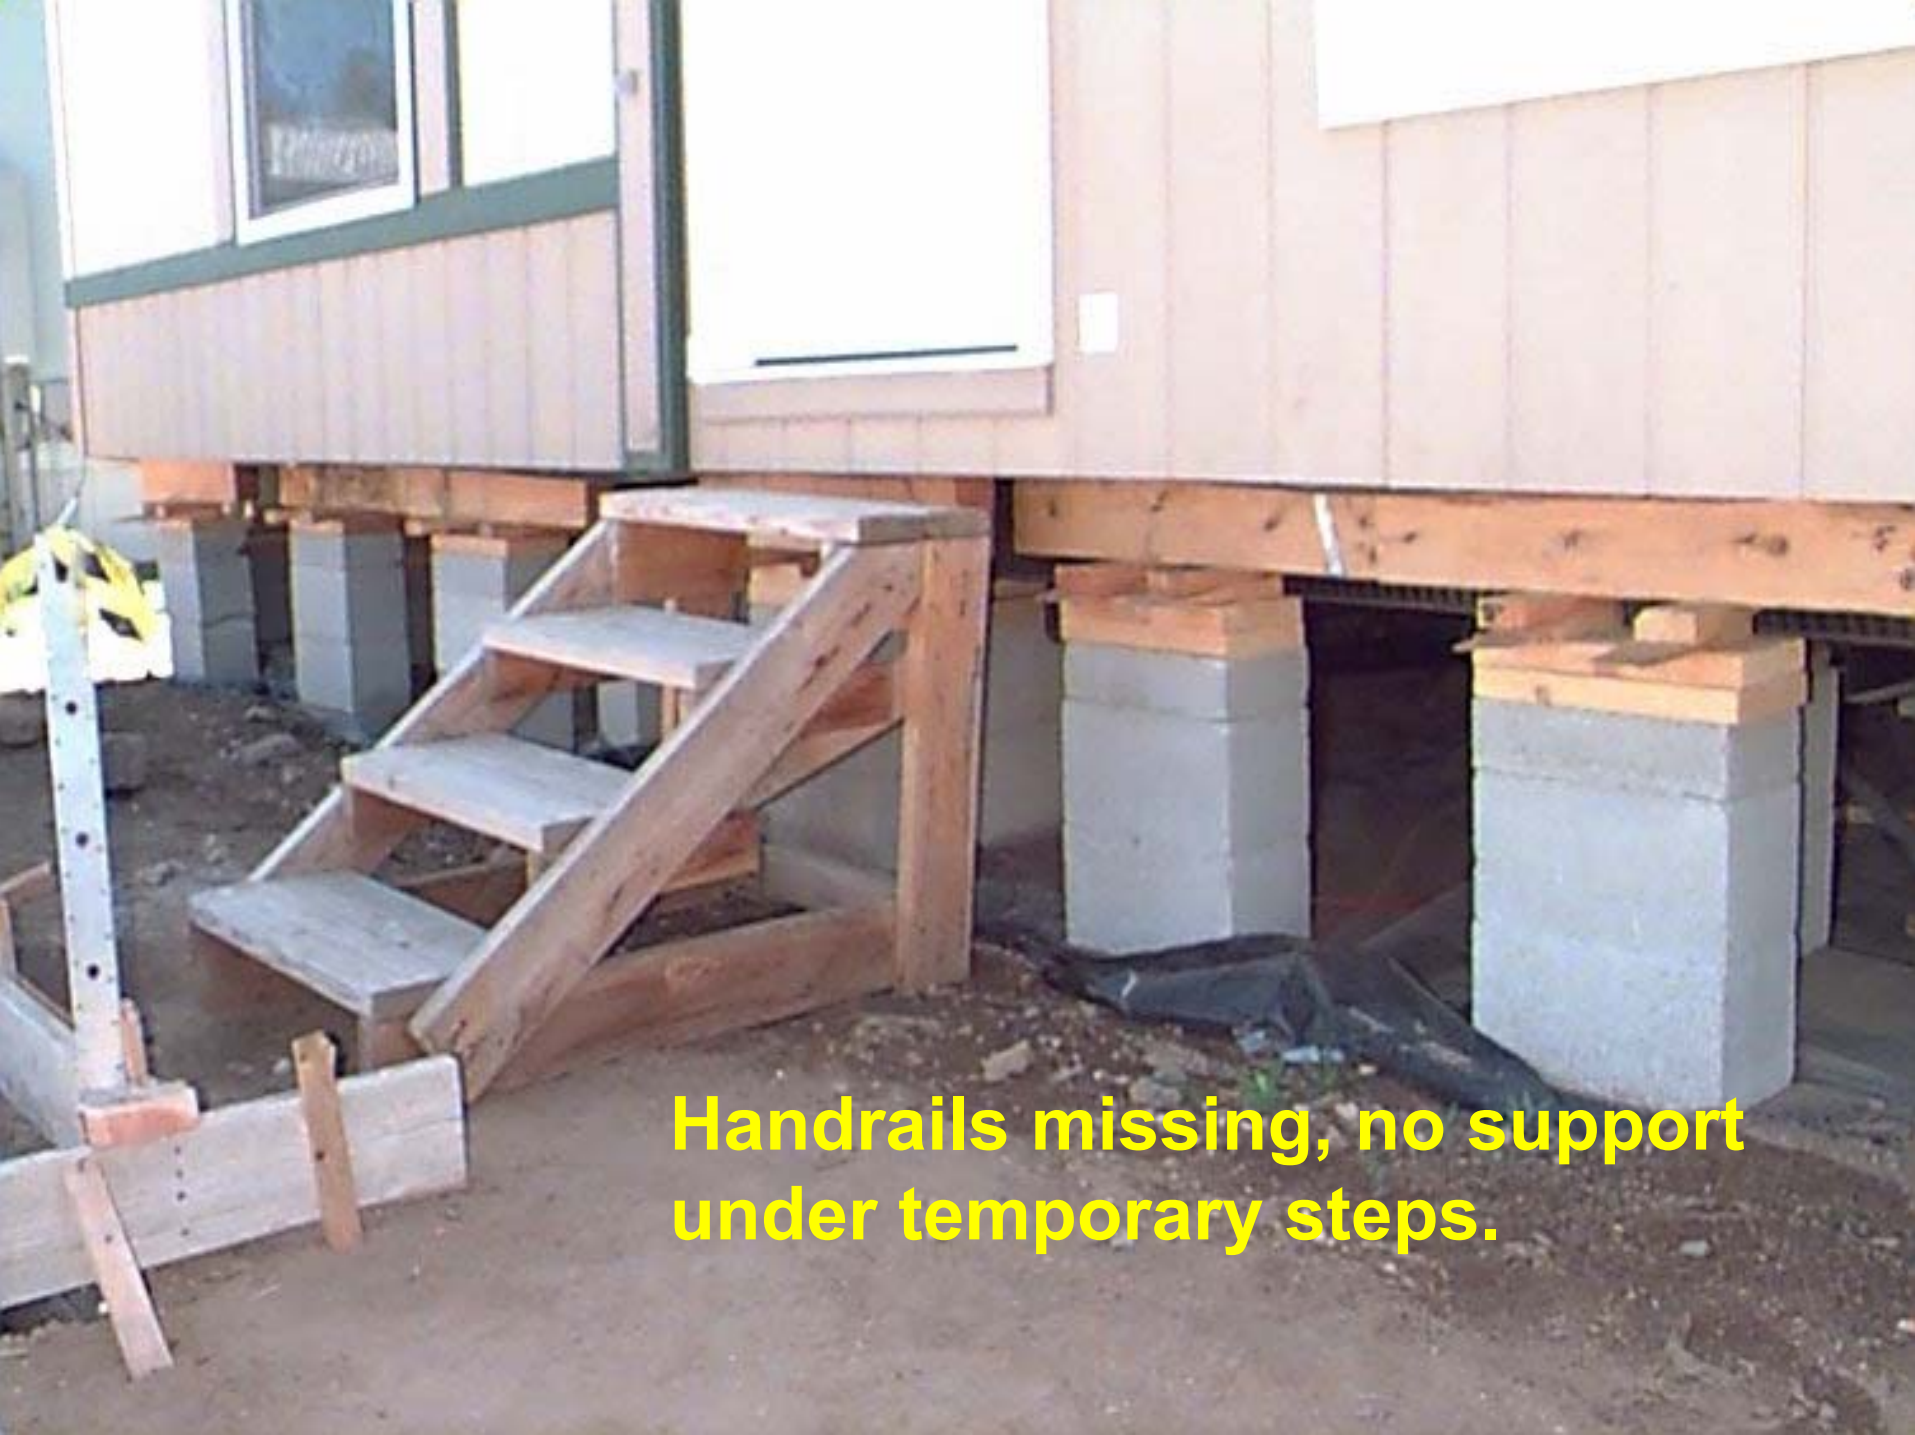
**Handrails missing, no support under temporary steps.**
