Measurement & Verification

Steven Winter Associates, Inc.

Session Overview

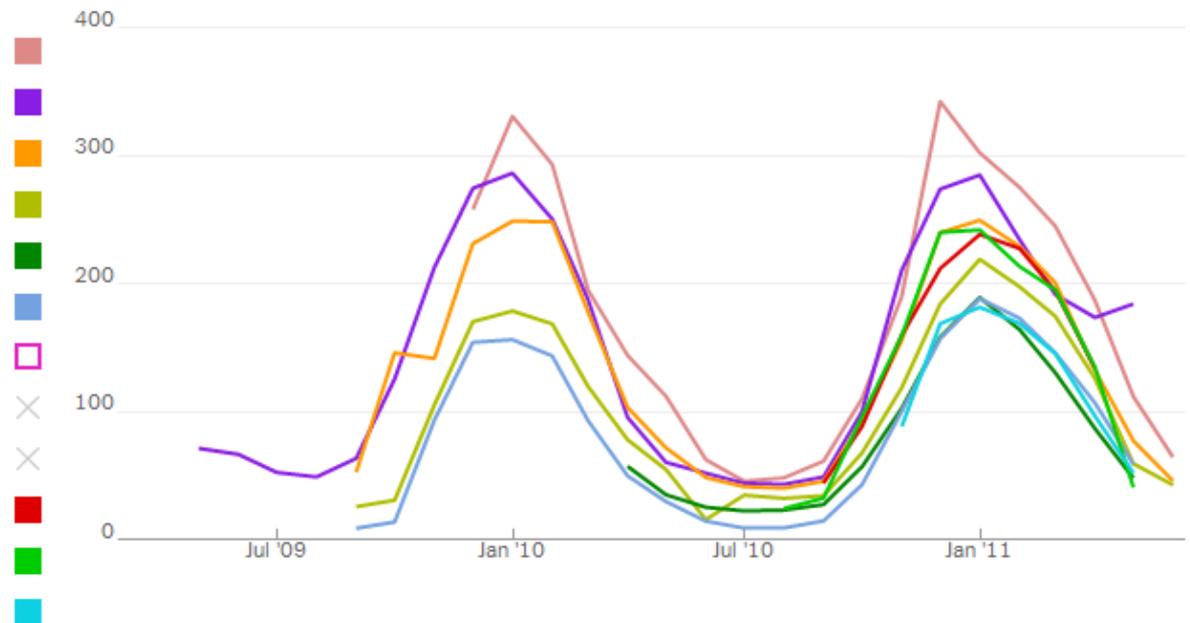
Natural gas use ▾ in Btu ▾ per square foot ▾

Name ↕ Click for detailed data	Full-Year Sum ▾
Myrtle Ave	59,840
MLK	55,574
Dunn Rockaway	46,672
Dunn Atlantic	38,798
The Andrew	31,027
Eltona Apartments	30,571
Executive Towers	4,776
585 Sixth Ave.	Not tracking gas
Hughes Gardens	No data available
El Jardin de Selene	Less than 1 year of data
Fortune Society	Less than 1 year of data
Liberty Apartments	Less than 1 year of data

Detailed Data per Month
Click a square to show or hide an item on the graph

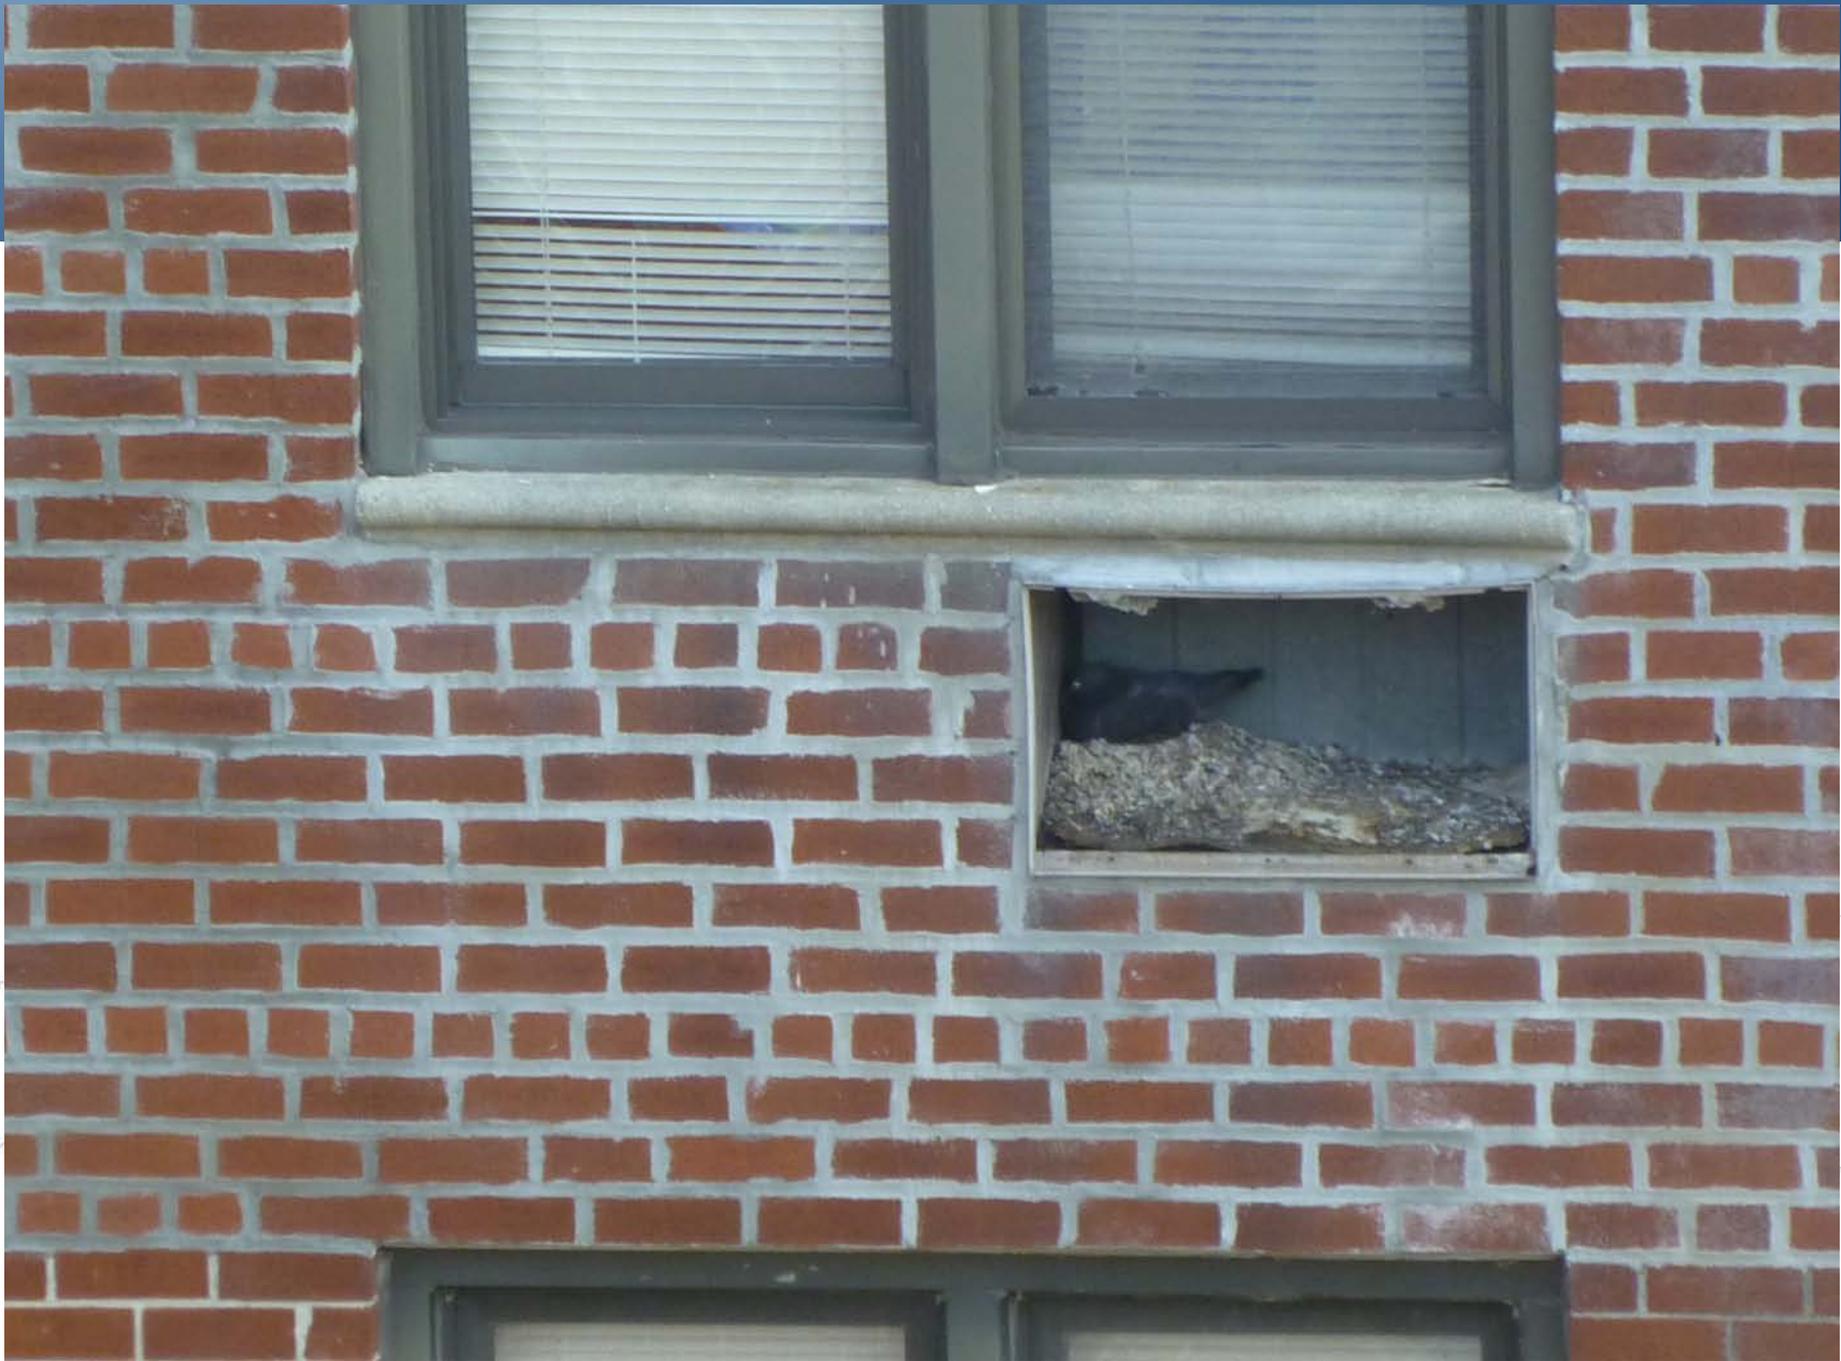
The Audit: Exterior Envelope

- Open Windows in Winter
- Window conditions
- Air conditioners
- Façade conditions
- Exterior lighting
- Cleanliness
- Exterior doors
- Trash chute vent

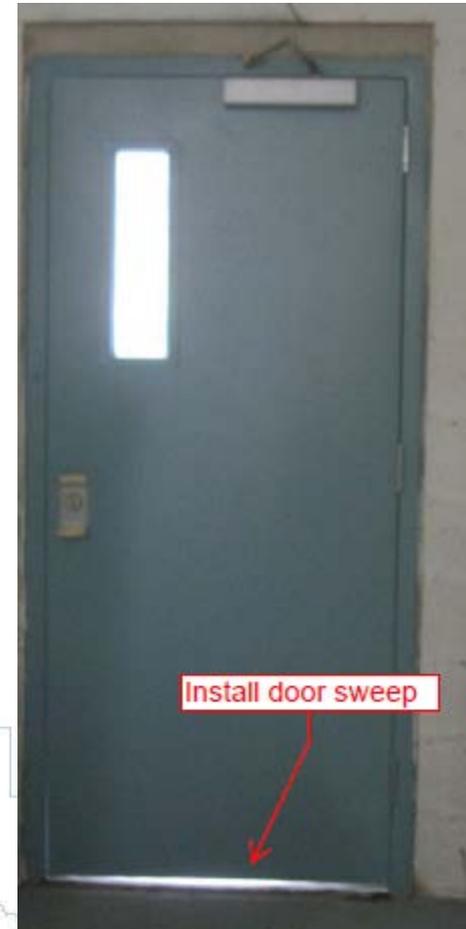
The Audit: Envelope Diagnostics

- Use Your Eyeballs
 - Weatherstripping
 - Caulking
 - A/C Covers
- Blower Door Testing
- Infrared Scan (seasonal)
- Low-e checker

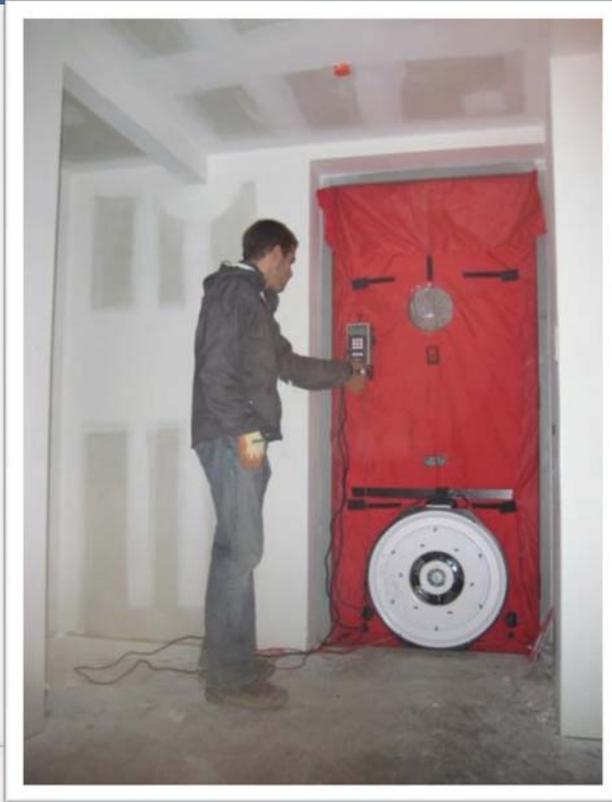
Envelope: Blower Door Testing

Project Name:	XXXXXXXX						
Apartment:	8B				Sherman Corr. Factor		
Location:	XXXXXXXX		Climate Factor, C	17		Function of Temperature and Wind. See CI	
Floor Area in sq.ft.:	924		Height Factor, H	1		1 Story = 1.0, 1.5 Stories = 0.9, 2 Stories =	
Surface Ar in sq.ft.:	2928		Shielding Factor, S	1		Well-Shielded = 1.2, Normal = 1.0, Exposed =	
Volume in cu.ft.:	8316		Type of Holes, L	1		Small Cracks = 1.4, Normal = 1.0, Large Holes =	
Outdoor Temp (F):	45		Correlation Factor, N	17		N = C*H*S*L	
Indoor Temp (F):	60						
Fan Position:	Depress						
Wind Condition:			Fan Baseline				
Baseline Pressure	0 Pa			0.4

House Pressure (Pa)	Fan Pressure (Pa)	Plate Position	Flow Rate (cfm)	Temp Corc Flo (cfm)	Log (HousePress)	Log (Flowrate)
47.4	156.7	1	518.5	526.1	1.676	2.721
49.1	166.9	1	535.1	543.0	1.691	2.735
51.8	175.1	1	548.1	556.2	1.714	2.745
53.9	181.6	1	558.2	566.4	1.732	2.753
57.1	197	1	581.4	589.9	1.757	2.771

Slope:	0.5811
Intercept:	1.7491
C:	56.11238873
n:	0.5811
R:	0.9872

From Regression:	
CFM ₅₀ :	545
ACH ₅₀ :	3.93
ACH _{nat} :	0.23 (ACH ₅₀ /N)
ELA:	35.6 in ² (4 Pa)
EqLA:	62.9 in ² (10 Pa) - Canada
Leakage Ratio:	0.186109439 CFM ₅₀ /ft ² surface area
ELA(in ²)/100ft ² :	1.22

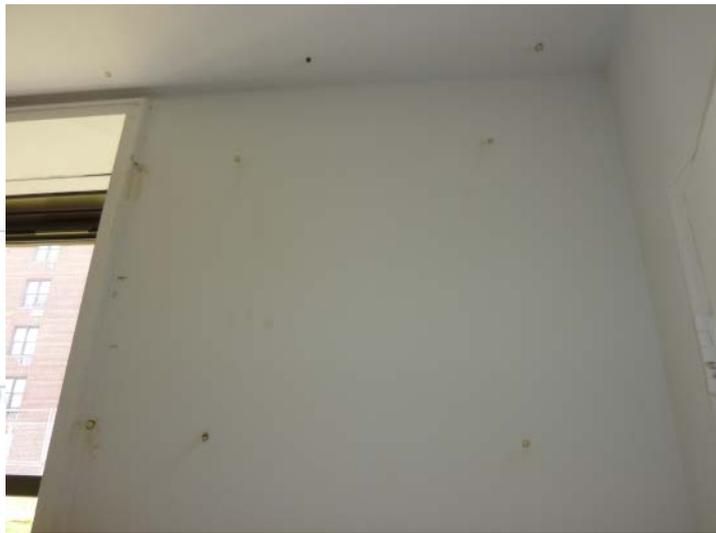
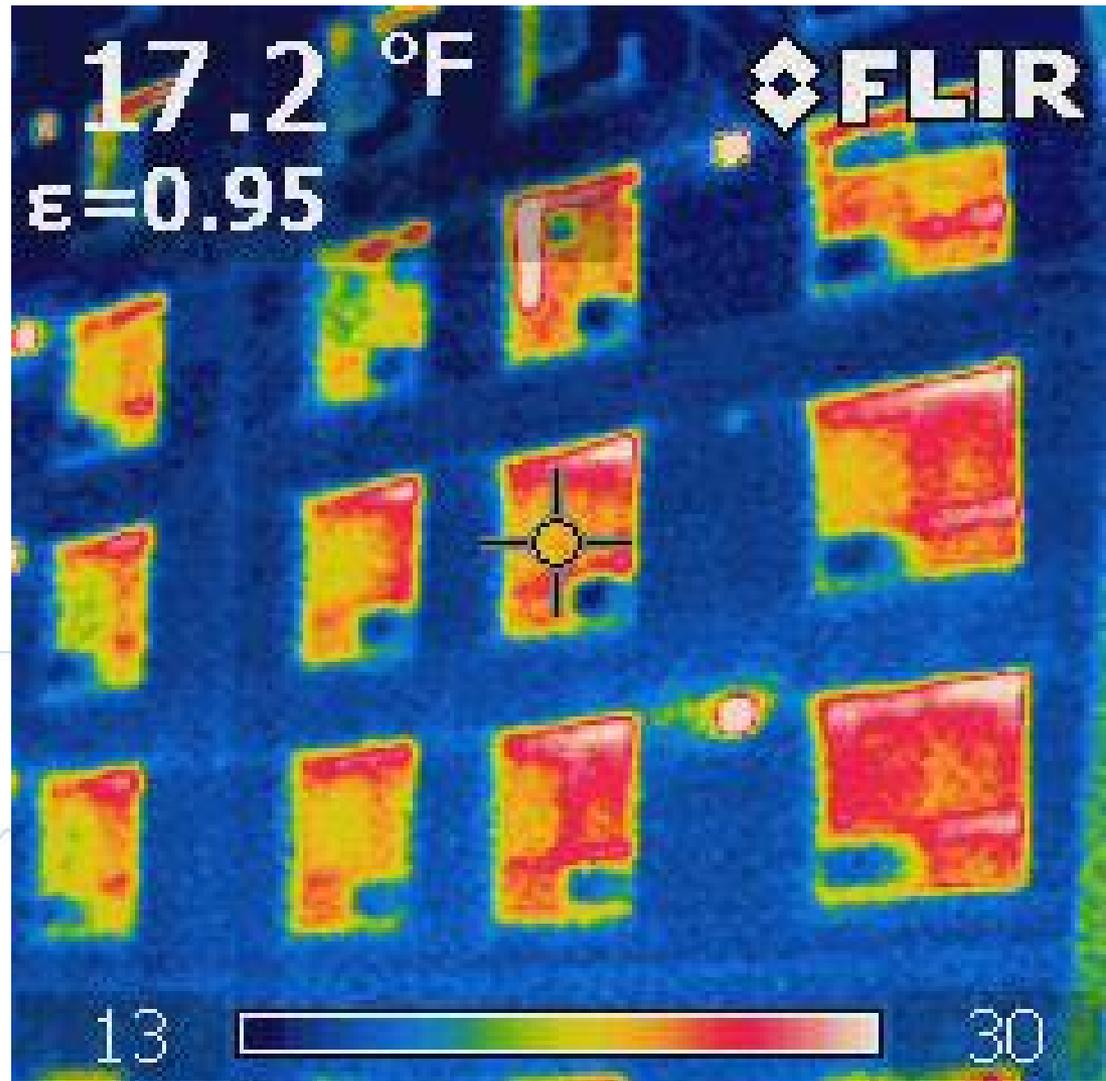
Infrared Diagnostics

- Diagnose and confirm insulation issues/installation

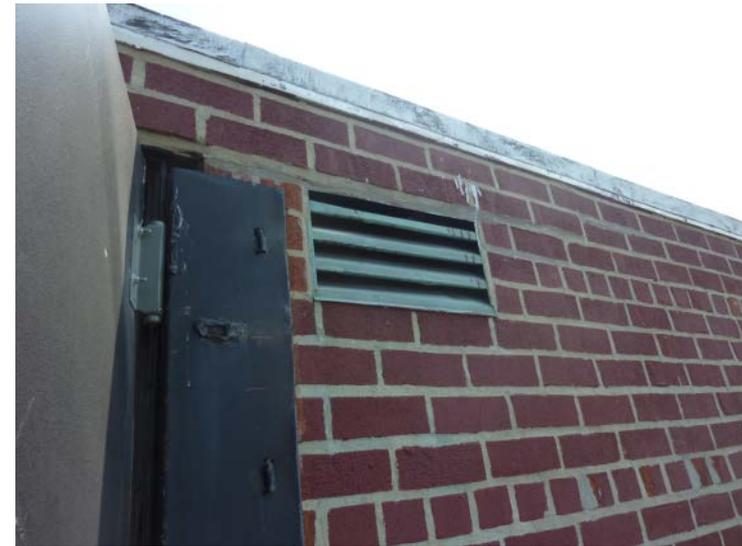
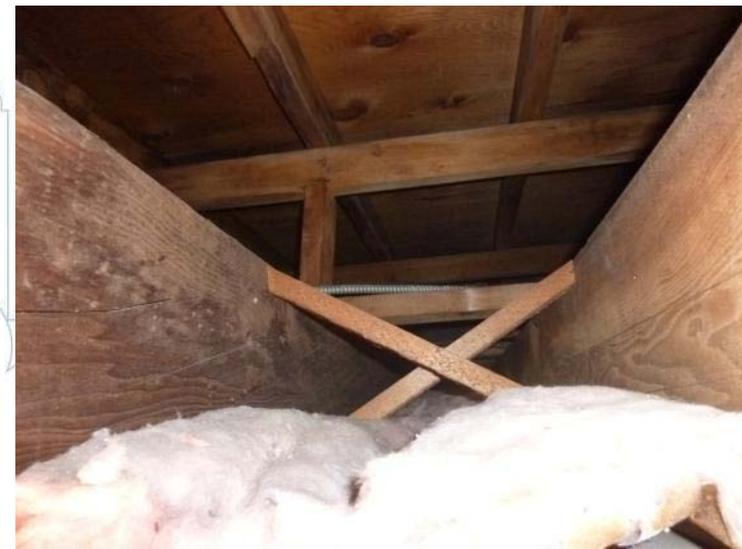
The Audit: Roof

- Open louvers at top of stairwell
- Elevator room venting
- Compactor Shaft
- Roof surface
- Roof cavity insulation
- Roof cavity venting
- Parapet condition
- Drainage

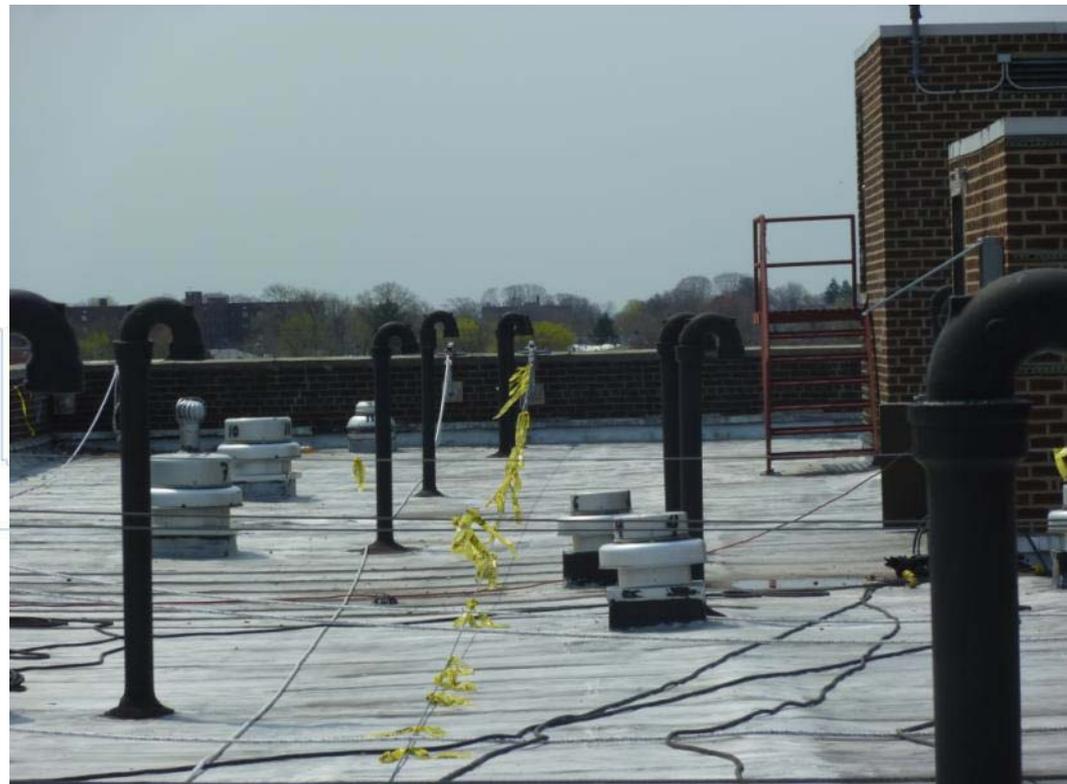
The Audit: Rooftop Fans

- What function do they serve
- Continuous operation
- Are they running?
- Fanflow testing
- Shaft construction
- Register condition

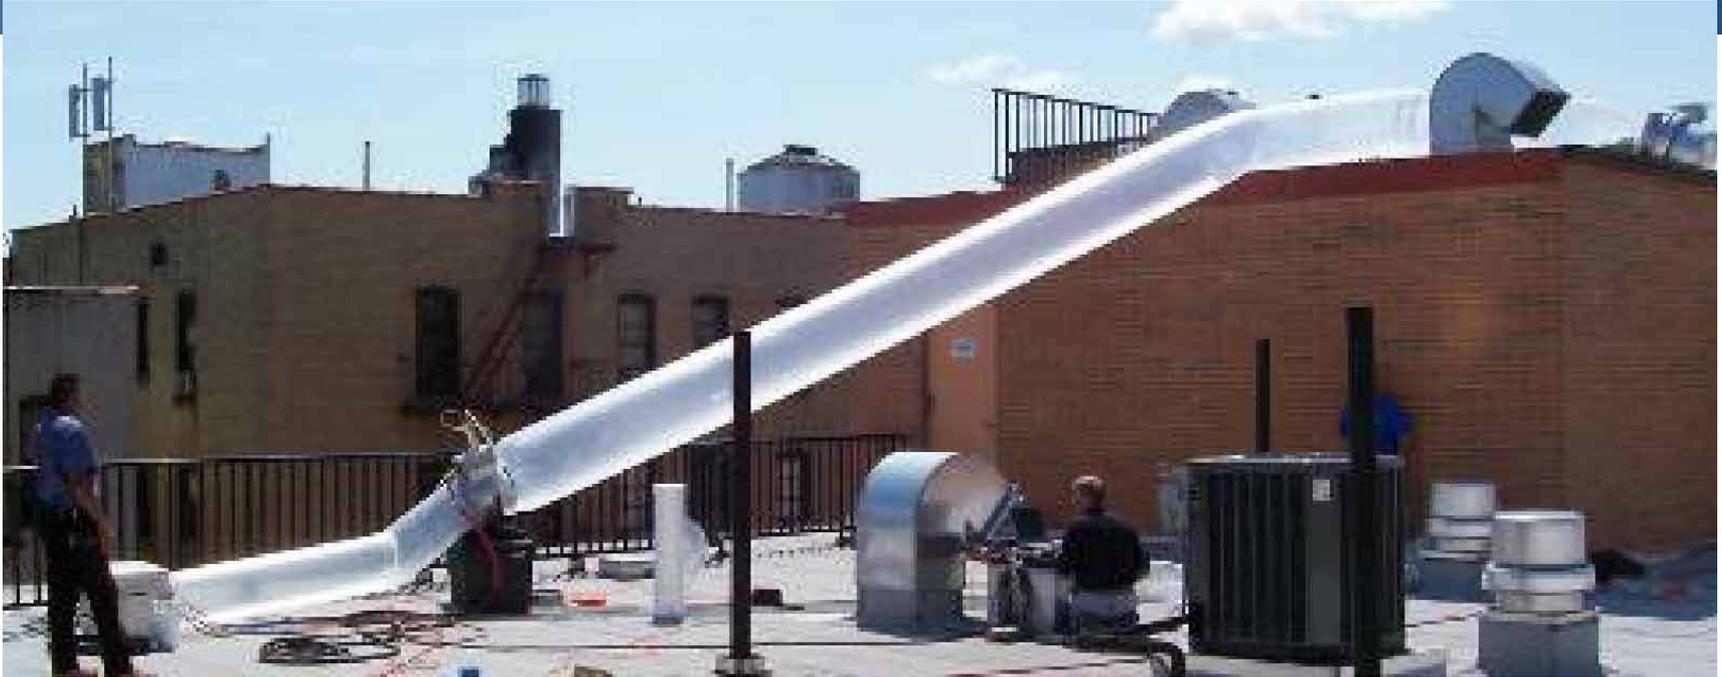
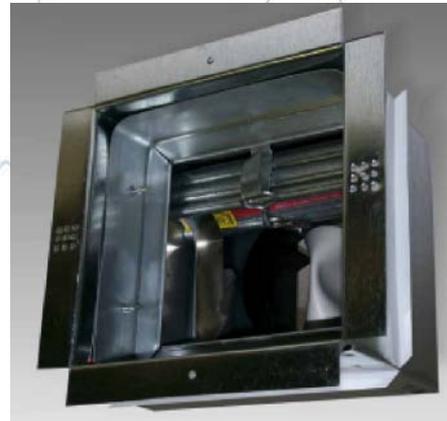
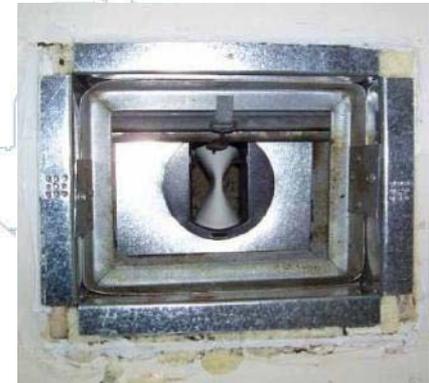
Ventilation: Solutions

The Central Ventilation Retrofit

- Test flows
- Clean shaft
- Seal shaft
- Seal registers at sheetrock
- CAR Dampers (auto balancing)
- New direct-drive fans (less maintenance)

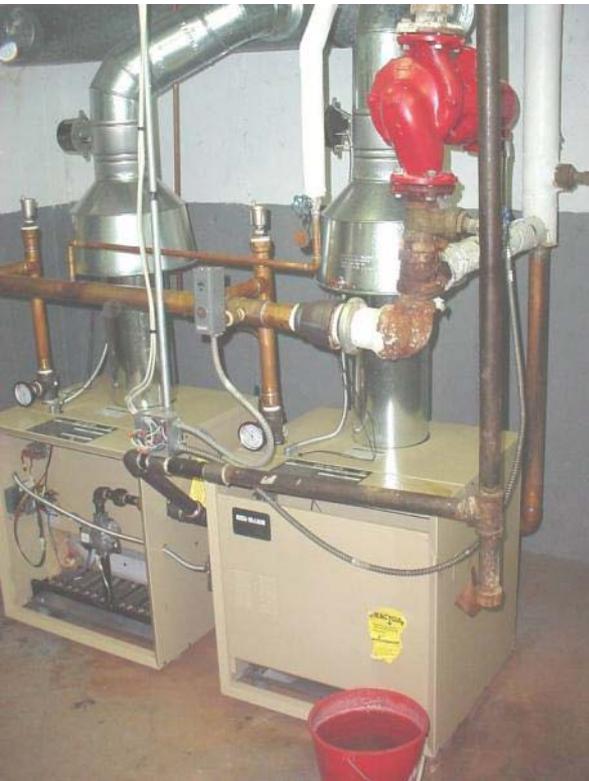
Atmospheric = Inefficient

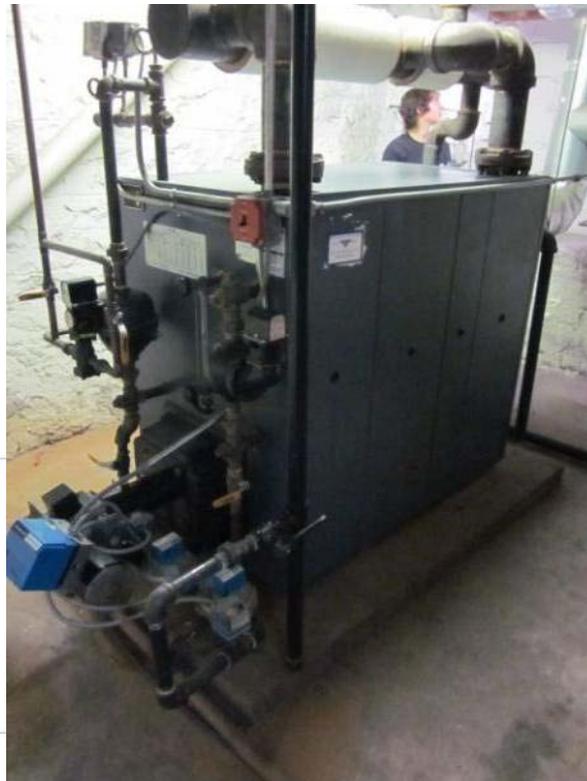
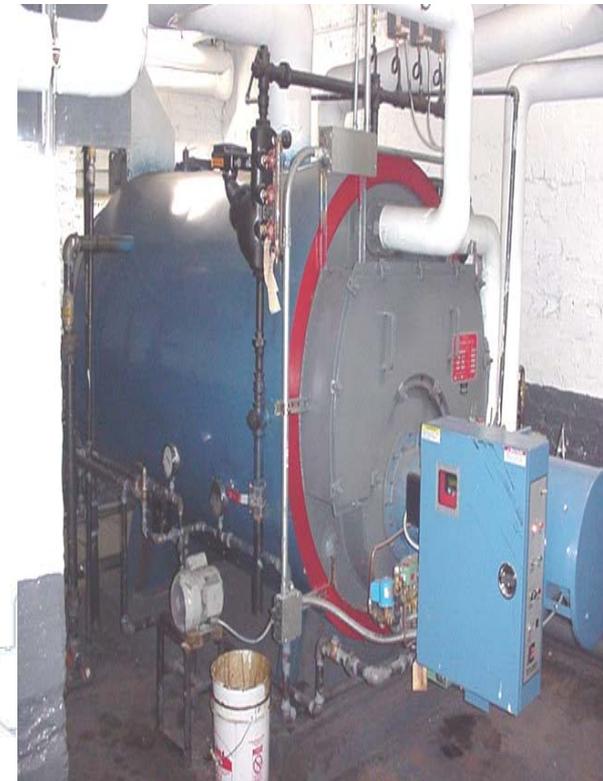
Solution = Sealed Combustion Boilers

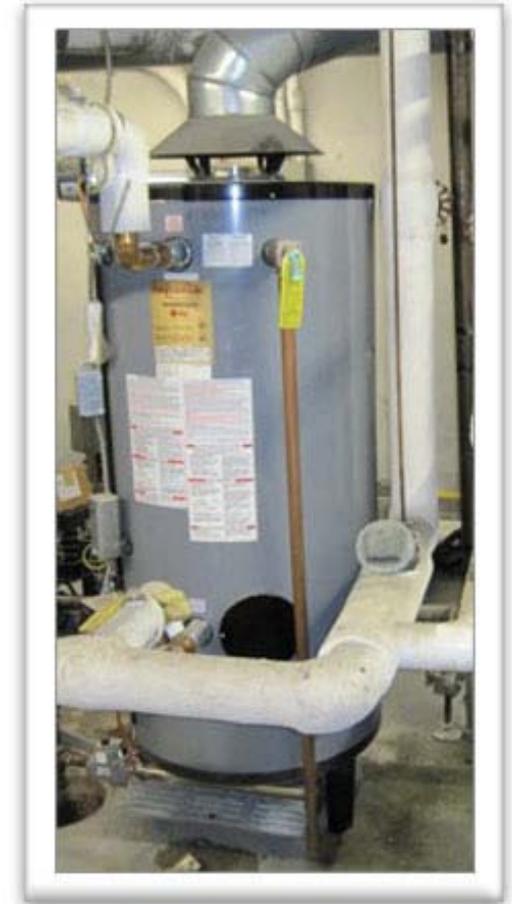
The Audit: Why Not Atmospheric?

Disadvantages

- Very inefficient.
- High standby losses when off due to open combustion chamber.
- Poor draft control.
- Many models have open pilot light.

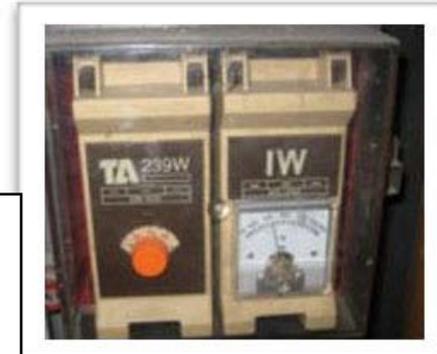
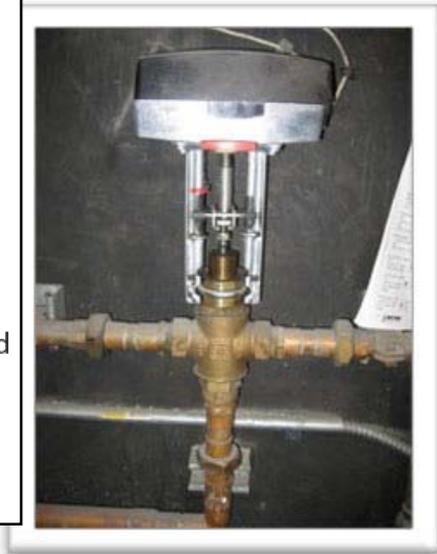
The Audit: Domestic Hot Water

- Mixing Valve
 - Upgrade to electronic
 - Temperature gauge at outlet
 - Thermostatic mixing valves fail in the HOT position; electronic mixing valves fail in the COLD position.
- Setpoint
 - Aim for 115 - 120°F

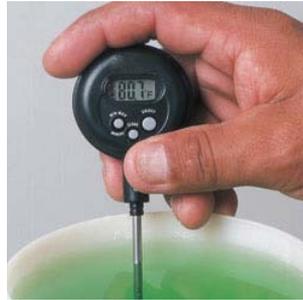
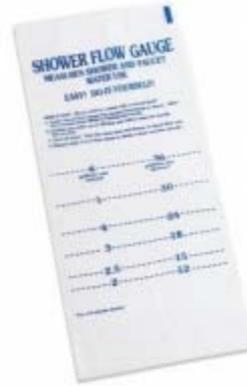
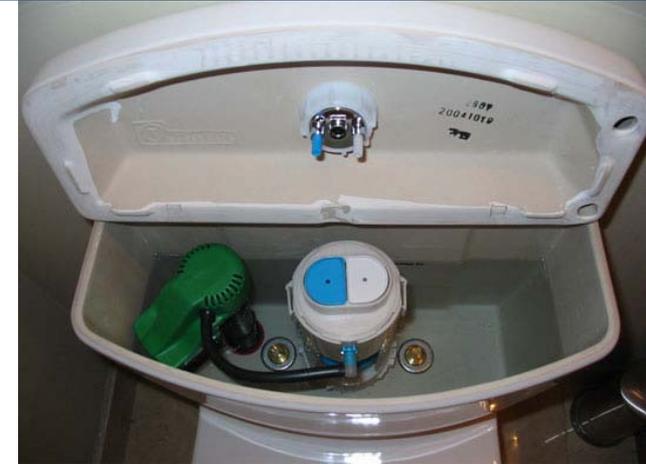
- Toilets
1.3 gpf or less

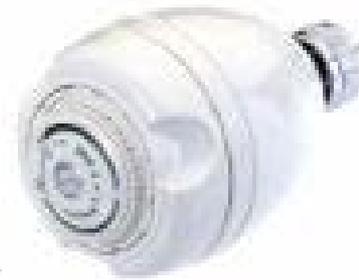
- Showerheads
1.75 gpm

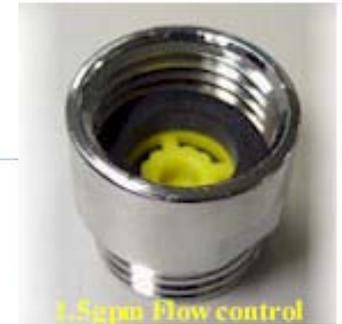
- Faucet Aerators
1.5 gpm Kitchen | 1.0 gpm lavatories

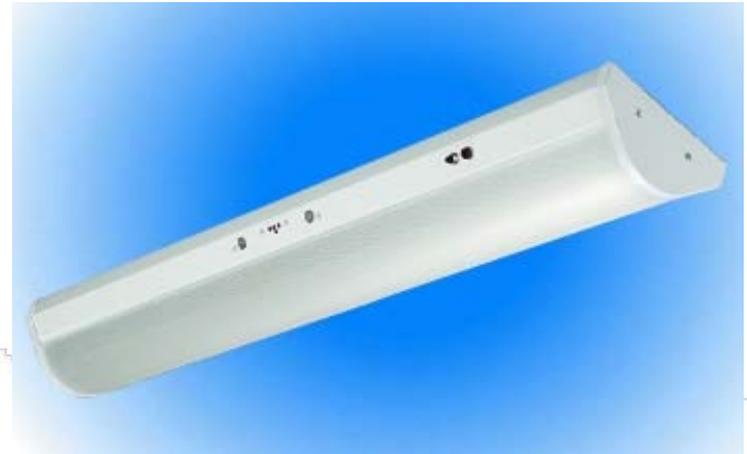
The Audit: Lighting

- Incandescents are no longer affordable
- Federal legislation phases out
- CFL's replace all
- T8 Tubes & CFL's
- LED Replacements
- Controls: Occupancy, Photosensor
- Some fixtures have controls built in!

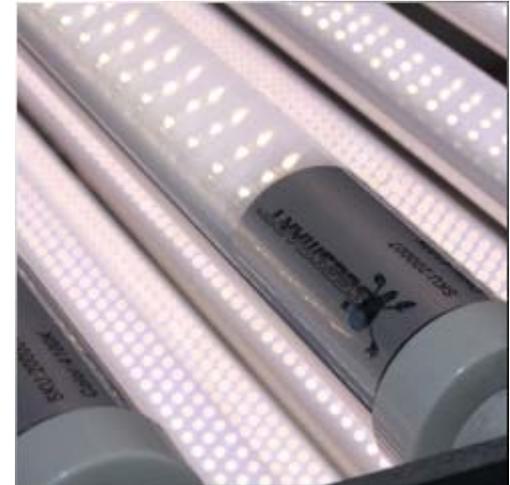
T12 Lamp Replacement

40W x 24/7/365 = 350 kWh

At \$0.15/kWh = \$52.56

LED

15W x 24/7/365 = 131 kWh

At \$0.15/kWh = \$19.71

Savings = \$32.85

At \$100 installed: Payback = 3.0 years | SIR = 1.7

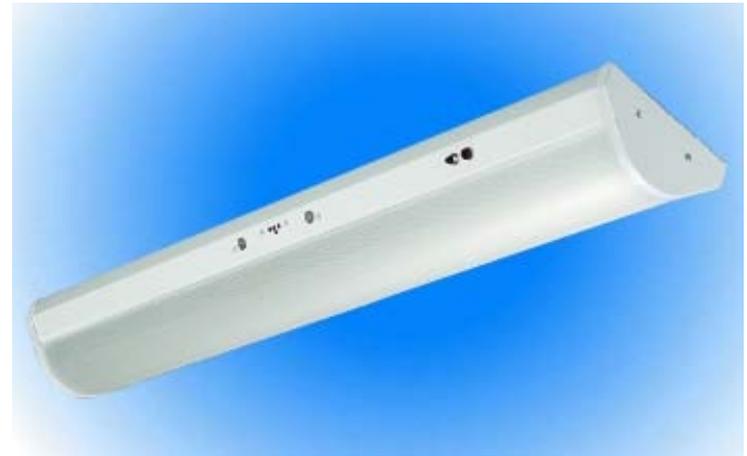
T12 – 2 Lamp Replacement

86W x 24/7/365 = 753 kWh

At \$0.15/kWh = \$113.00

T8 Bi-level Fixture

62W x 4/7/365 = 90.5 kWh

19W x 20/7/365 = 138.7 kWh

At \$0.15/kWh = \$34.38

Savings = \$78.62

At \$300 installed: Payback = 3.8 years
