**TRANSPORTATION  
AND OTHER  
DAMAGE**

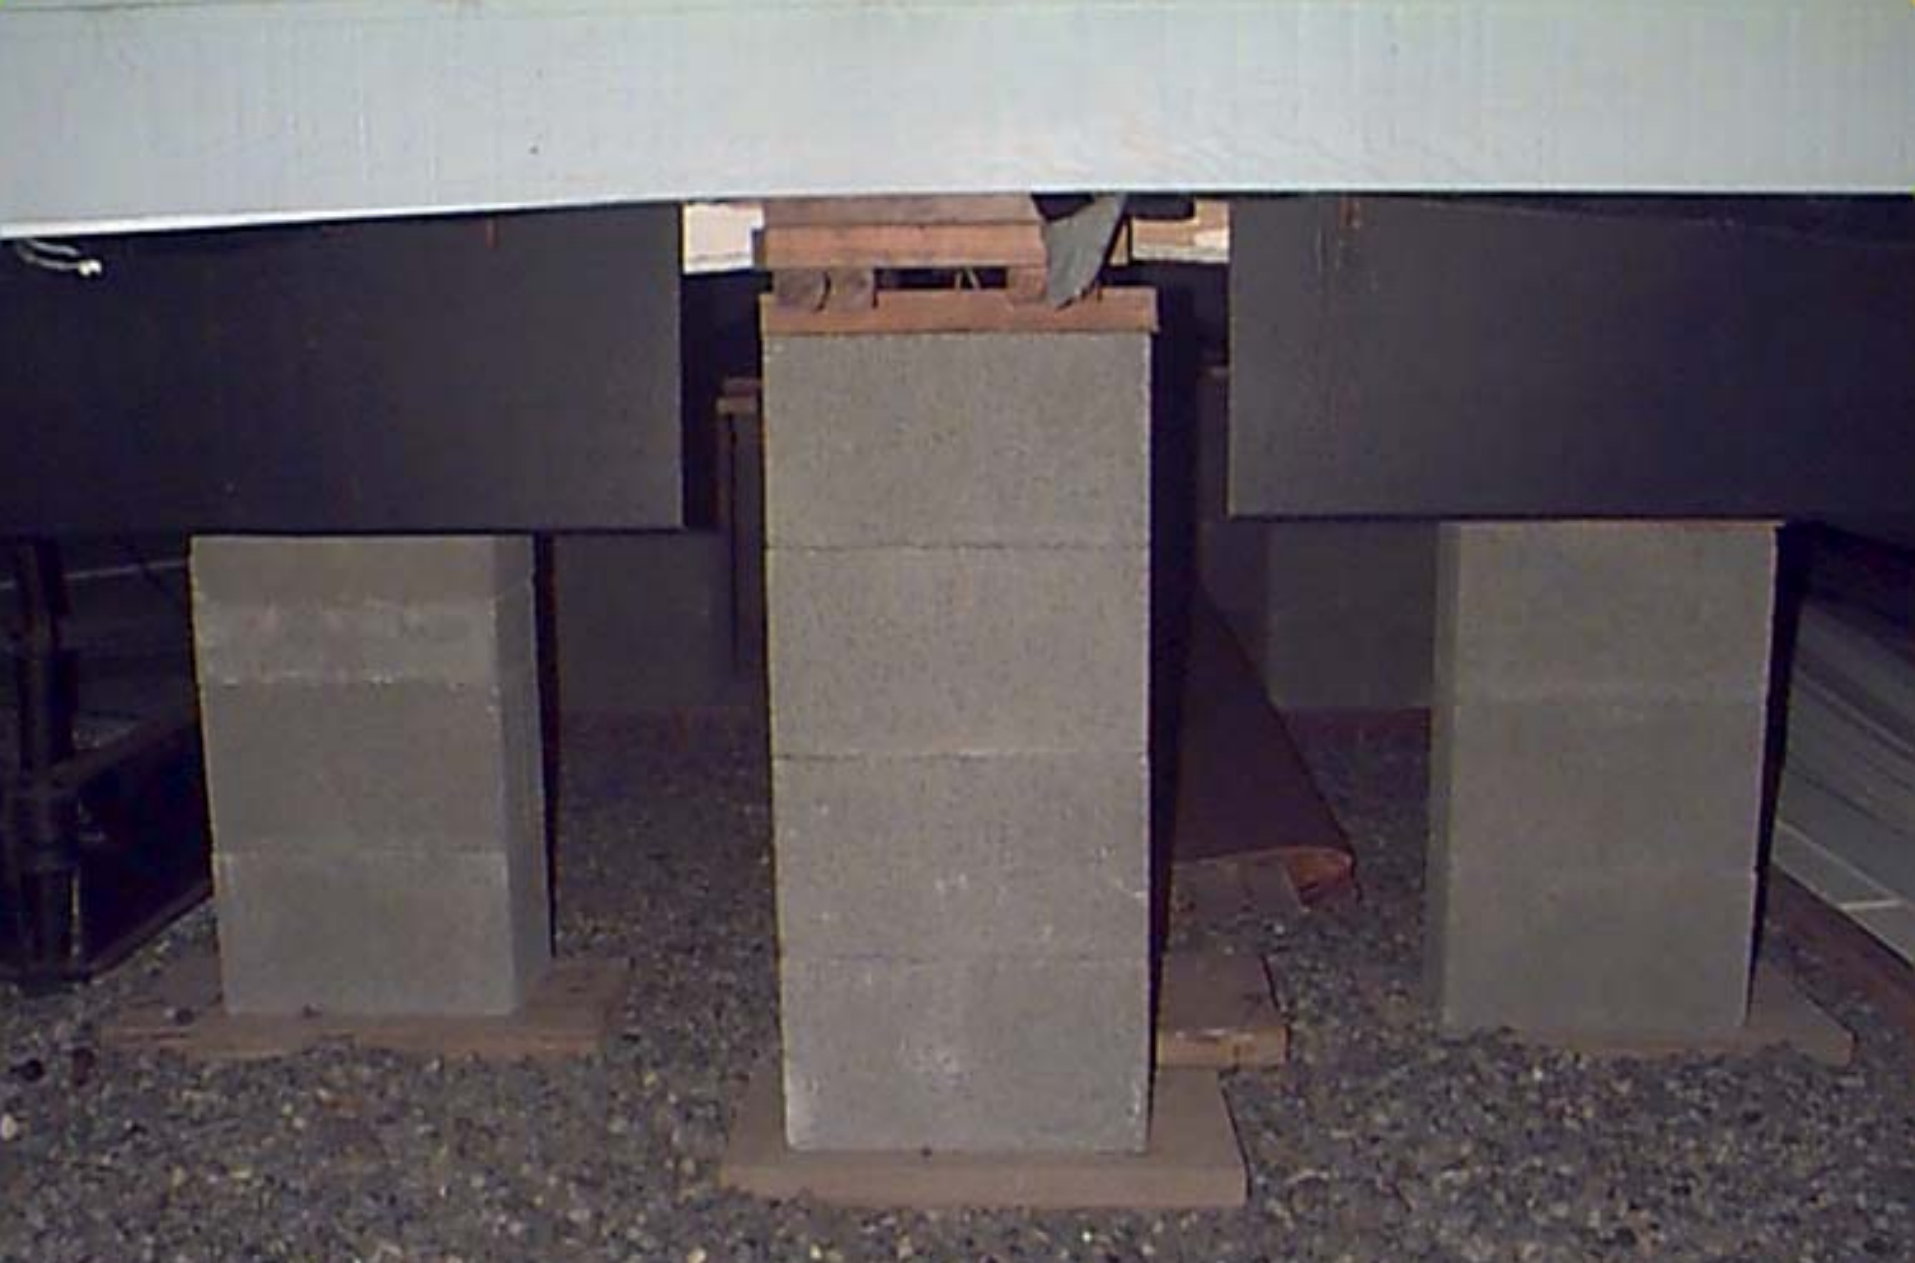
**Properly erected piers on proper footings**
