**TRANSPORTATION  
AND OTHER  
DAMAGE**

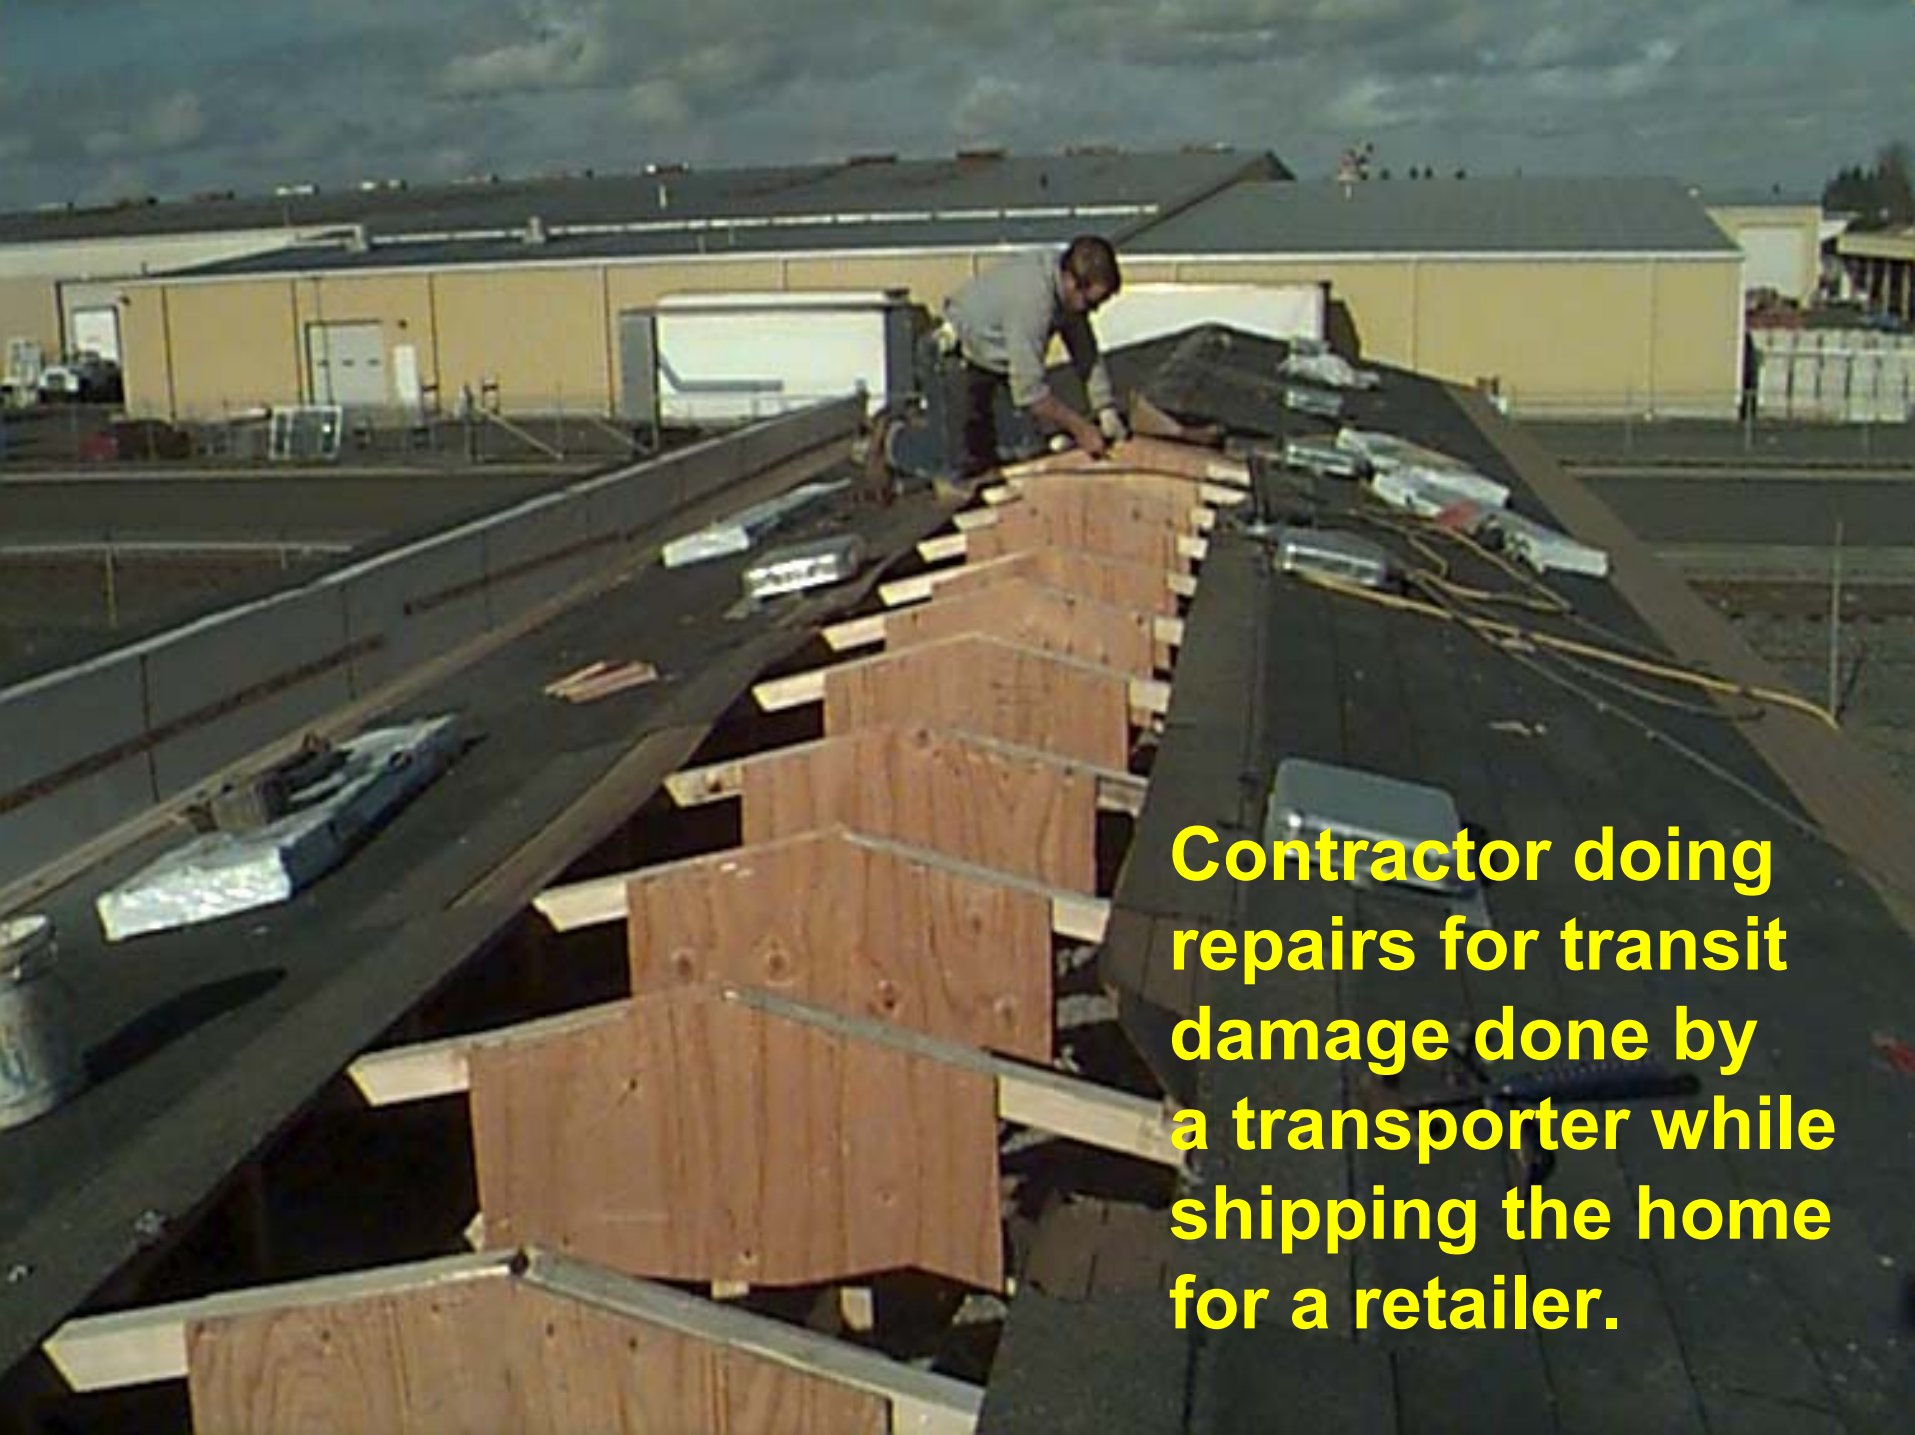
**Contractor doing repairs for transit damage done by a transporter while shipping the home for a retailer.**

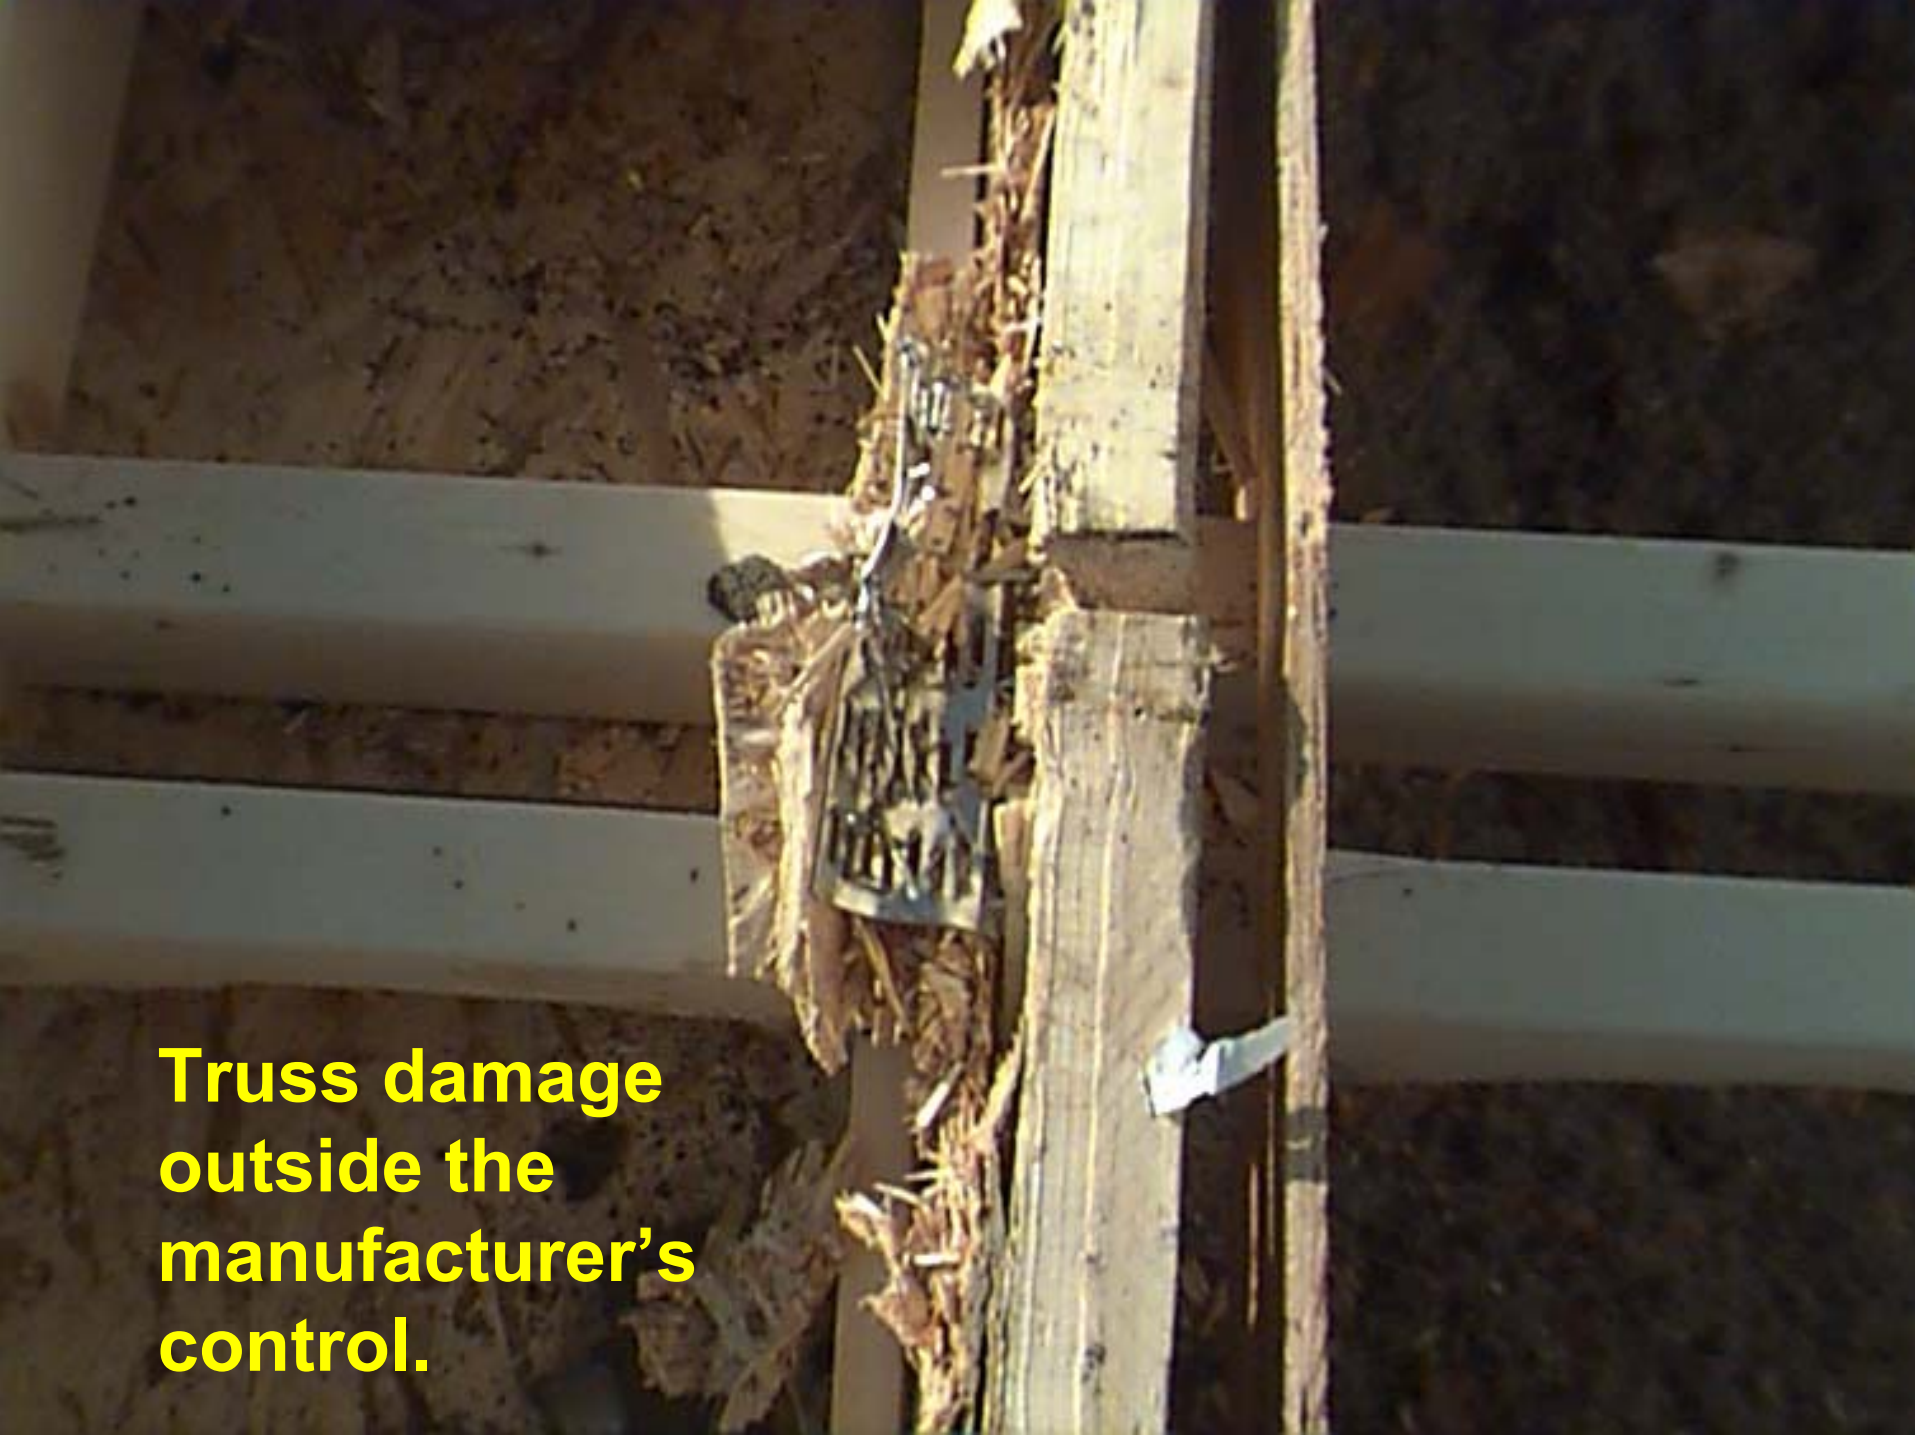
**Truss damage  
outside the  
manufacturer's  
control.**

**This is an overhead electrical power line that hung too low over the road. It cut its way down the roof before it was pulled off the pole.**

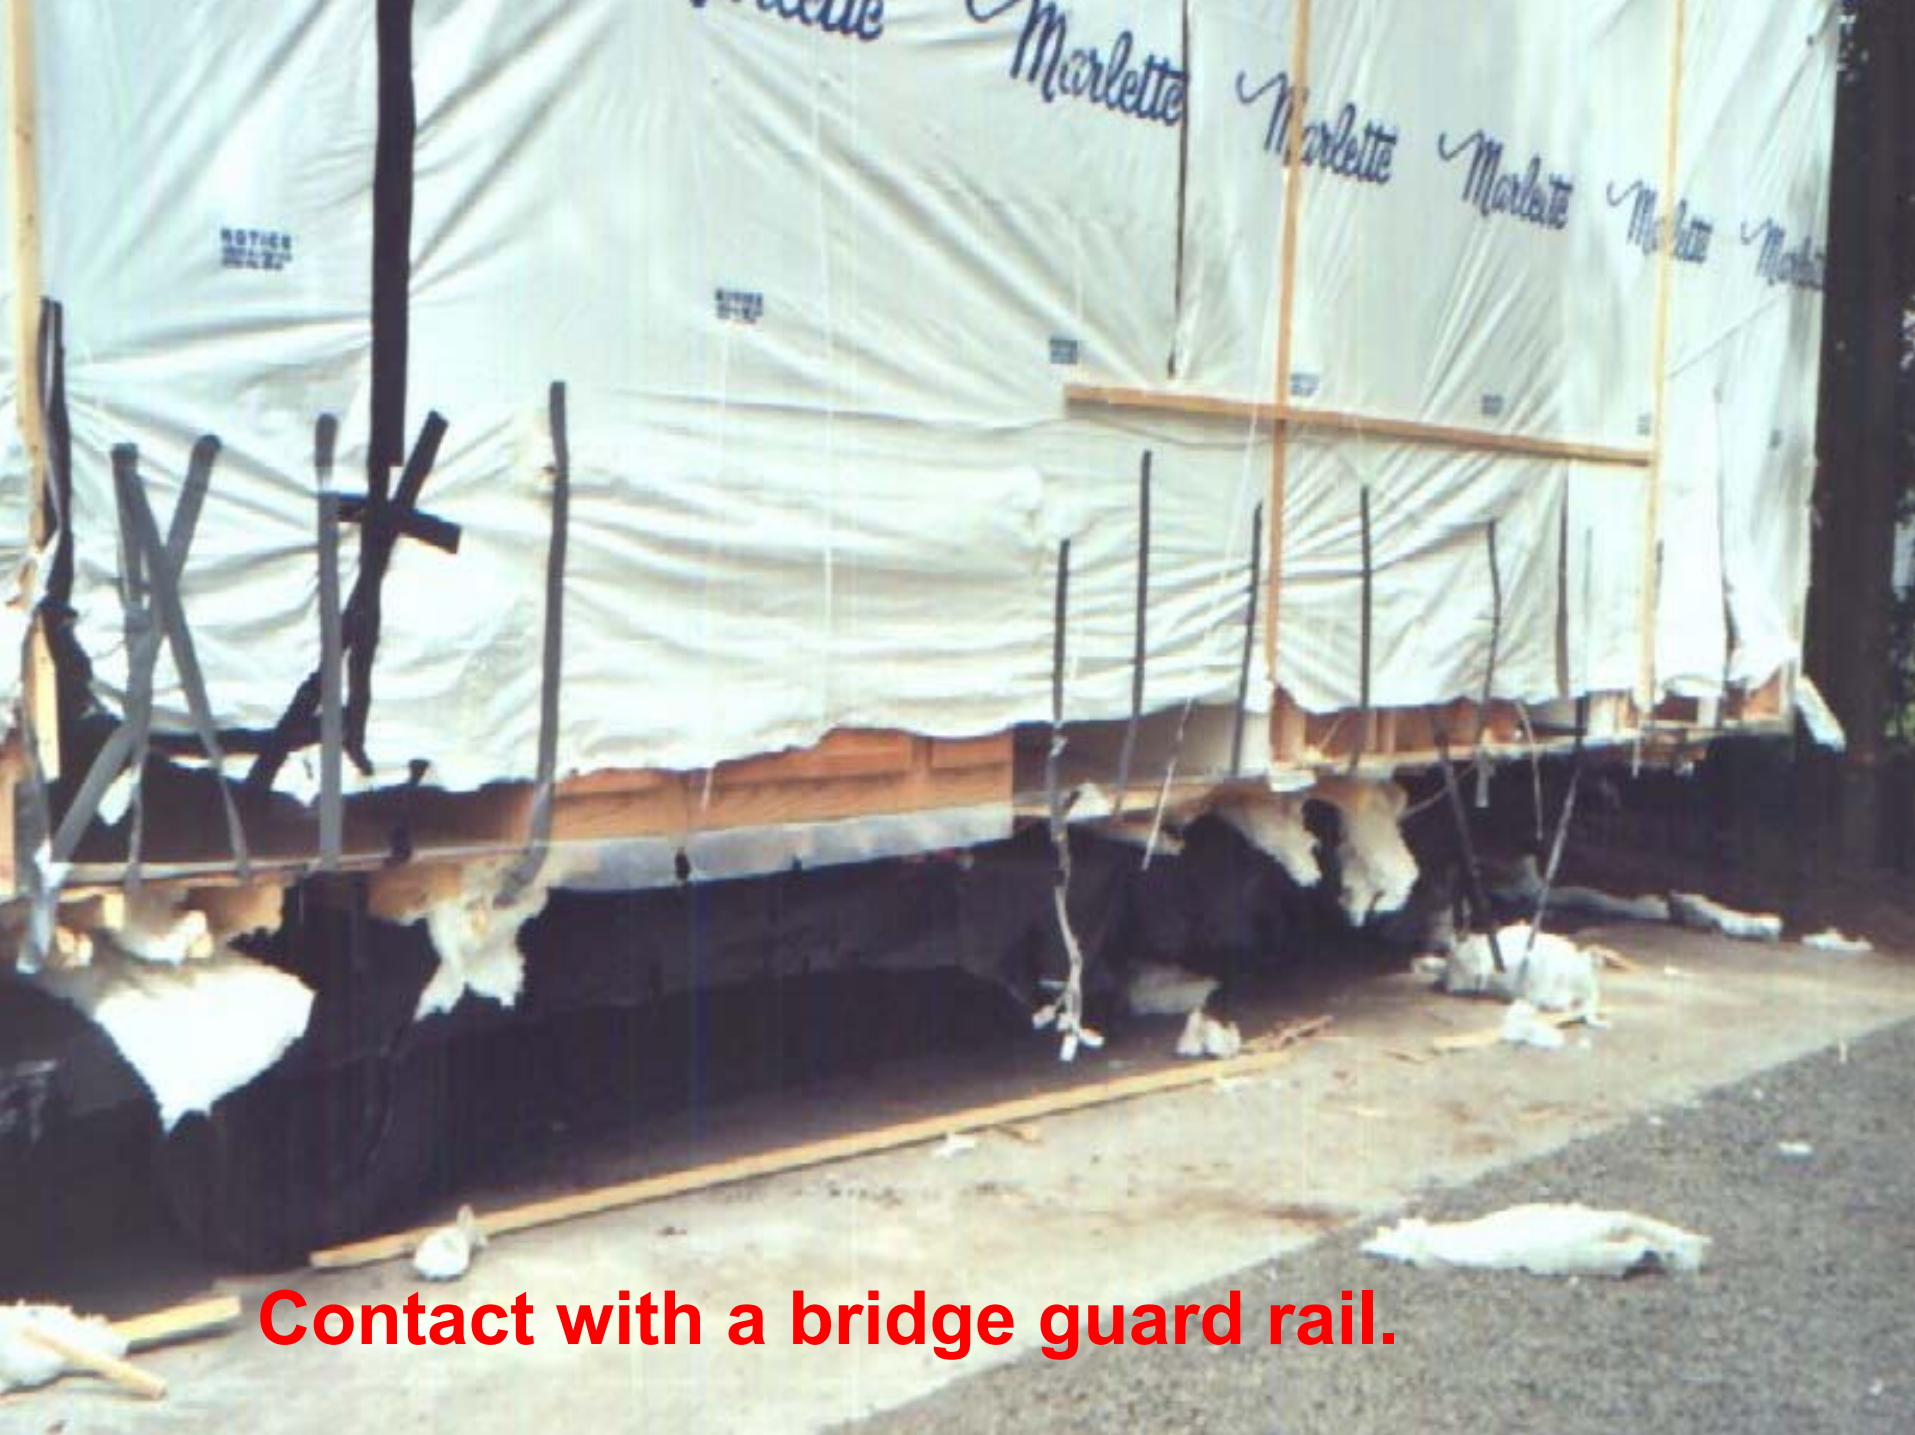
**Contact with a bridge guard rail.**

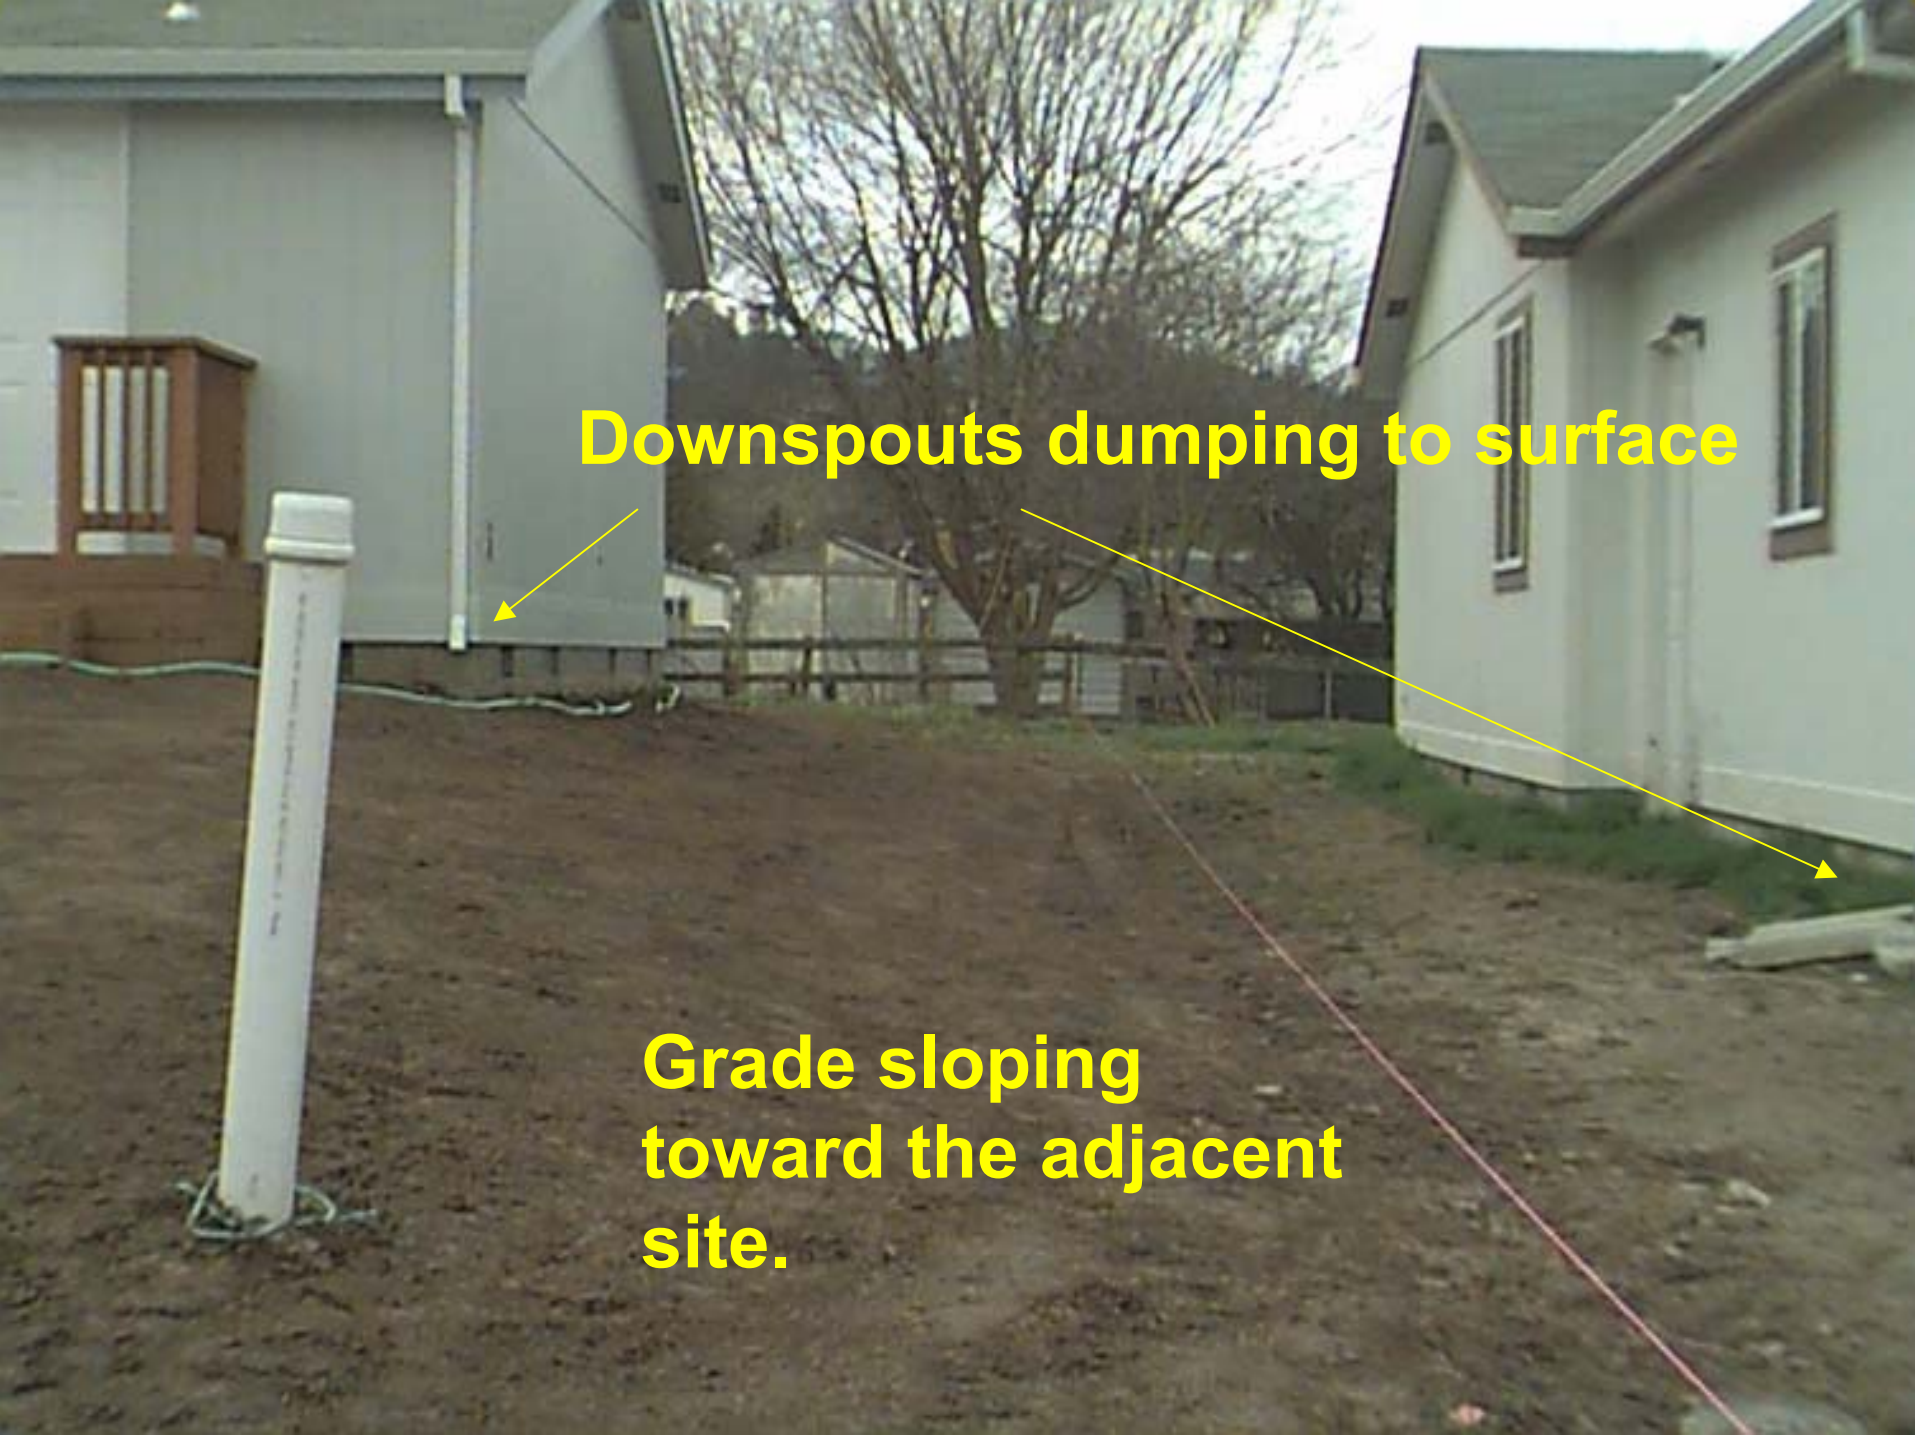
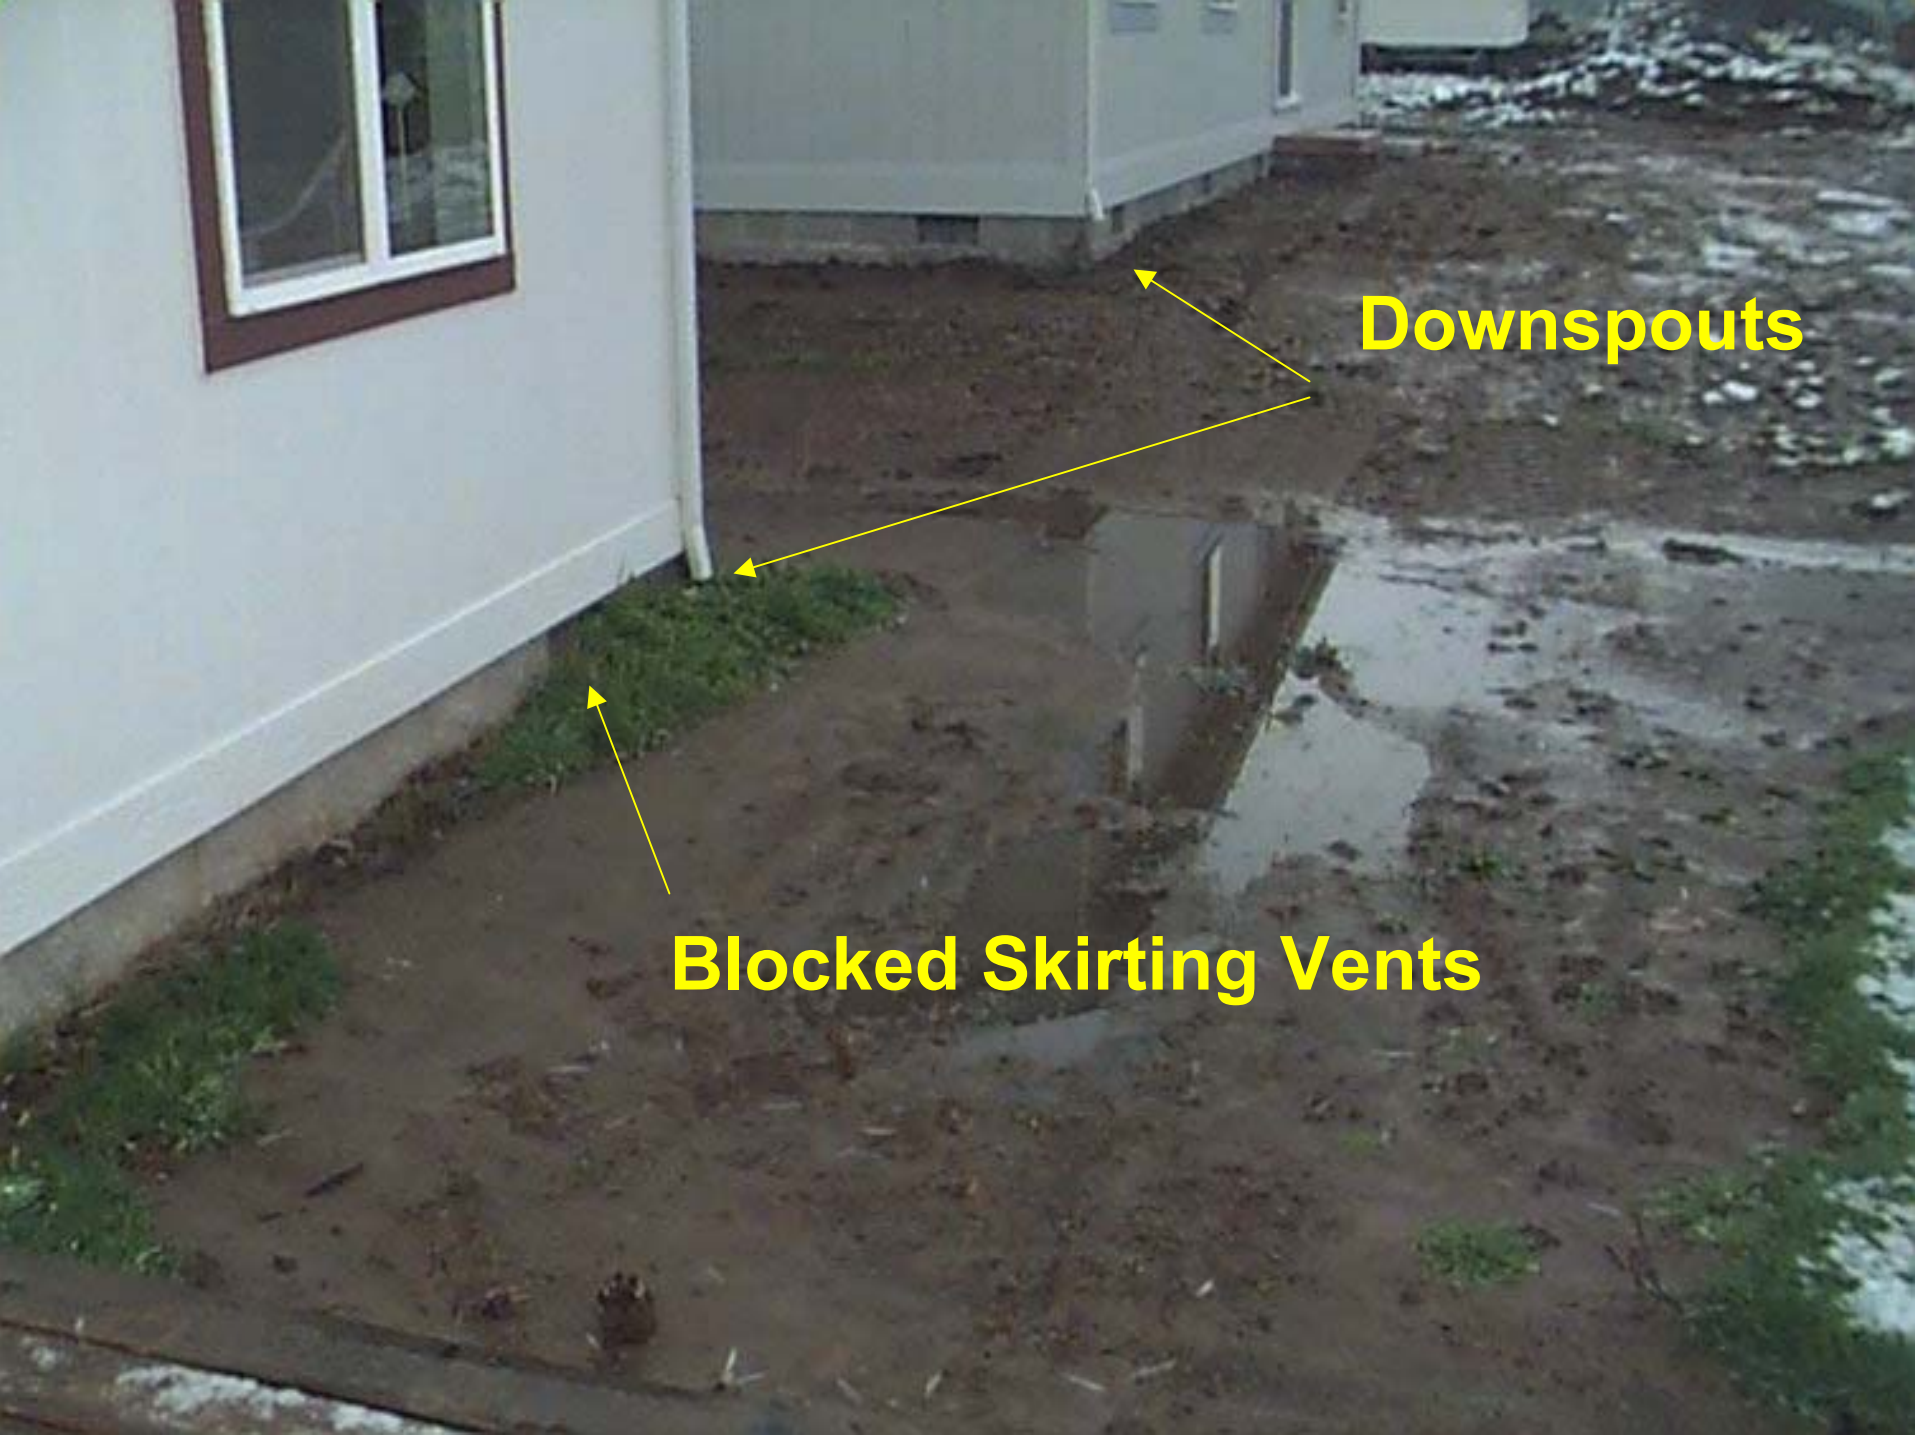
**Downspouts**

**Blocked Skirting Vents**

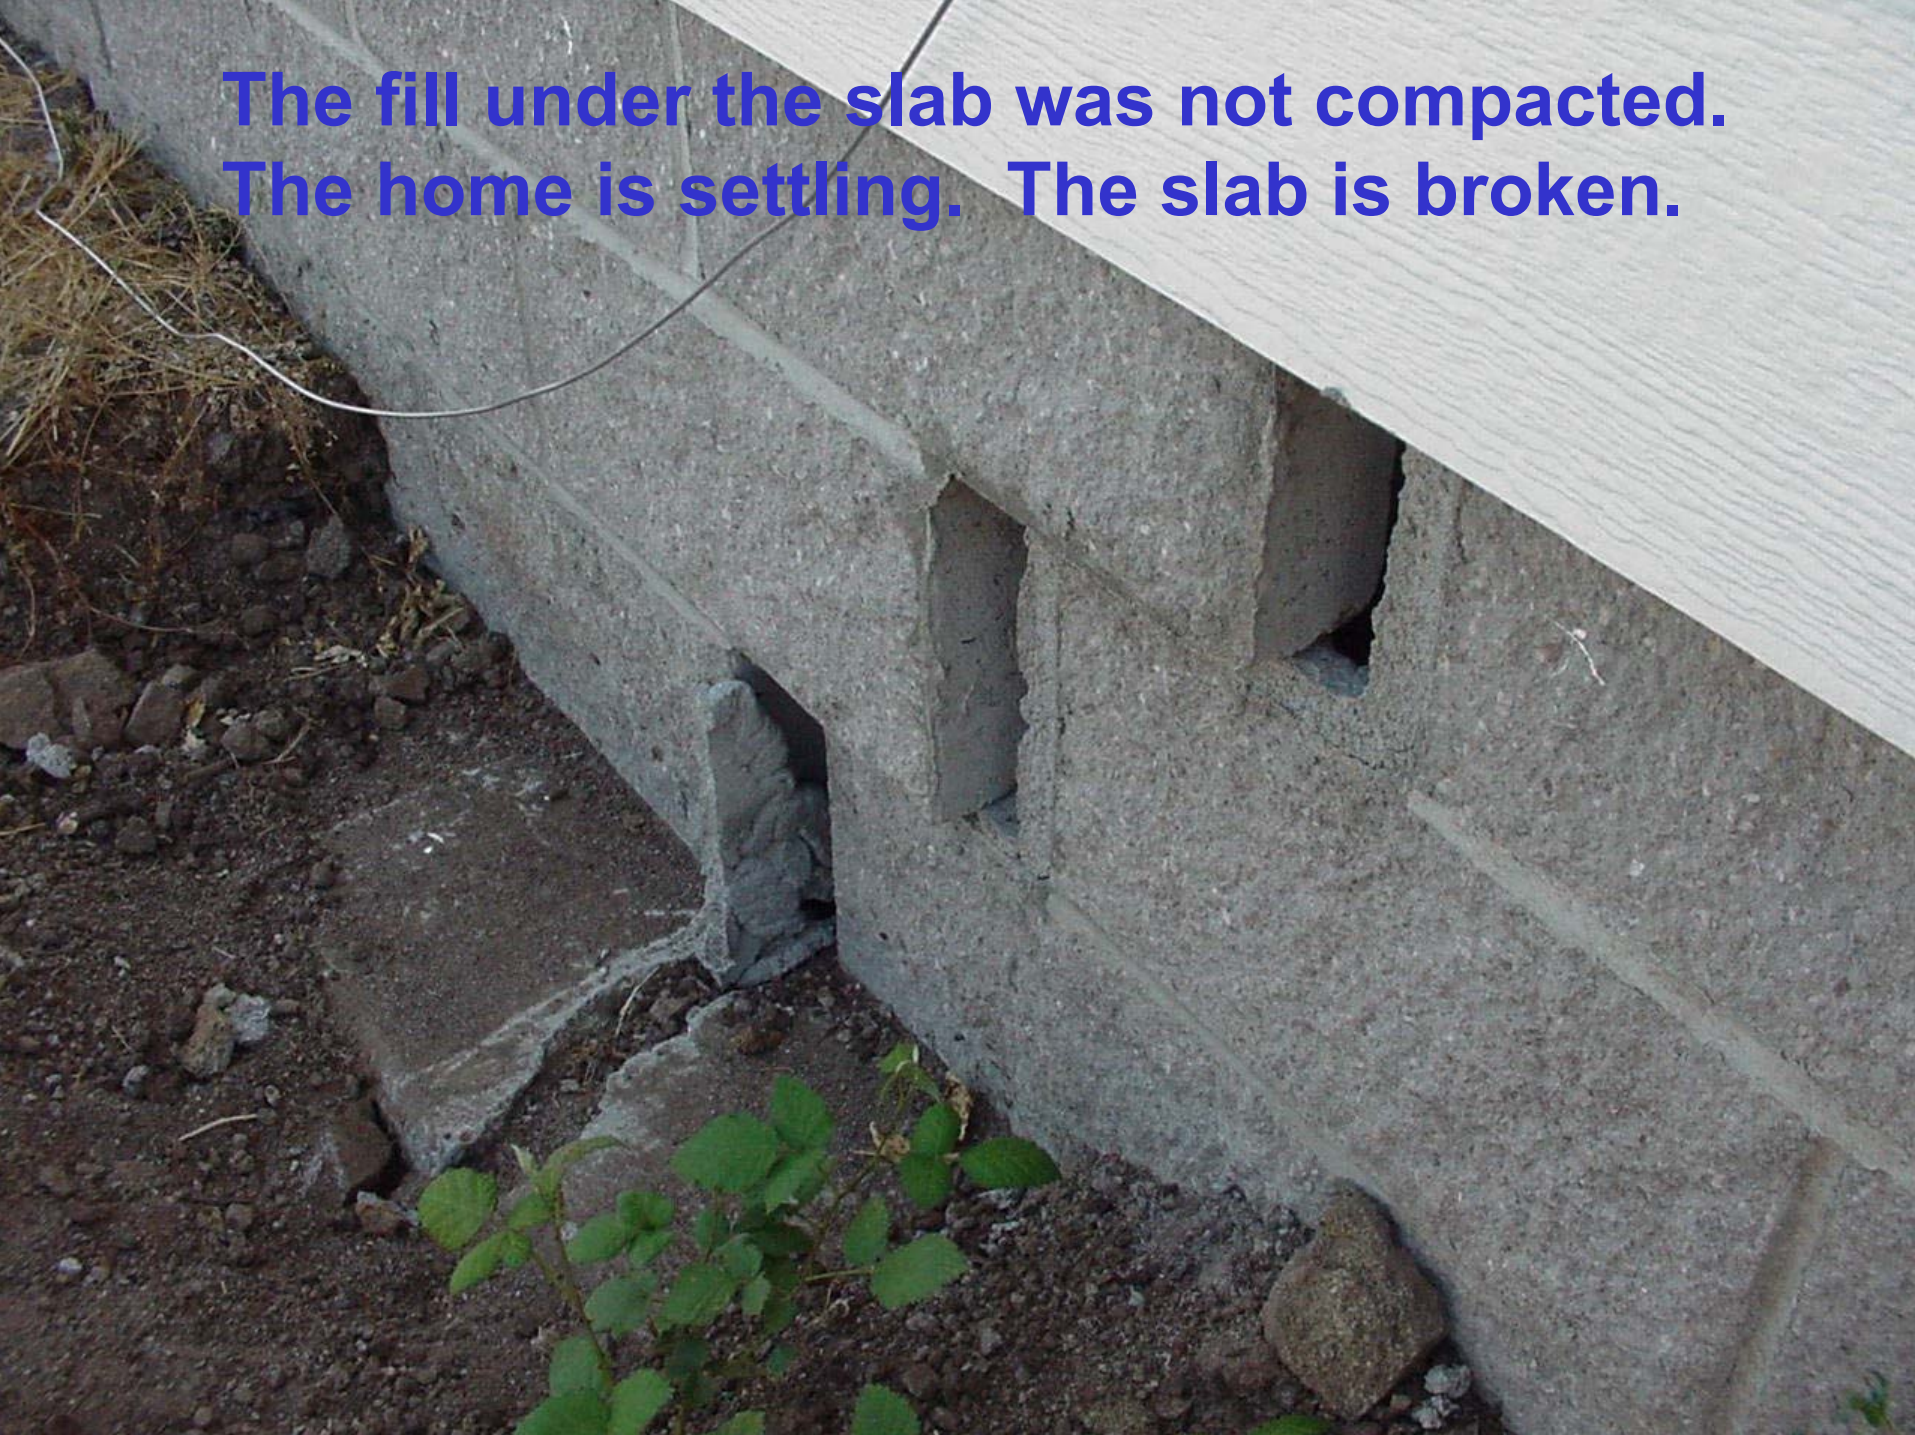
**Innovative footing design, not in compliance.**

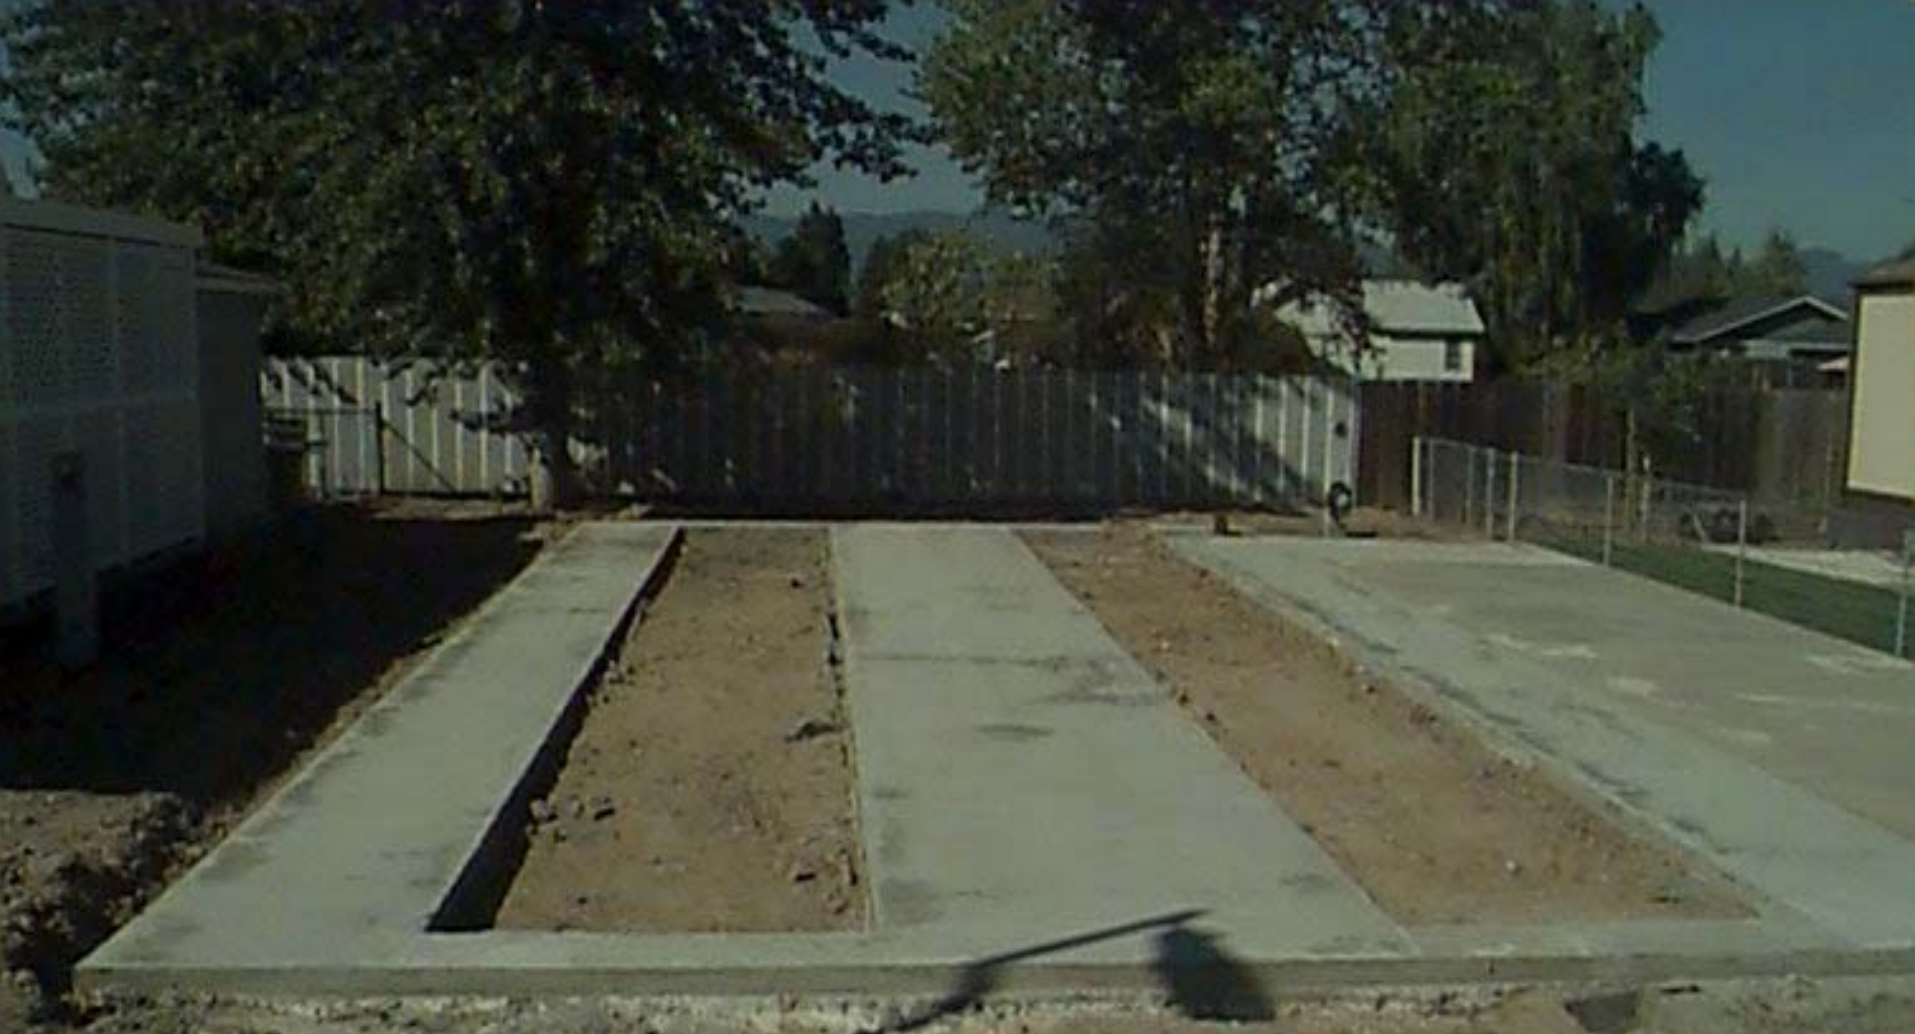
**This is commonly called a 3 pad pour. It is one of the best. All piers are placed on a uniform surface and exhibit little differential movement.**

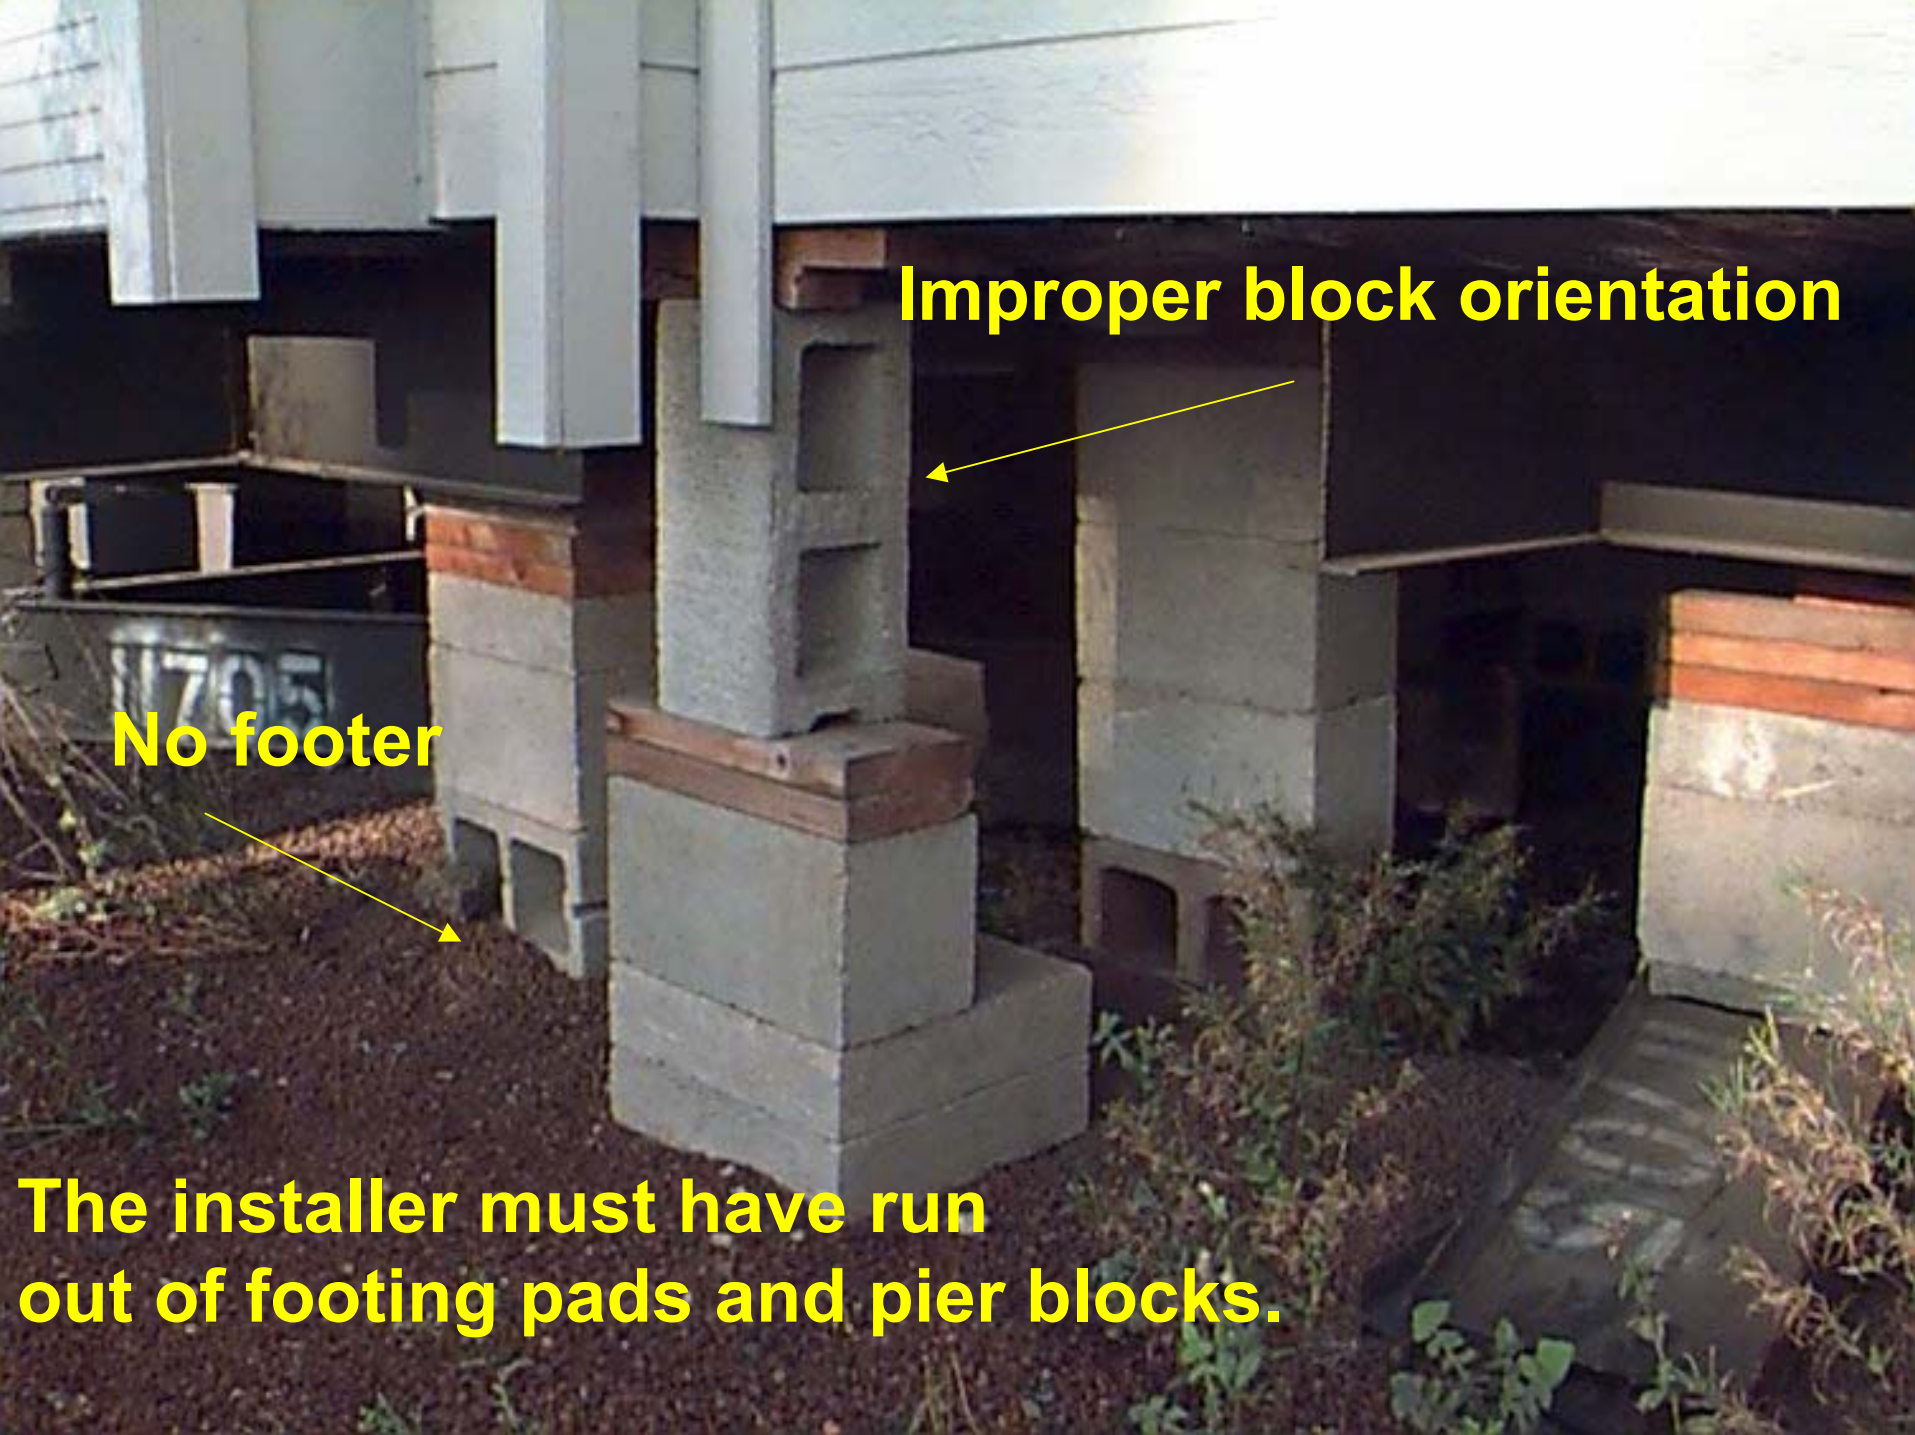
**Improper block orientation**
