**TRANSPORTATION  
AND OTHER  
DAMAGE**

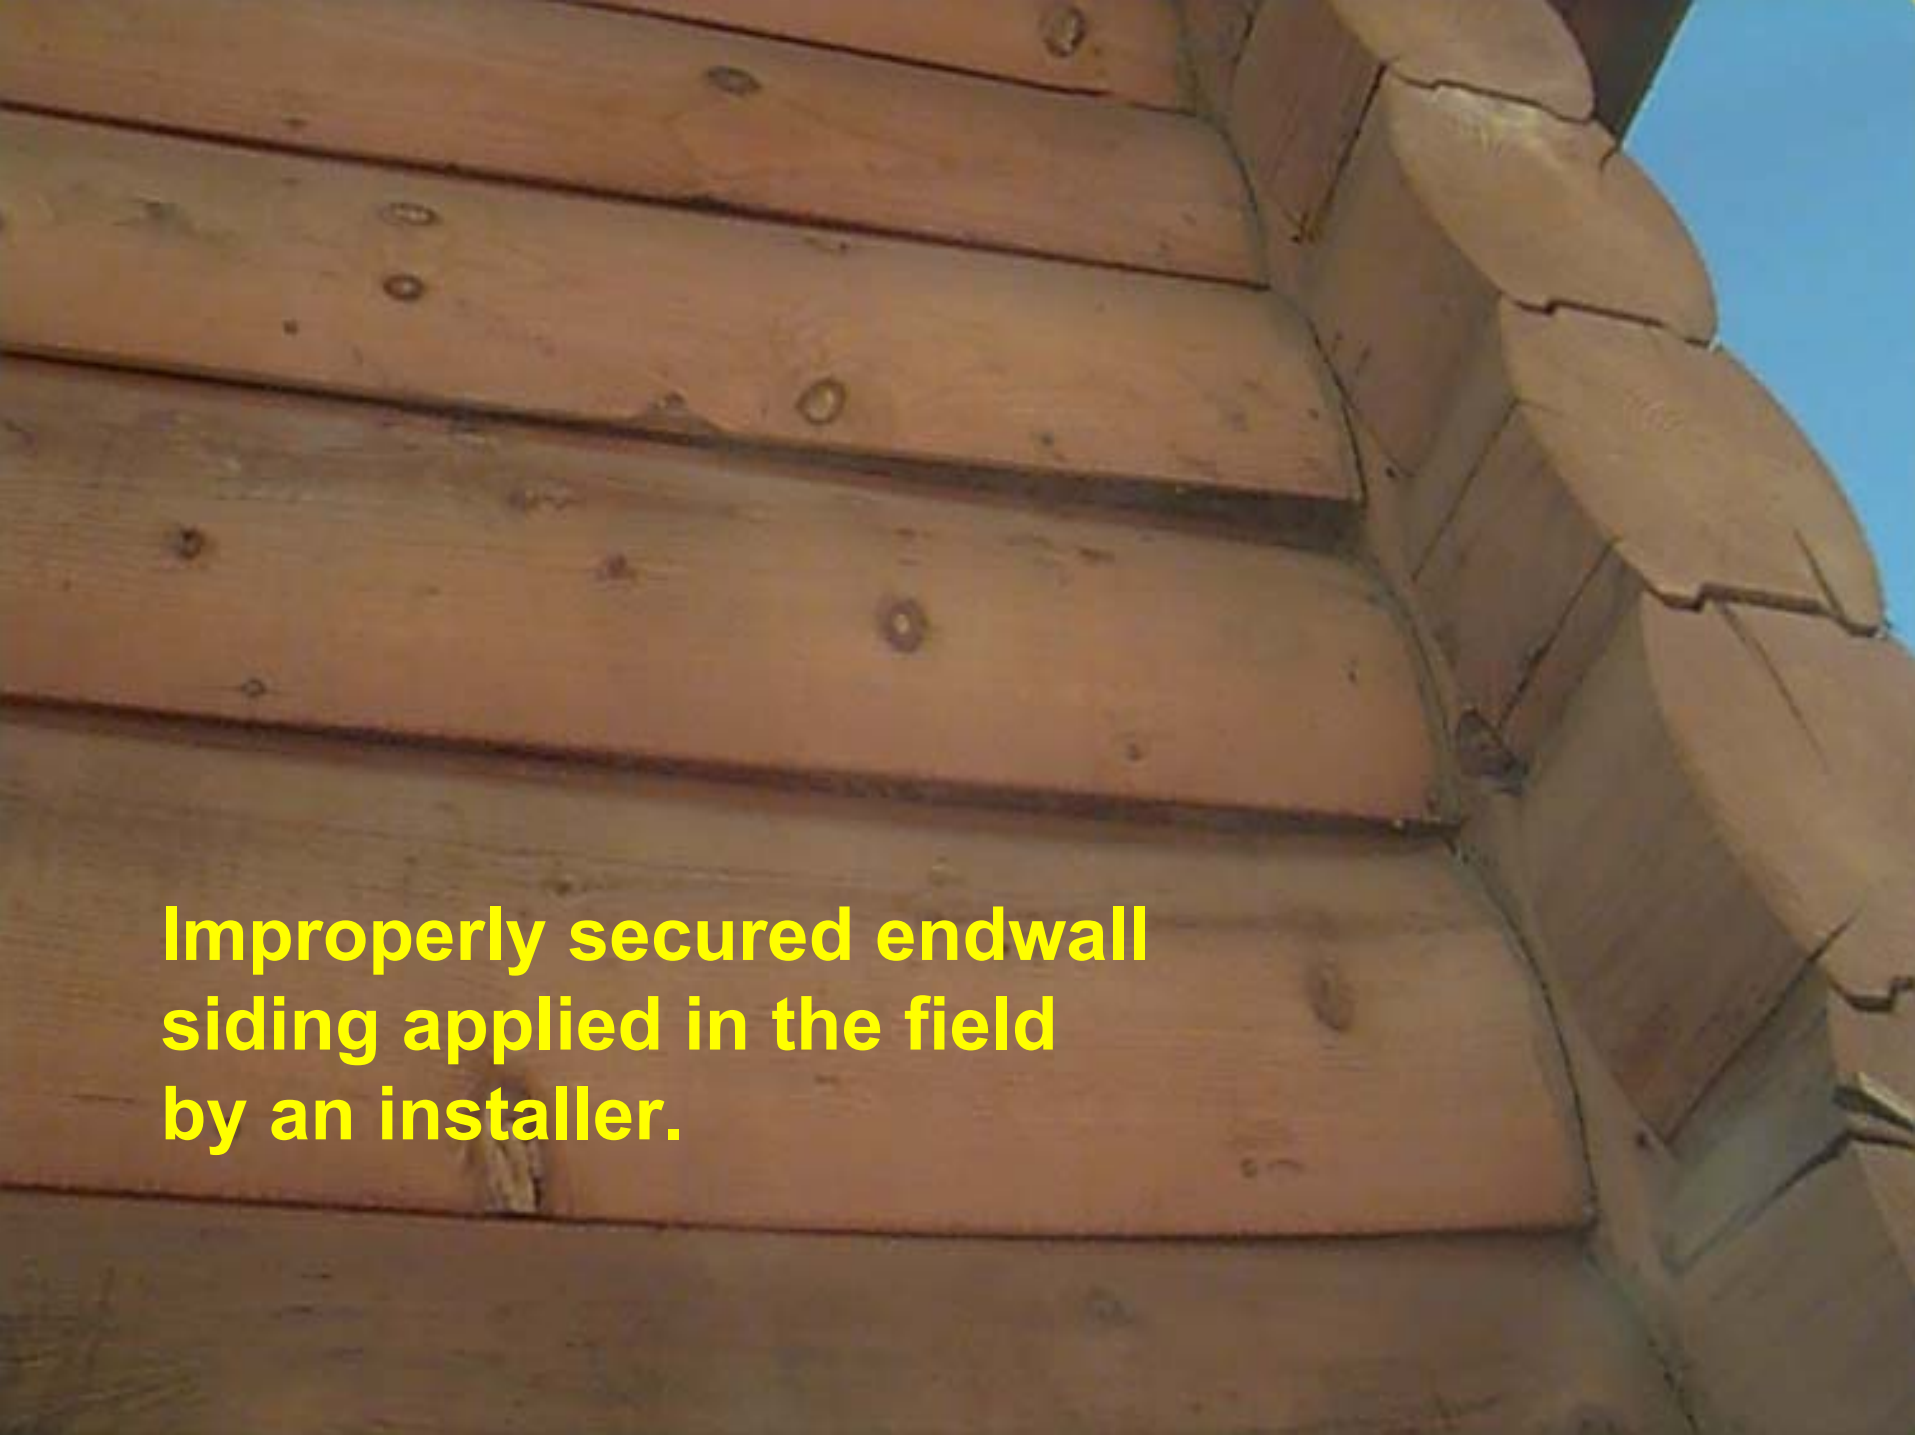
**Improperly secured endwall  
siding applied in the field  
by an installer.**

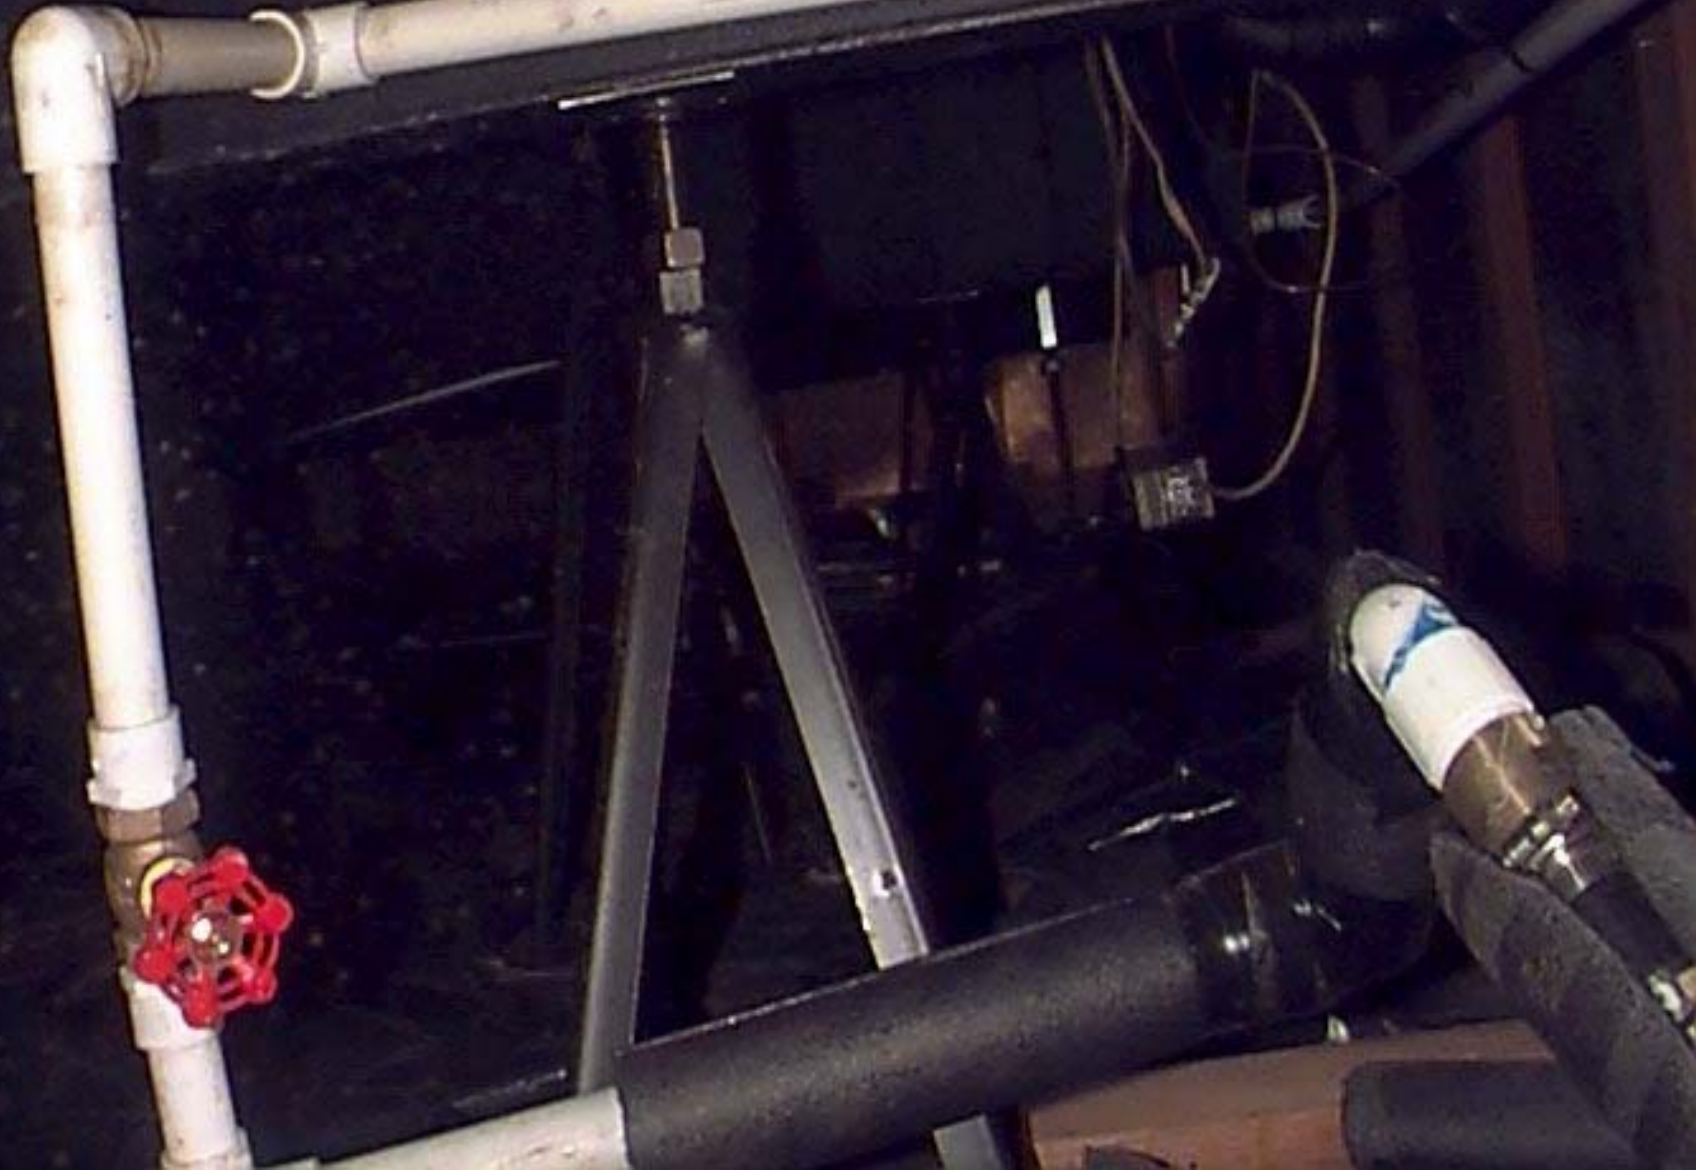
**Uninsulated pressure line**

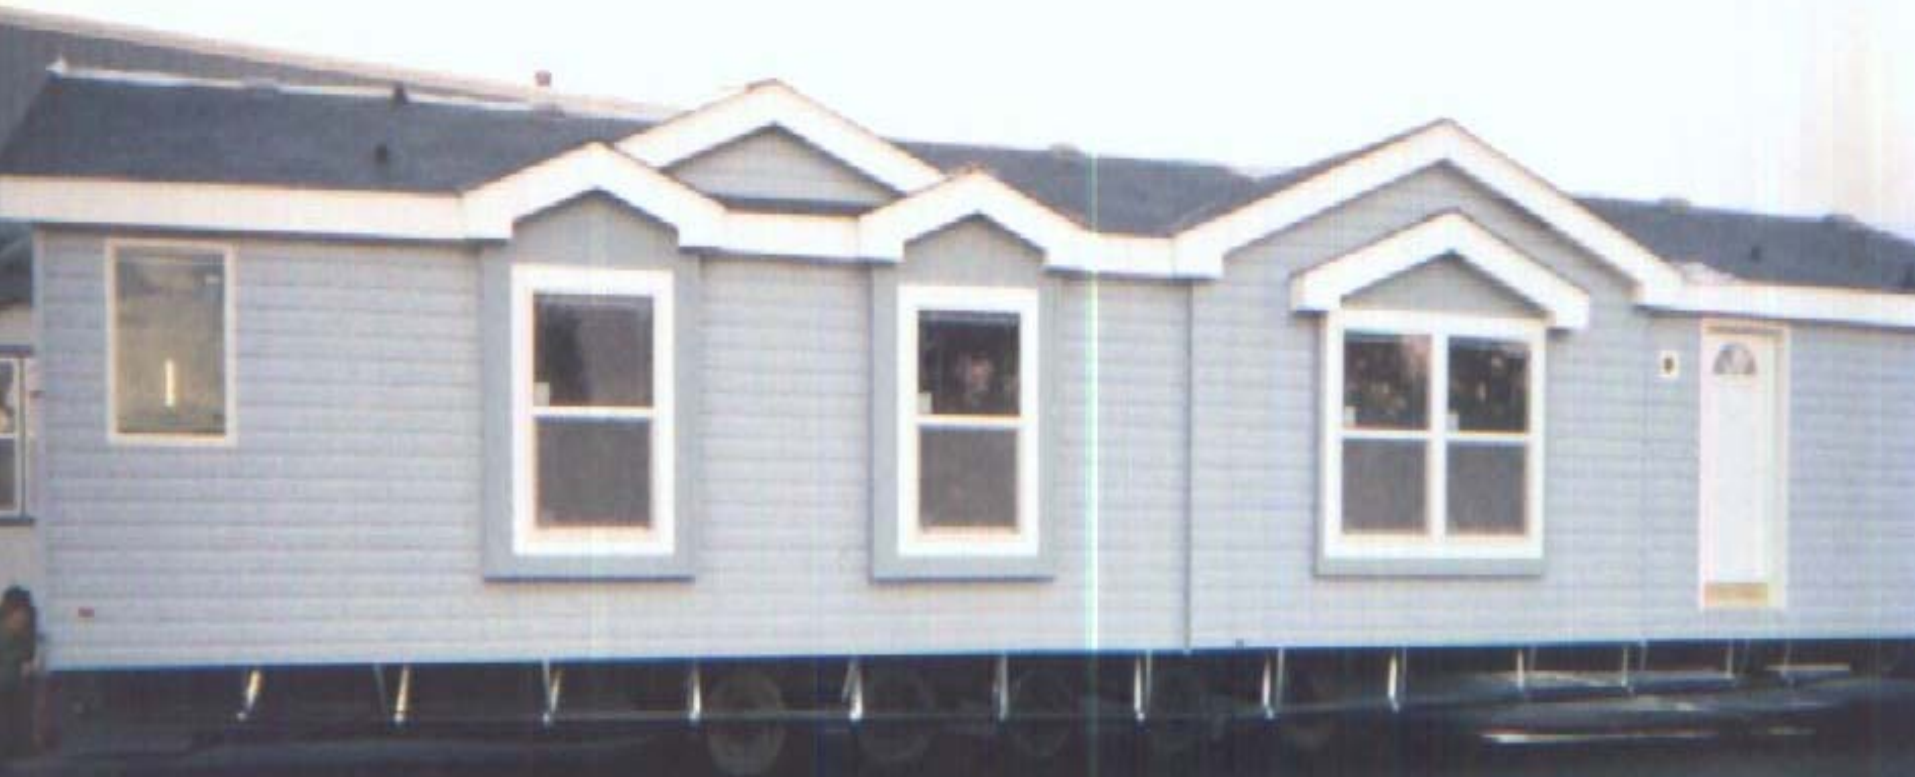
**Drain line supported at the factory.**

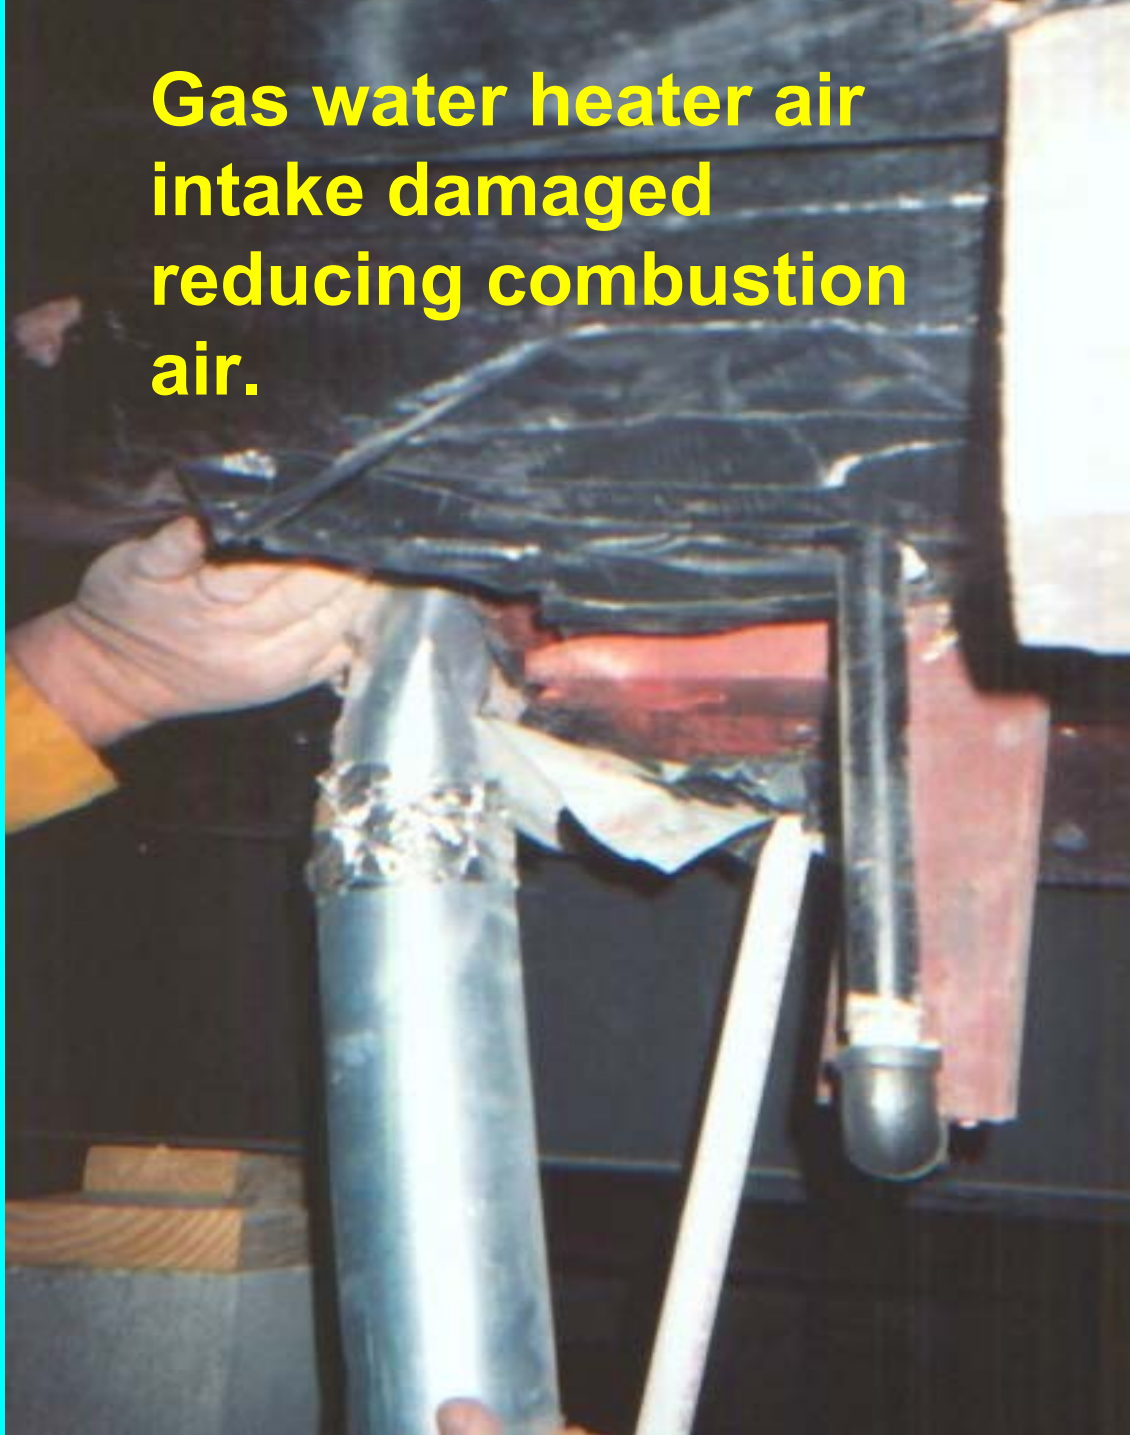
**Gas water heater air  
intake damaged  
reducing combustion  
air.**

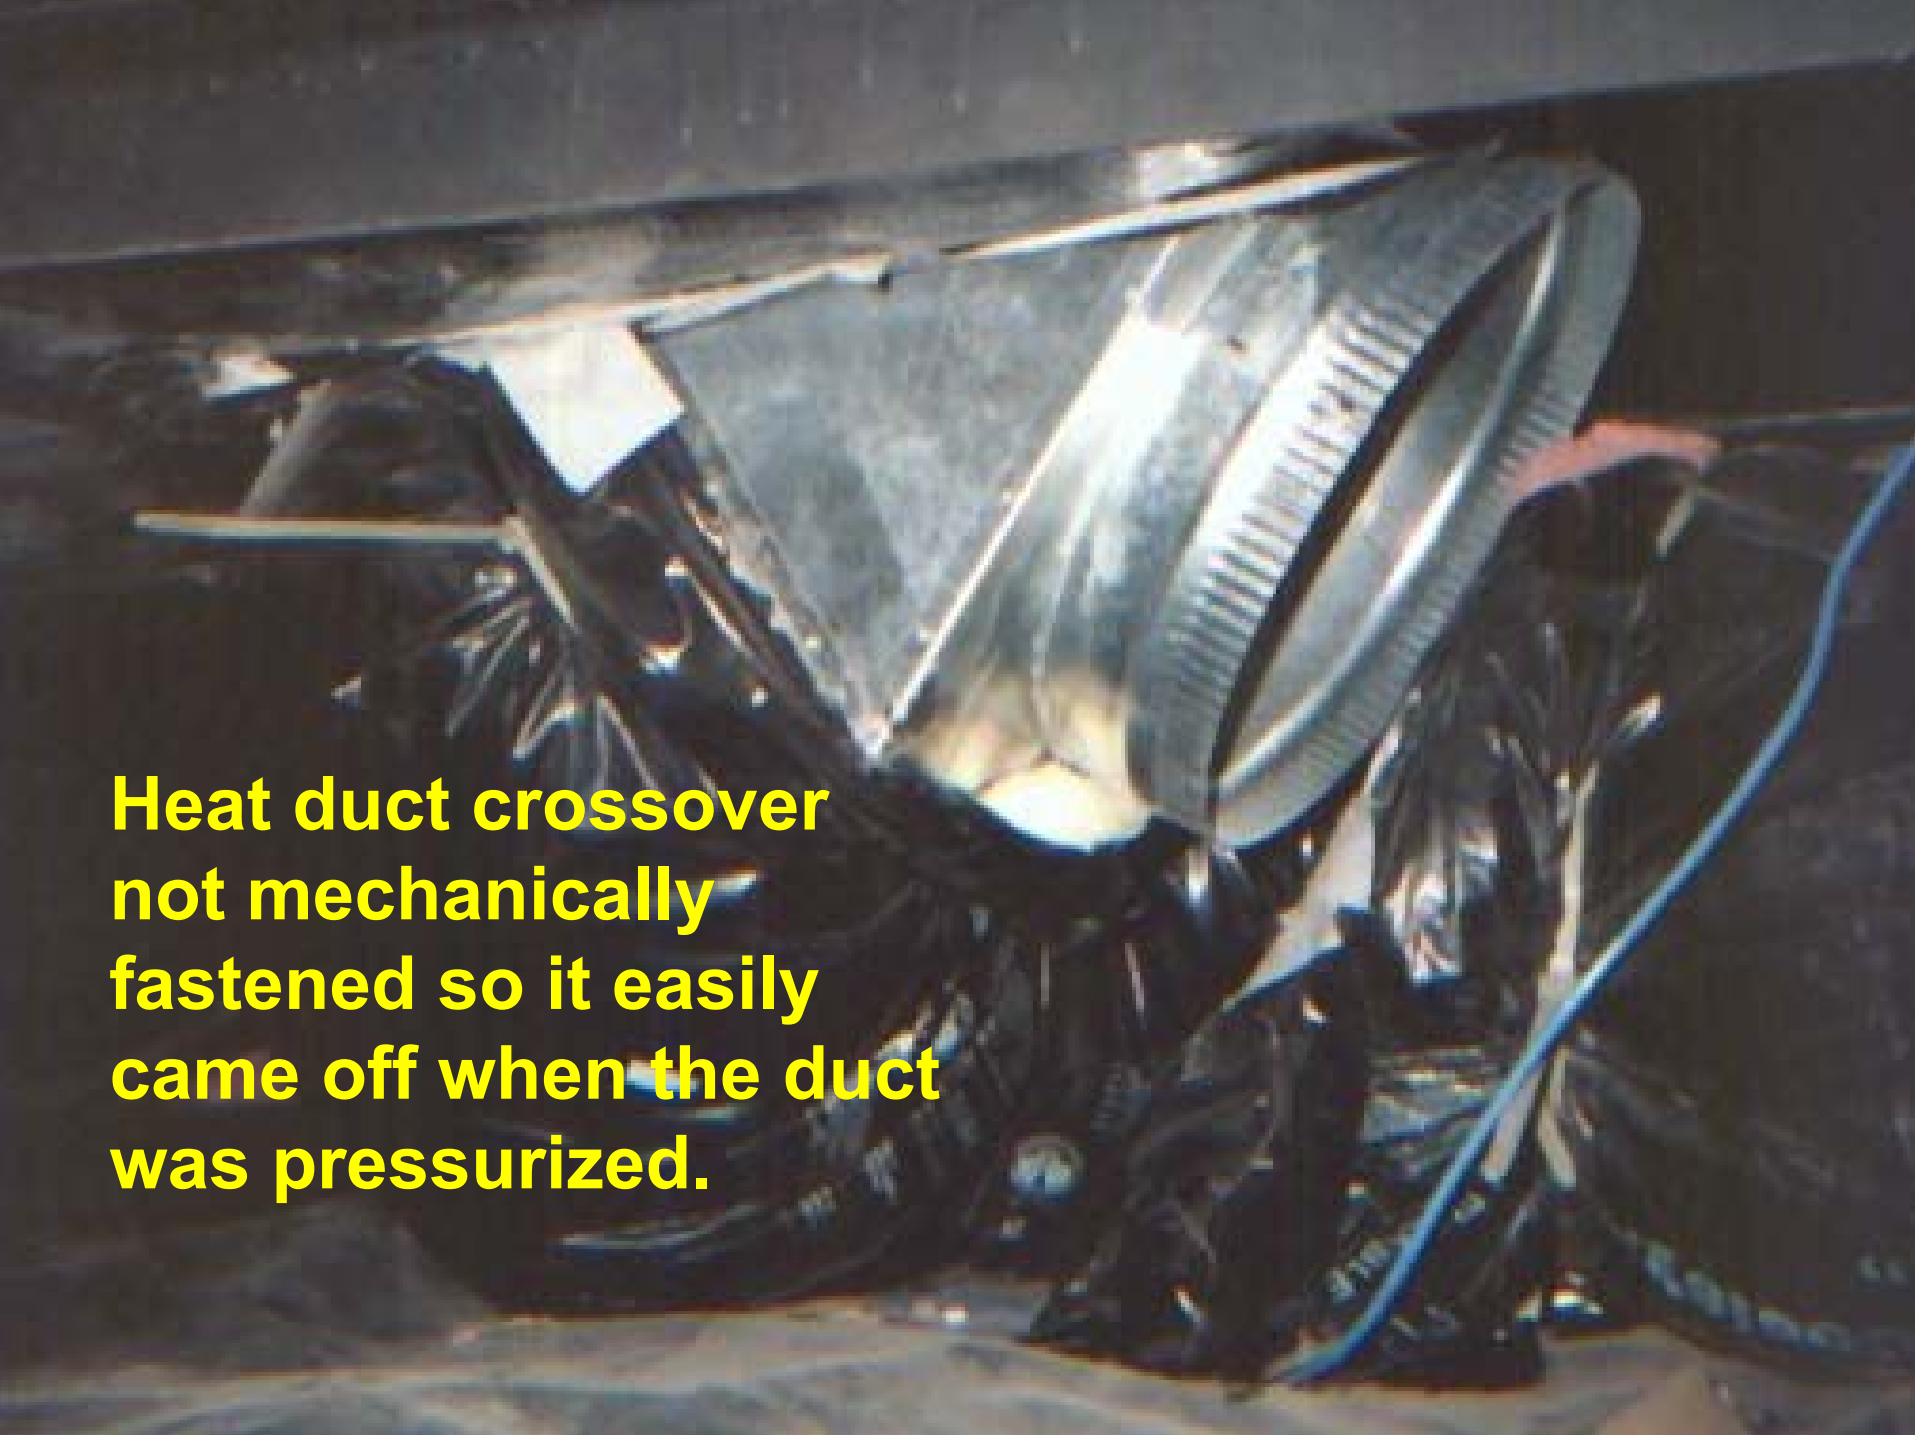
**Heat duct crossover  
not mechanically  
fastened so it easily  
came off when the duct  
was pressurized.**

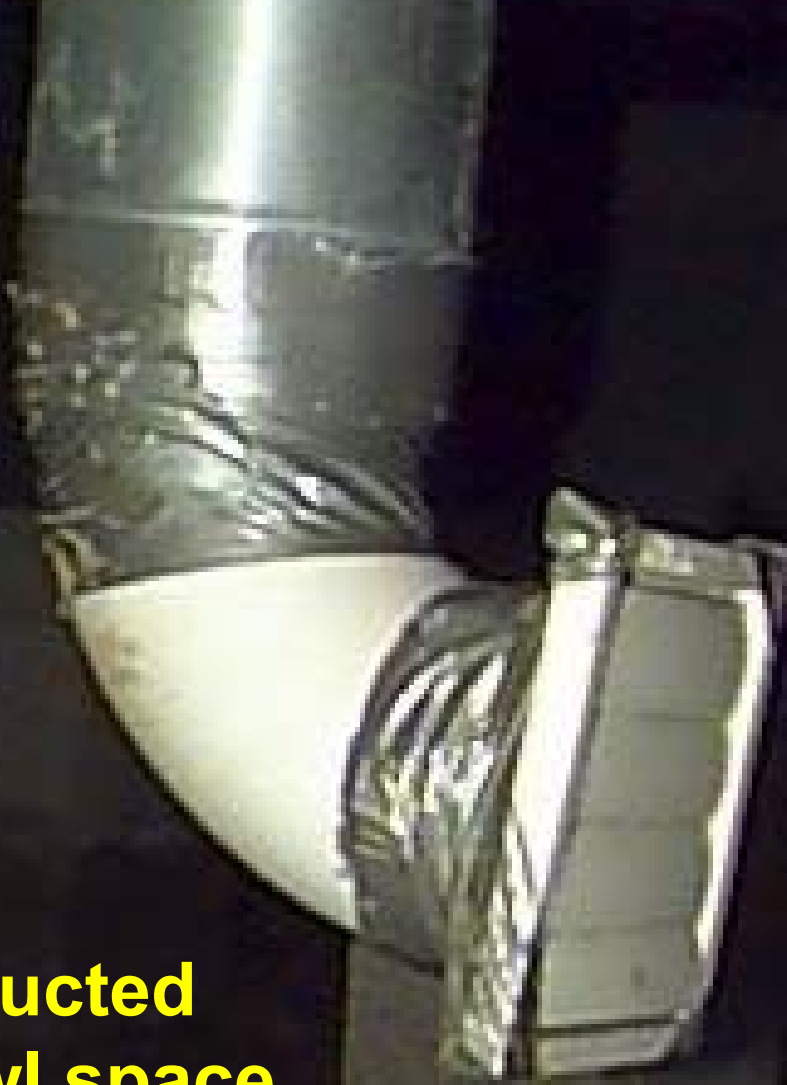
**This dryer vent duct will  
tend to trap water and  
lint in the dip.**

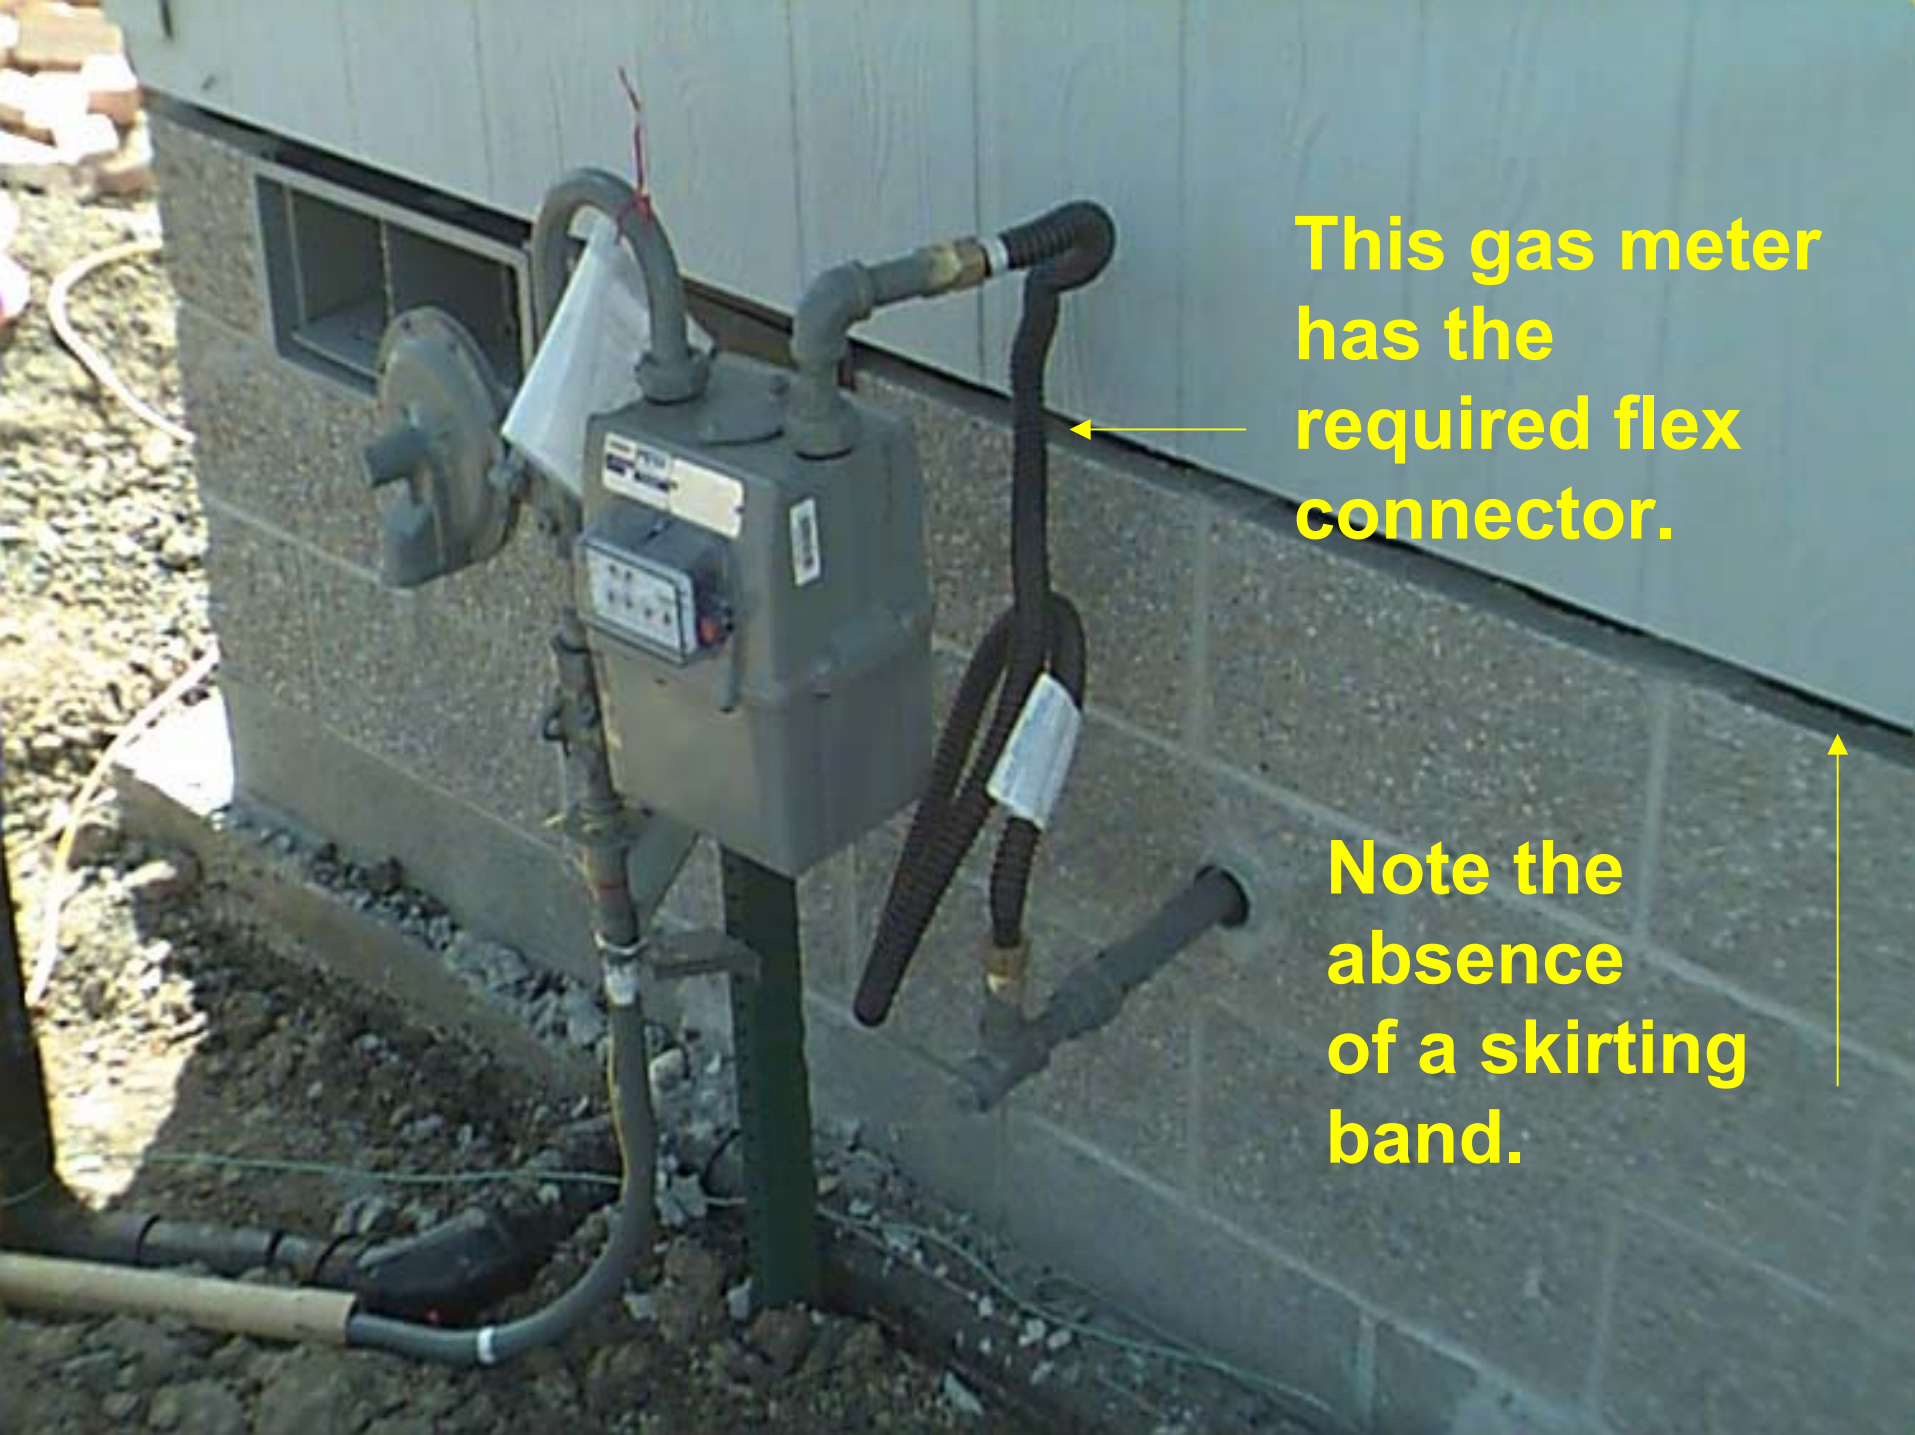
**Dryer vent not ducted  
outside the crawl space.  
Note the dryer lint buildup.**

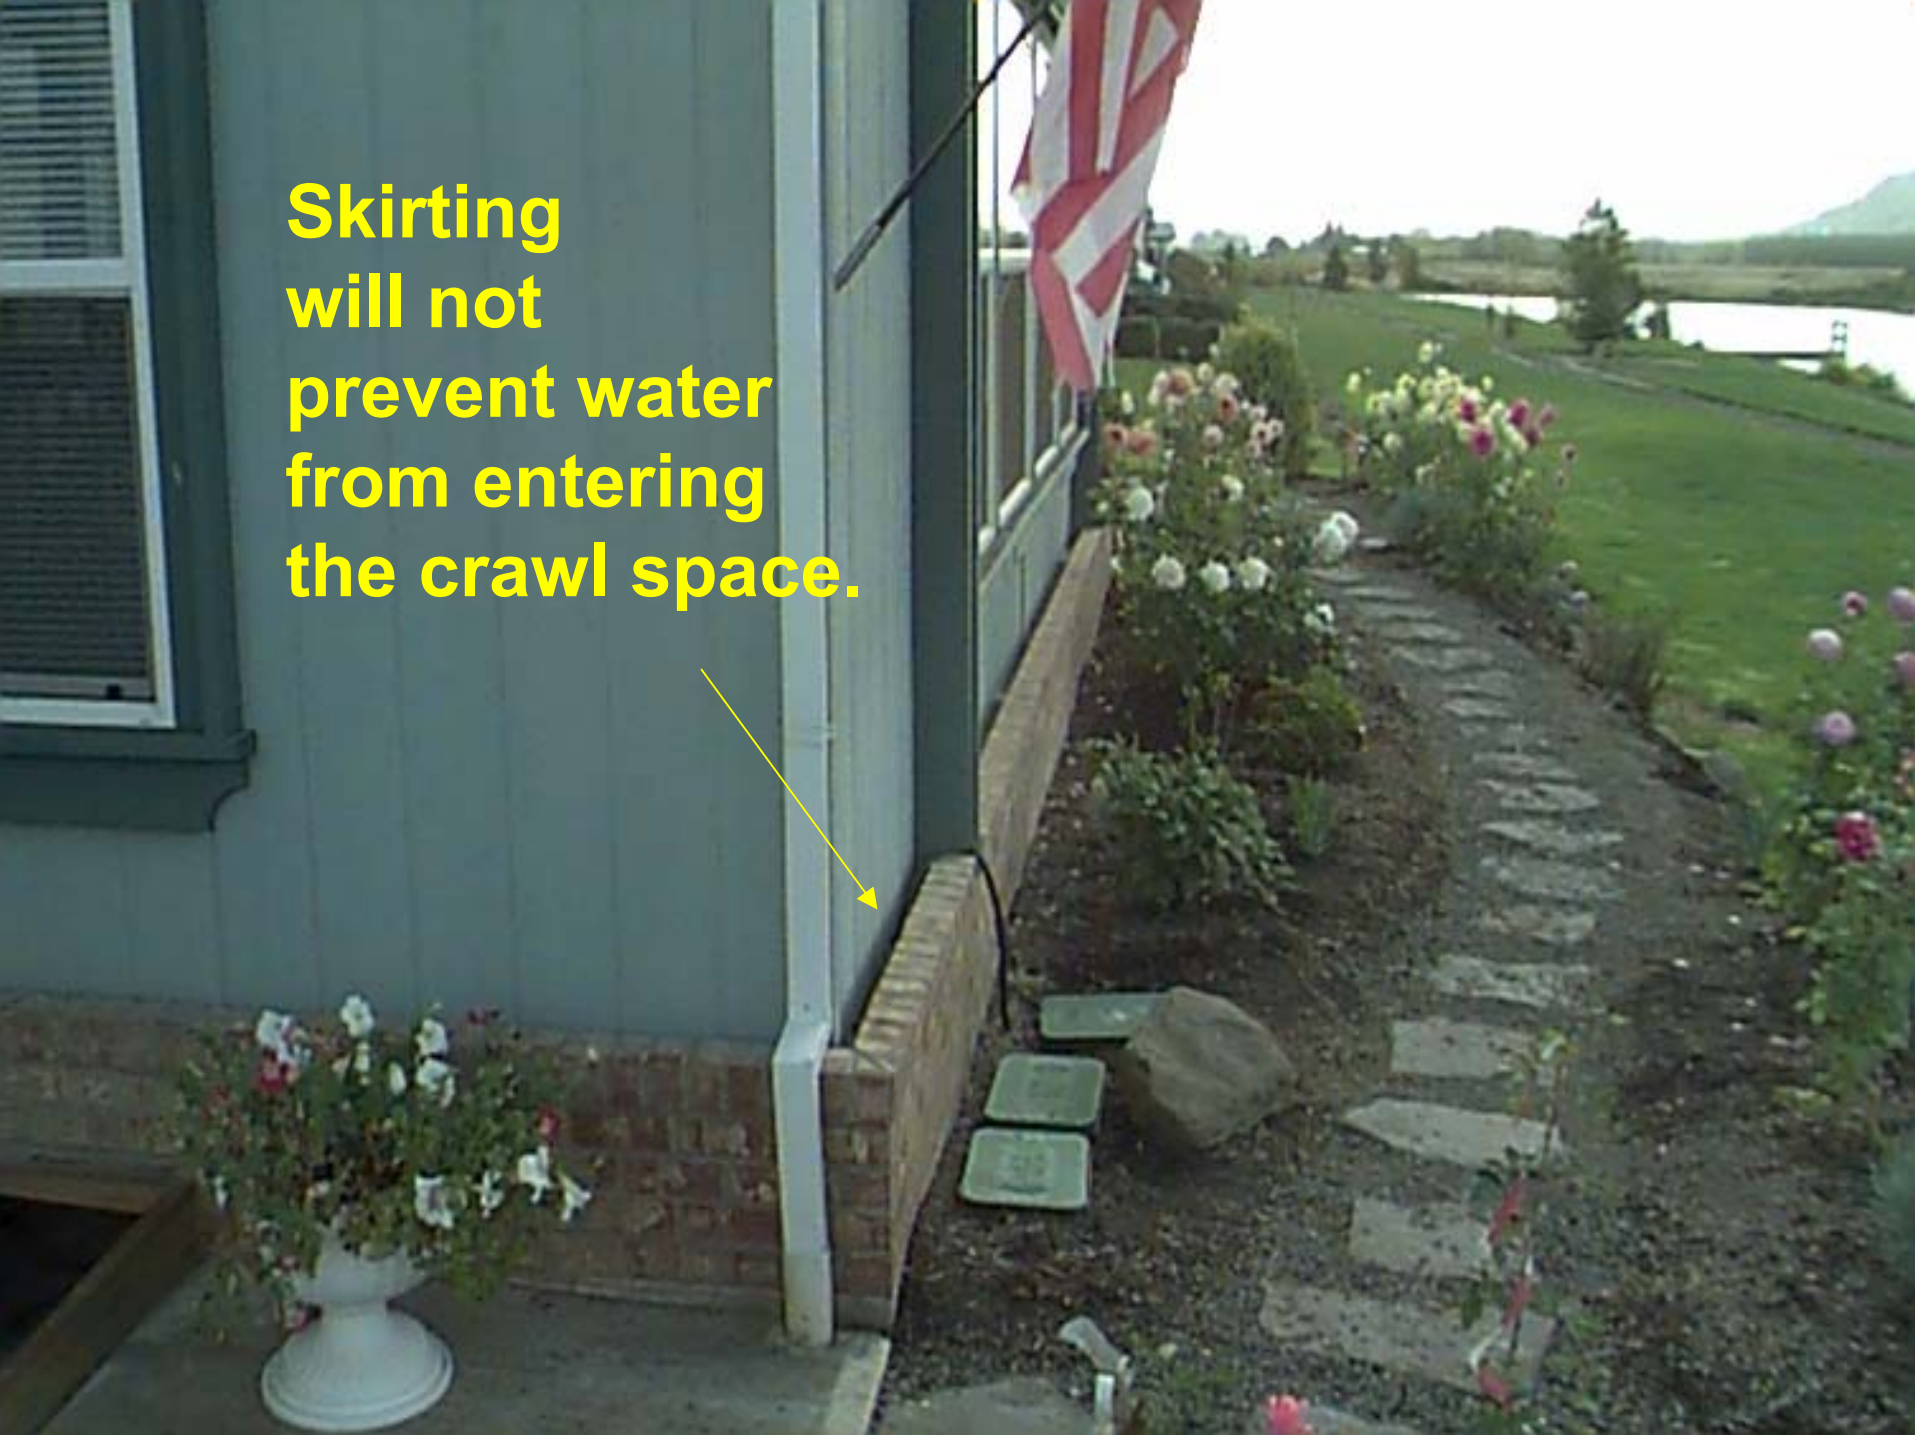
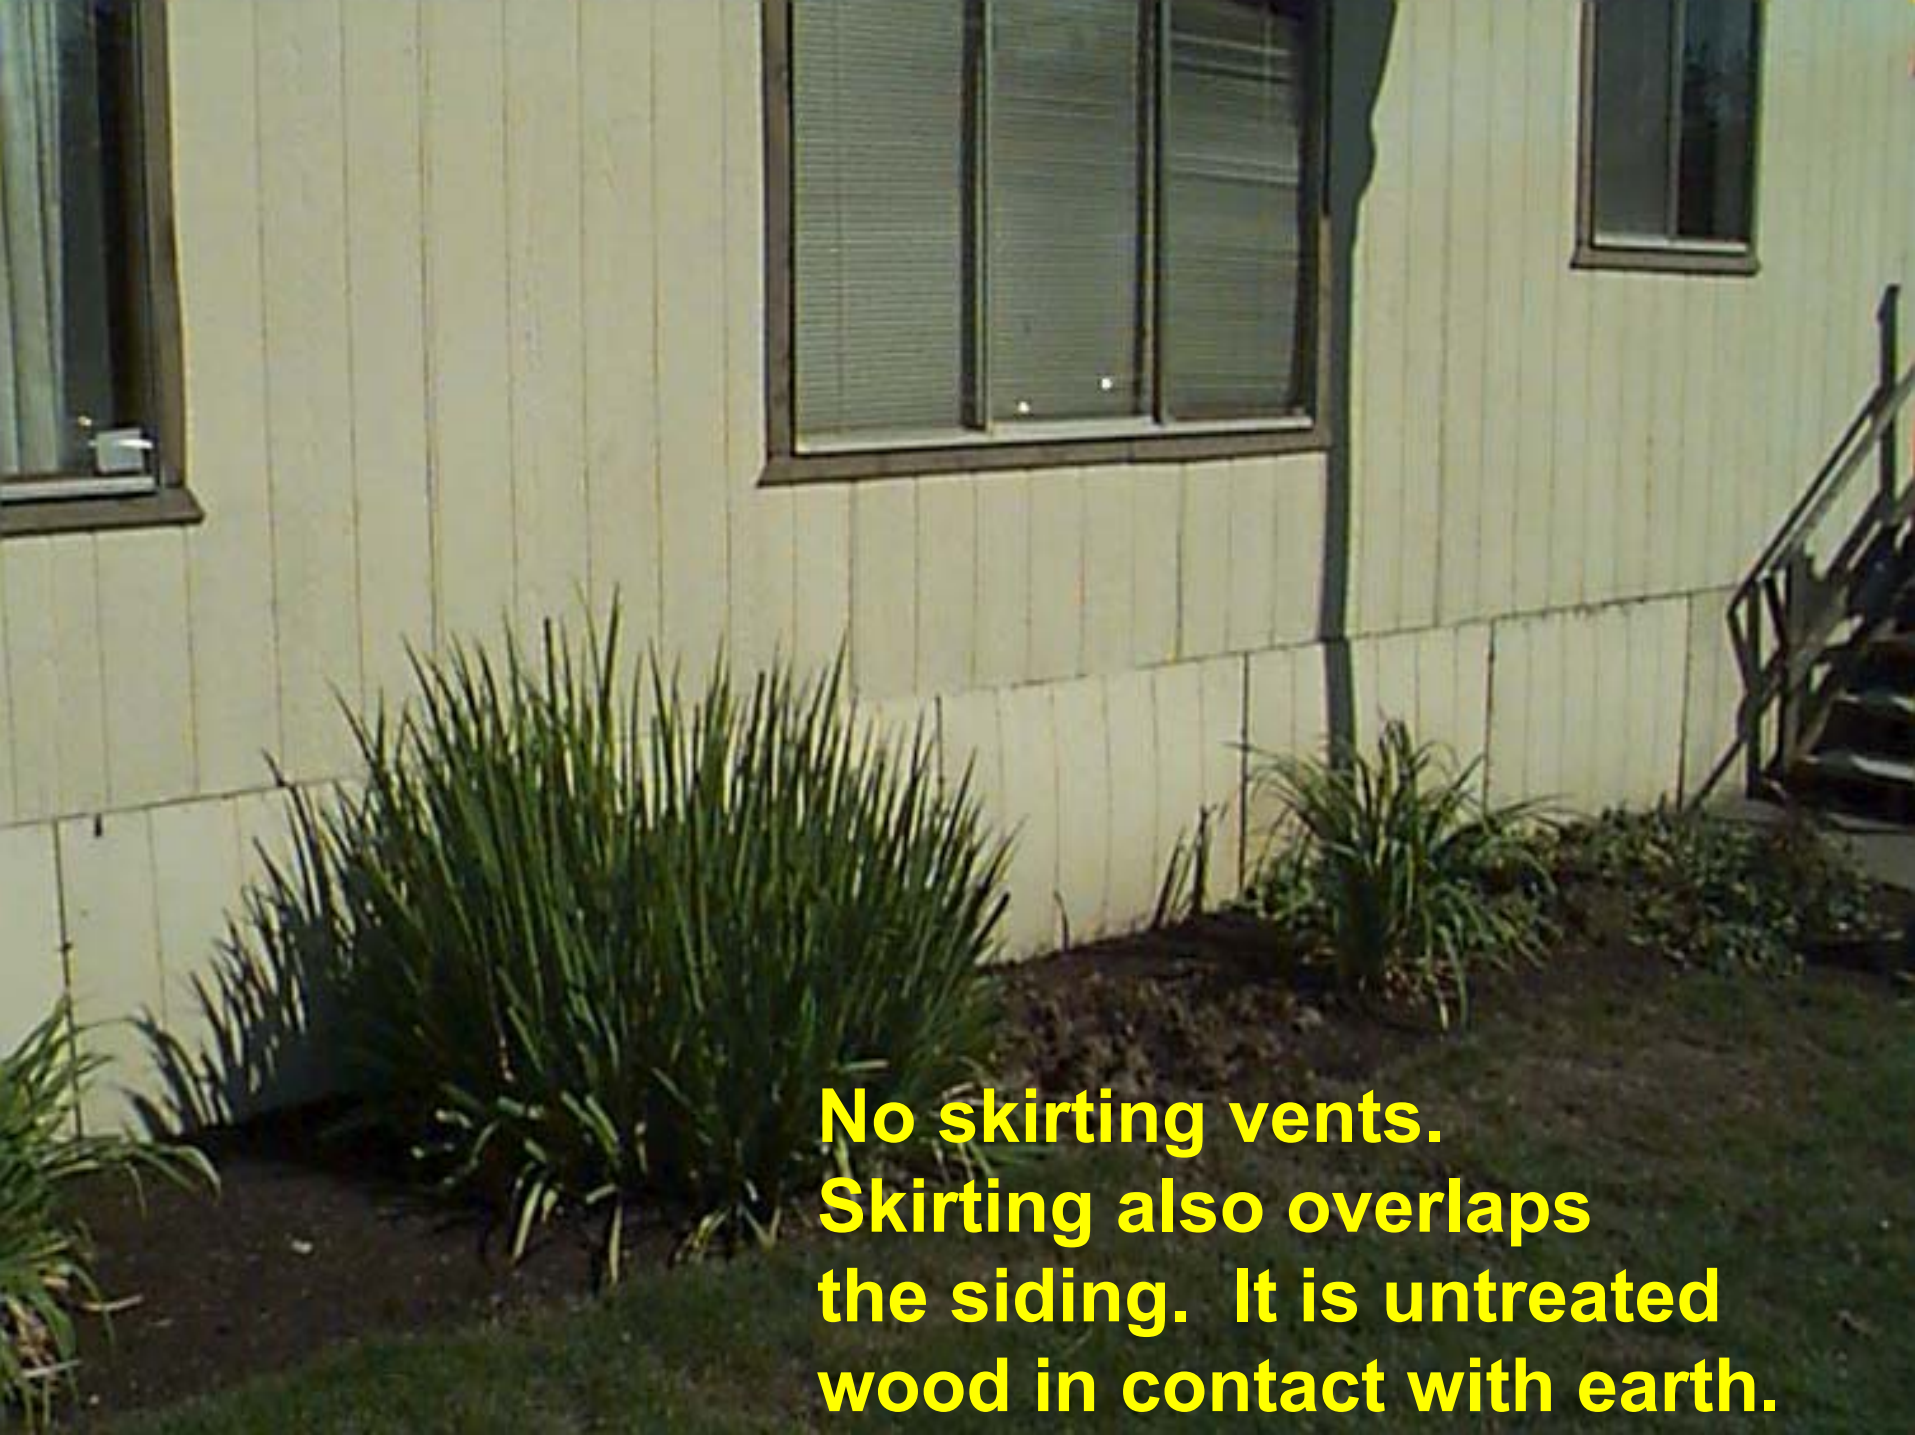
**No skirting vents.  
Skirting also overlaps  
the siding. It is untreated  
wood in contact with earth.**

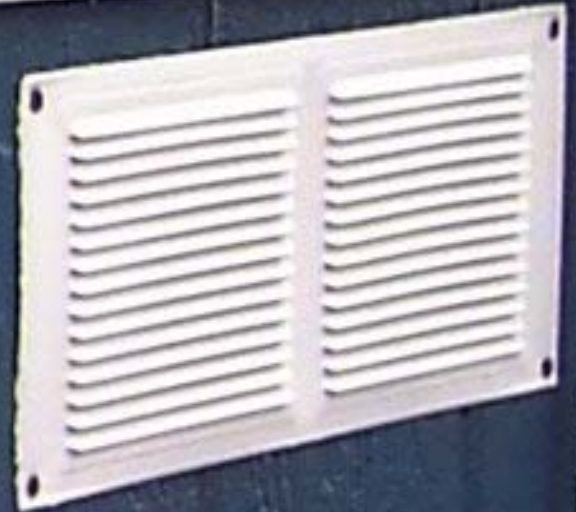
**Skirting band properly sealed  
at the factory but not properly  
sealed by the skirting installer.**

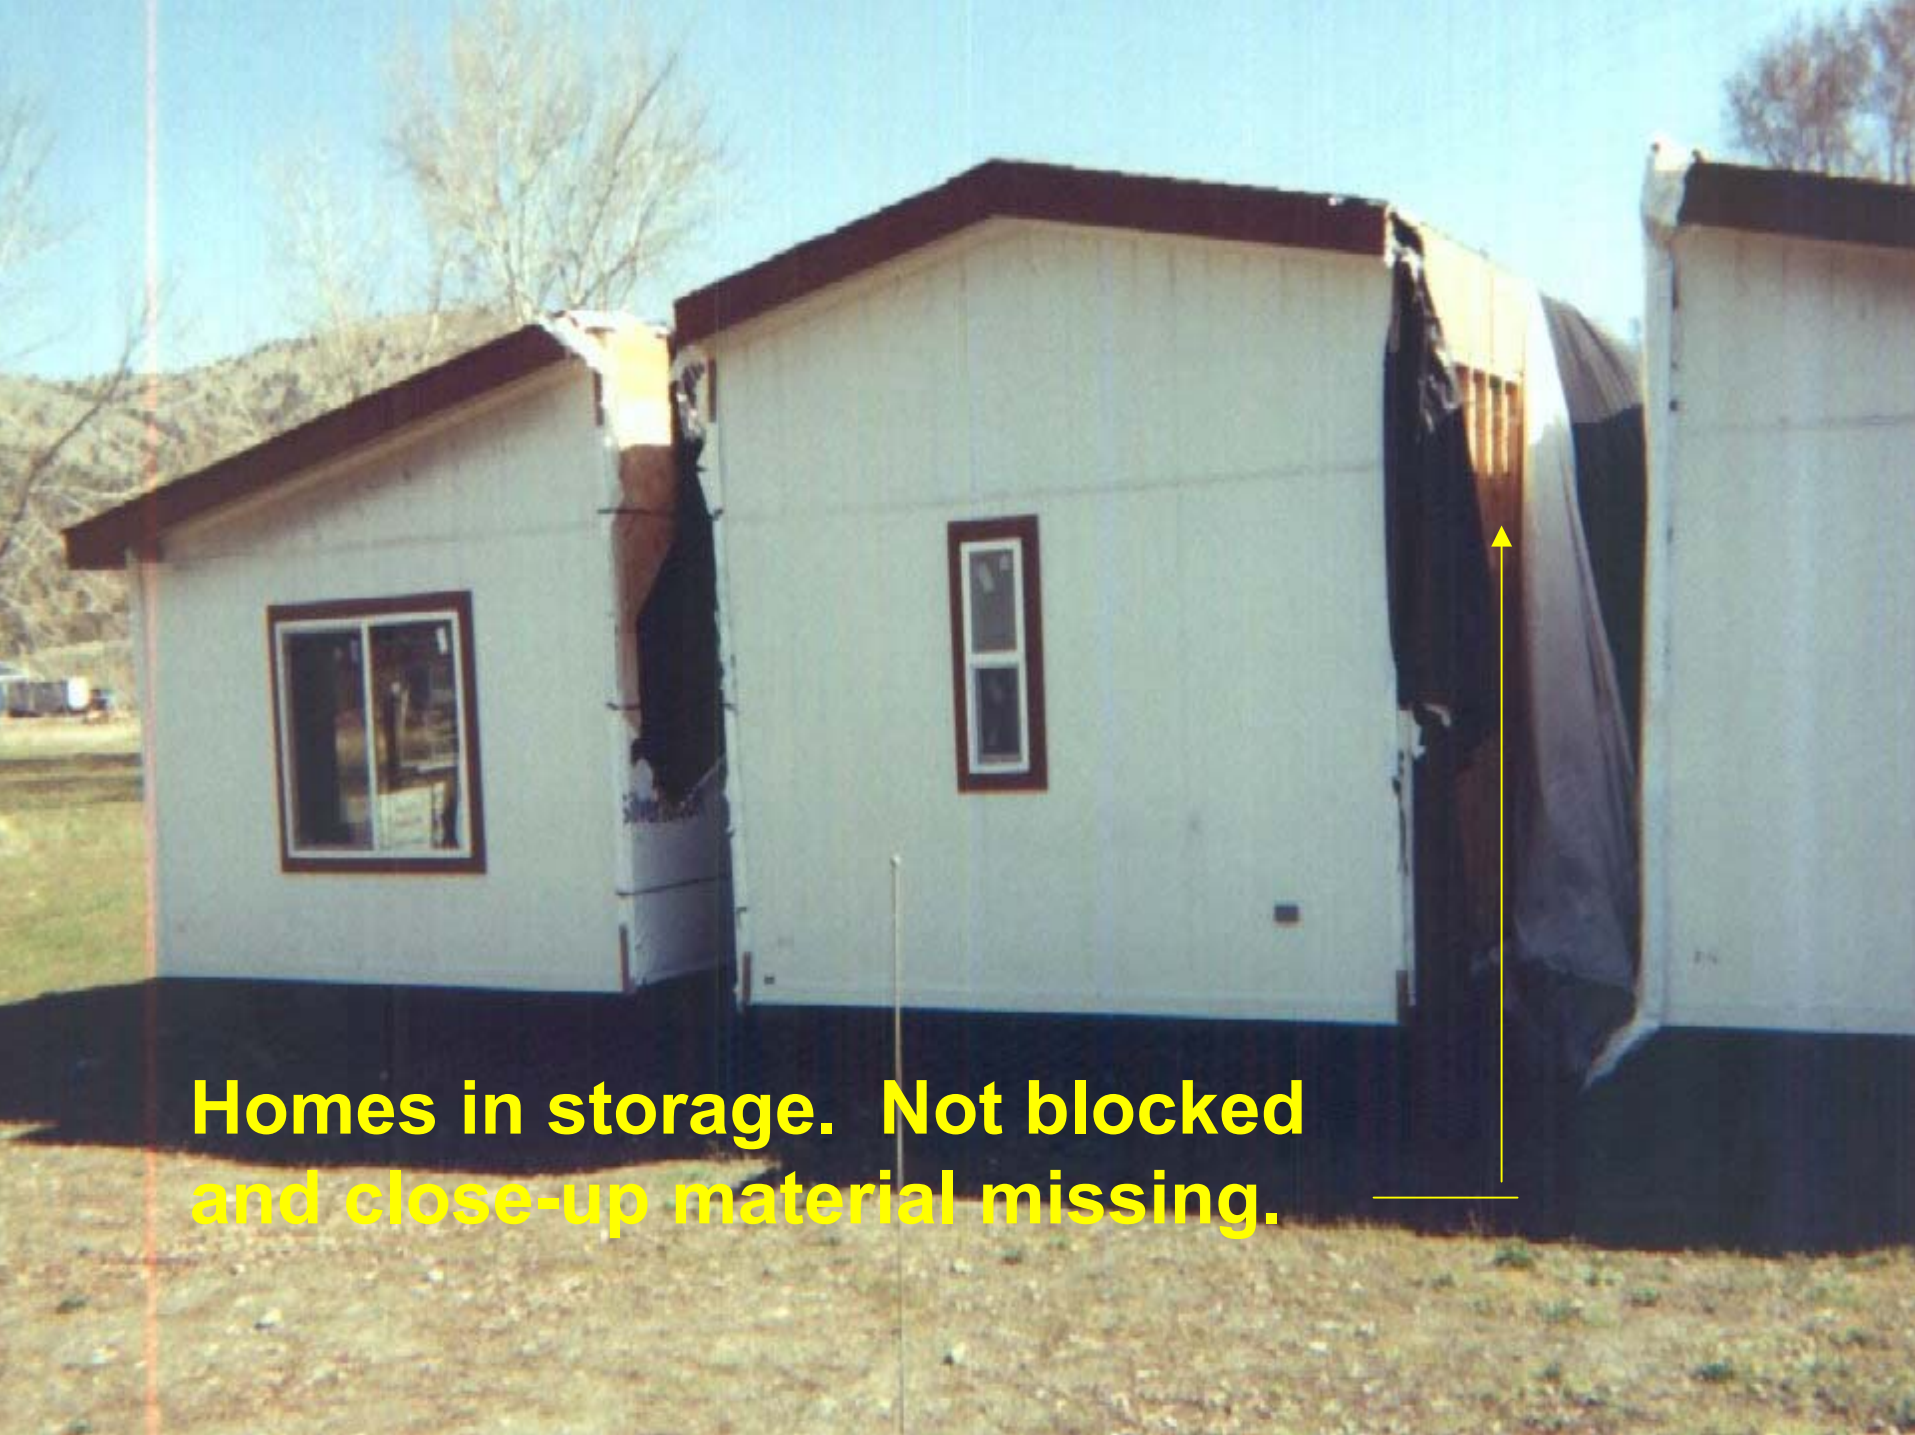
**Mold from a home leaking  
while in storage.**

**Homes in storage. Not blocked  
and close-up material missing.**
