**TRANSPORTATION  
AND OTHER  
DAMAGE**

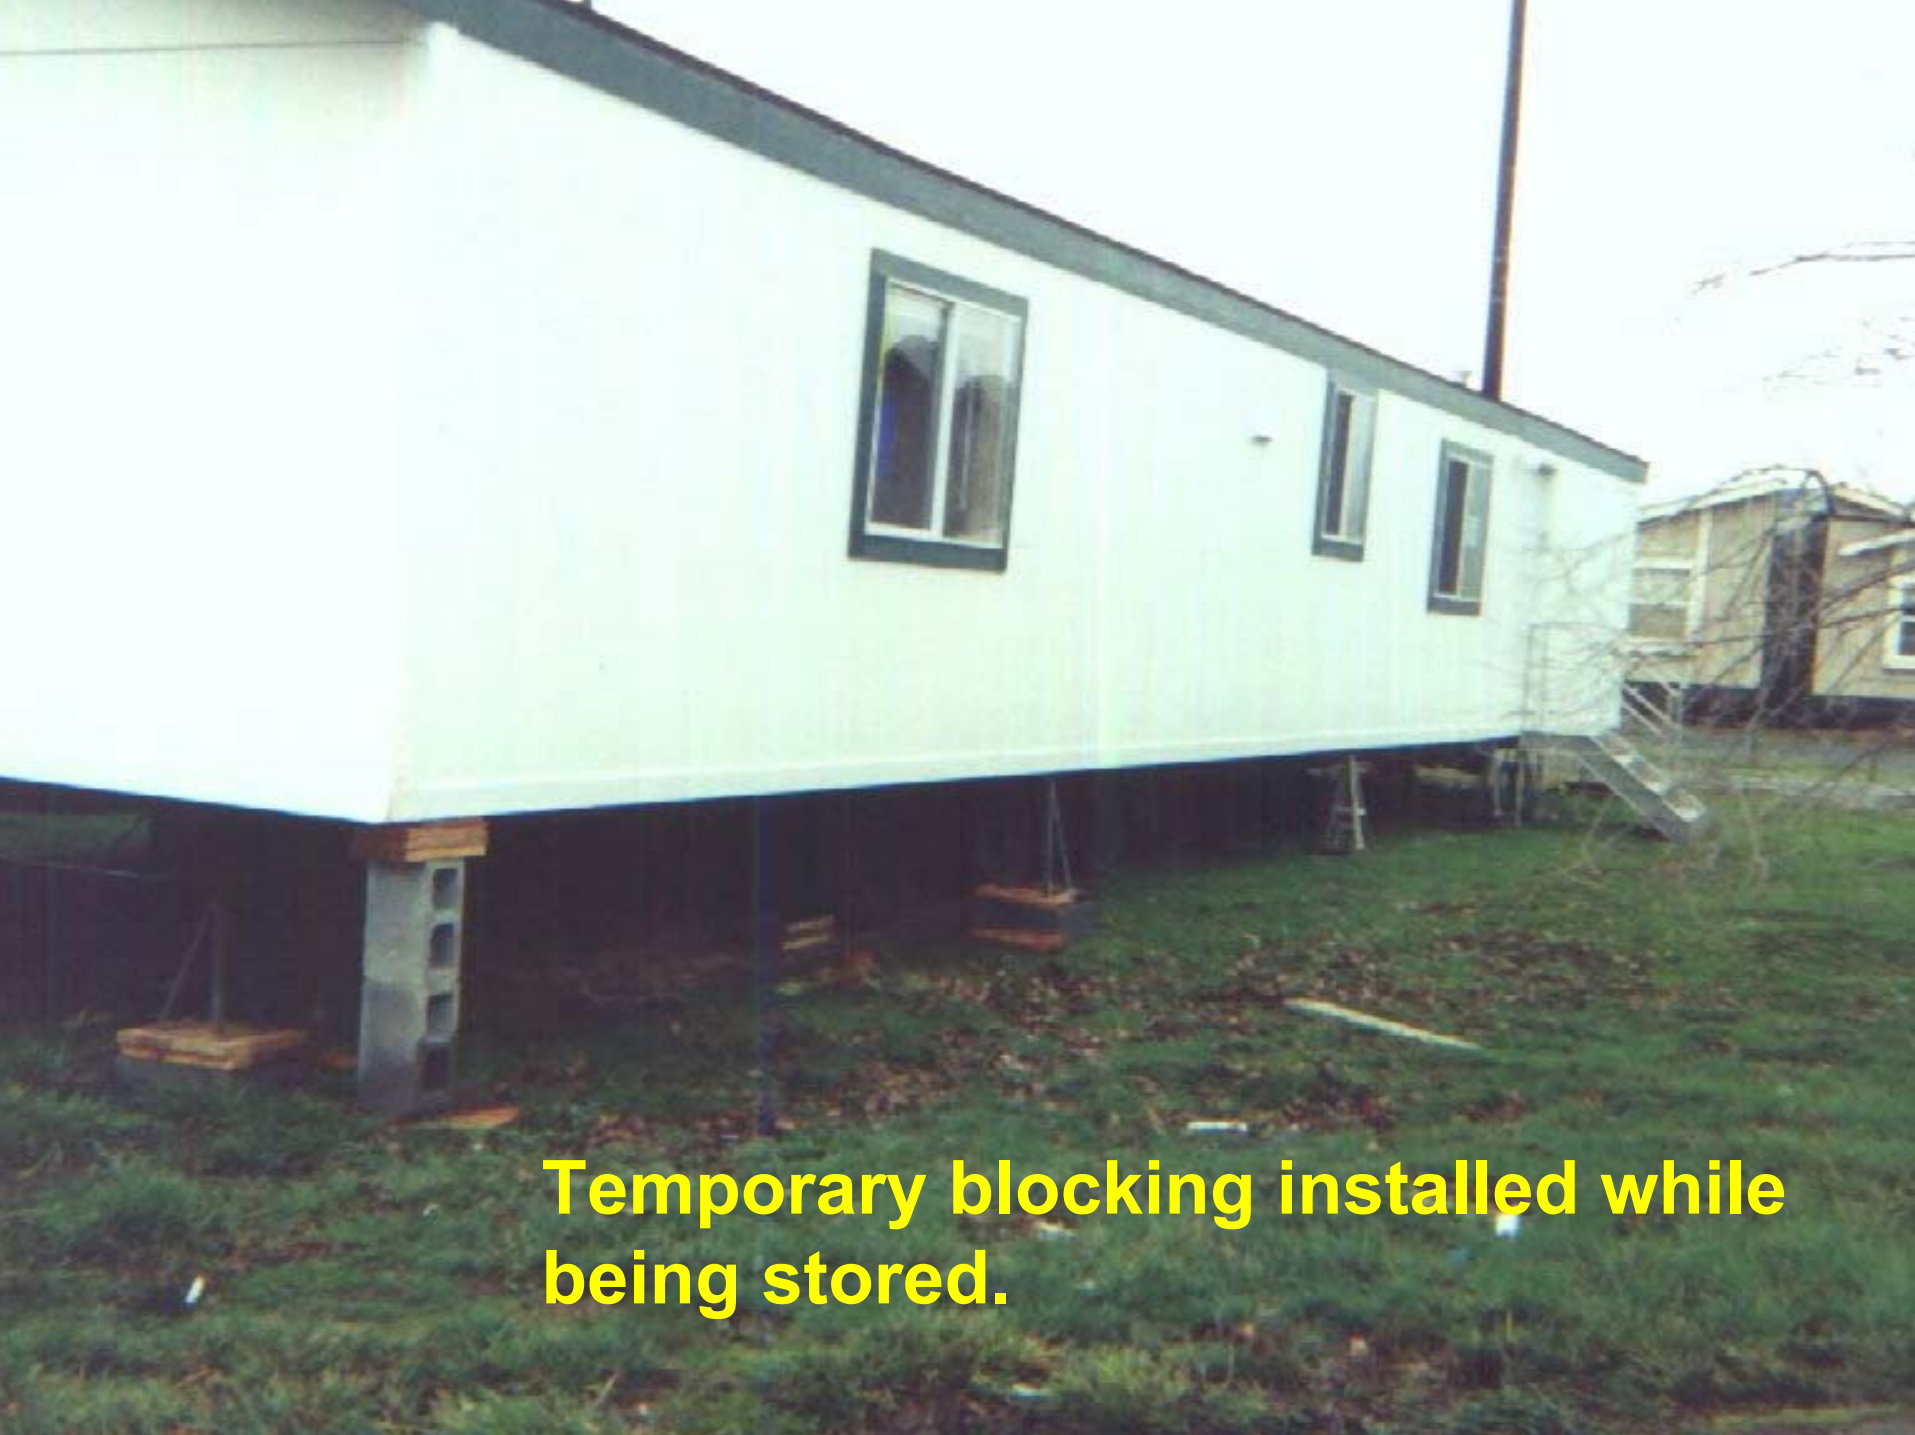
**Temporary blocking installed while being stored.**

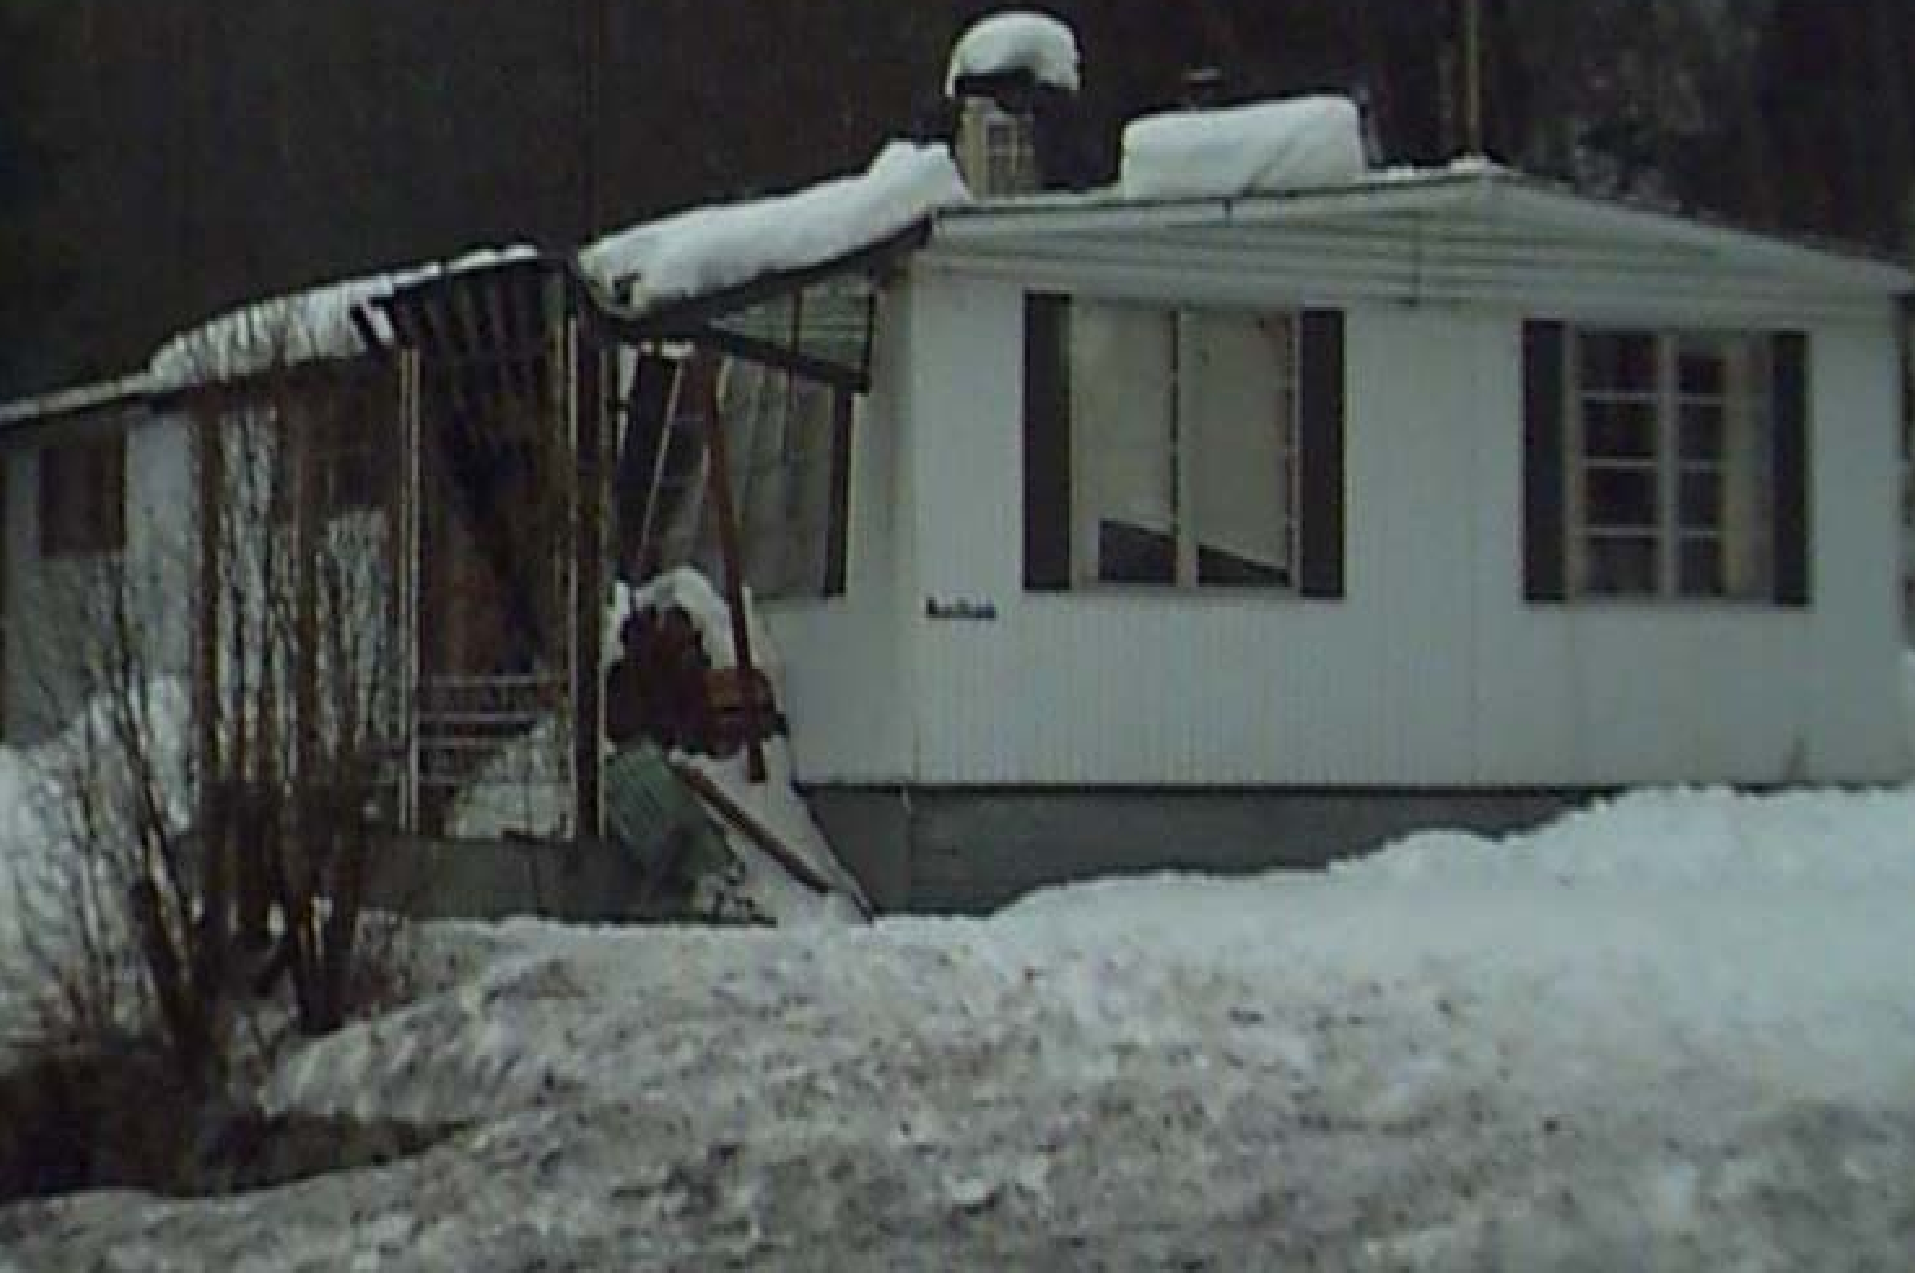
**Awning not built properly. Could not hold load.**

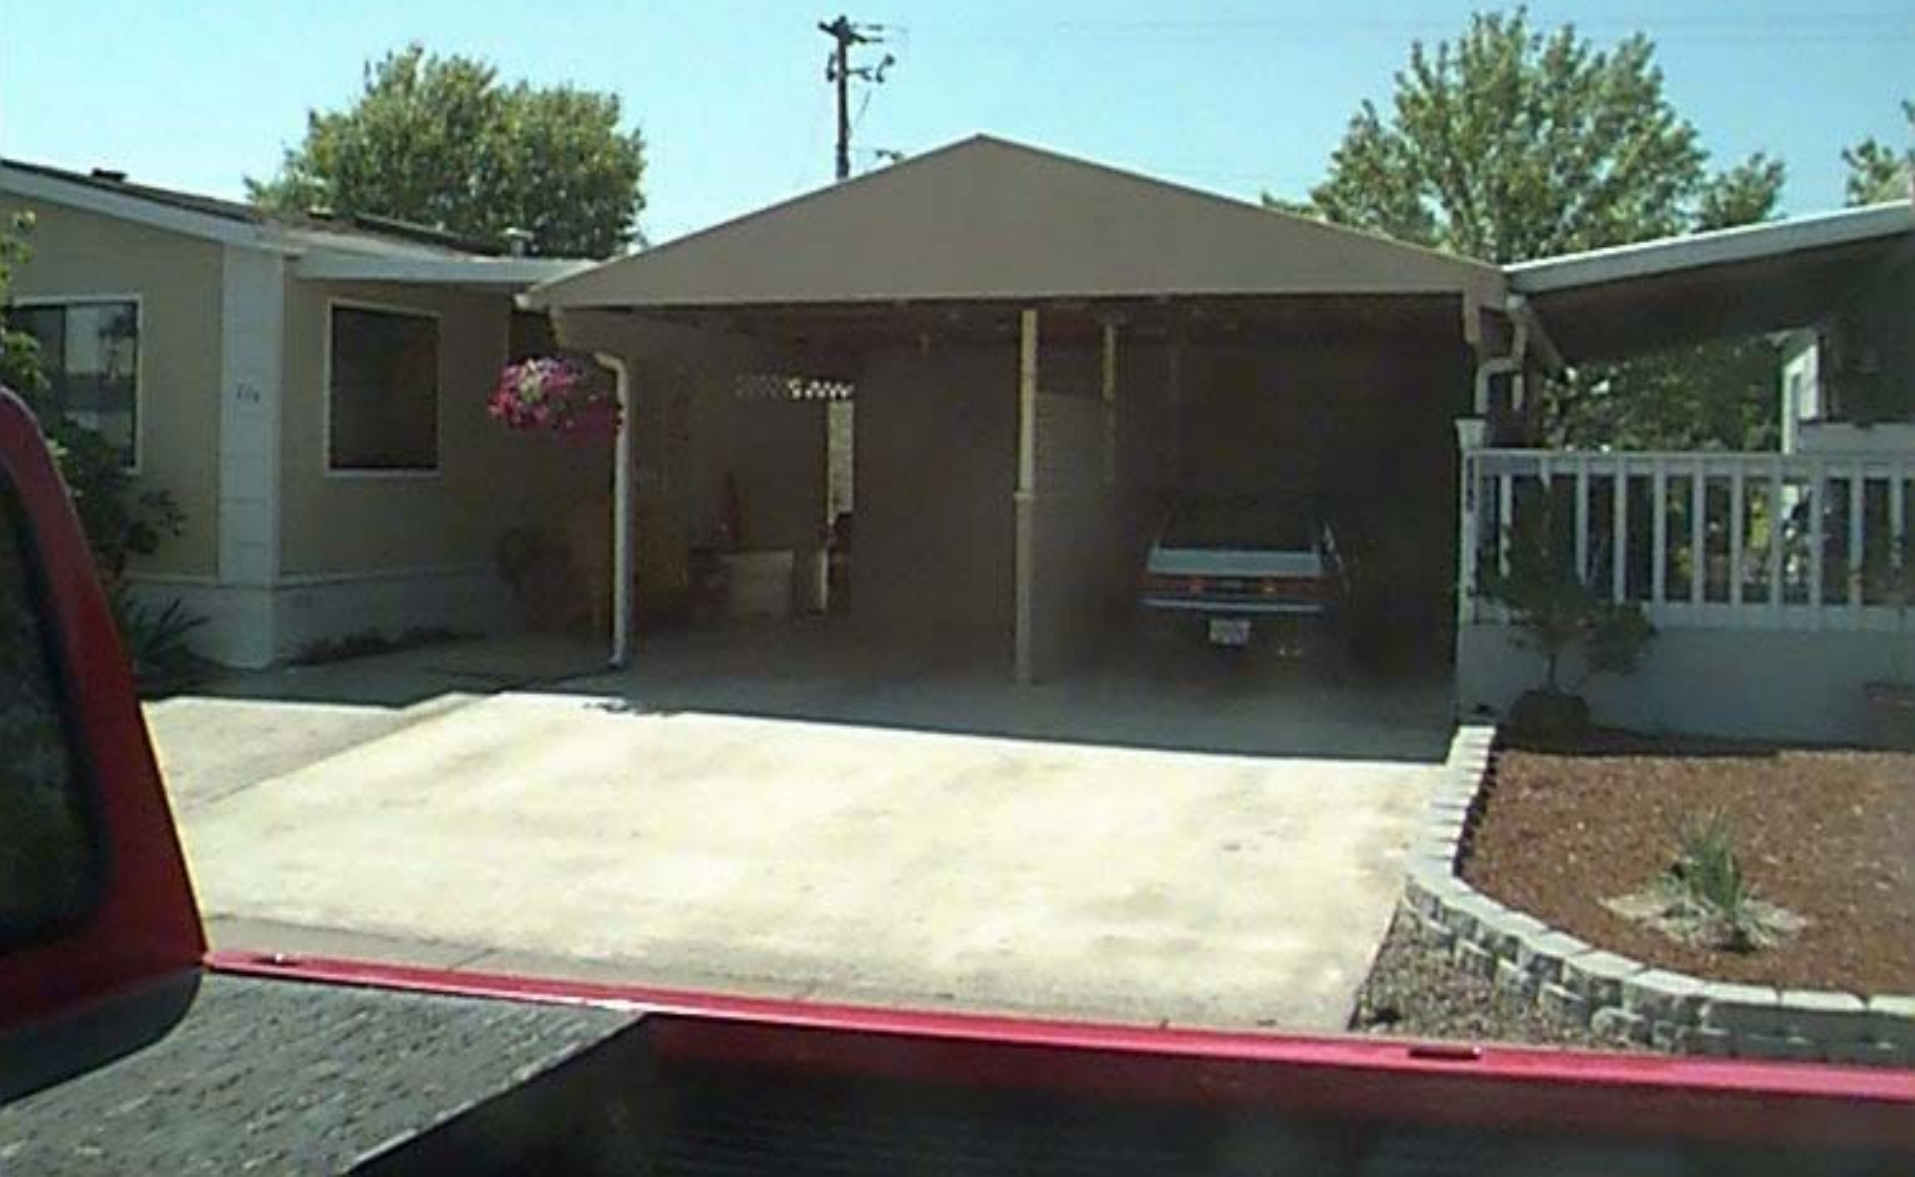
**Fire separation not present between structures on adjoining lots.**

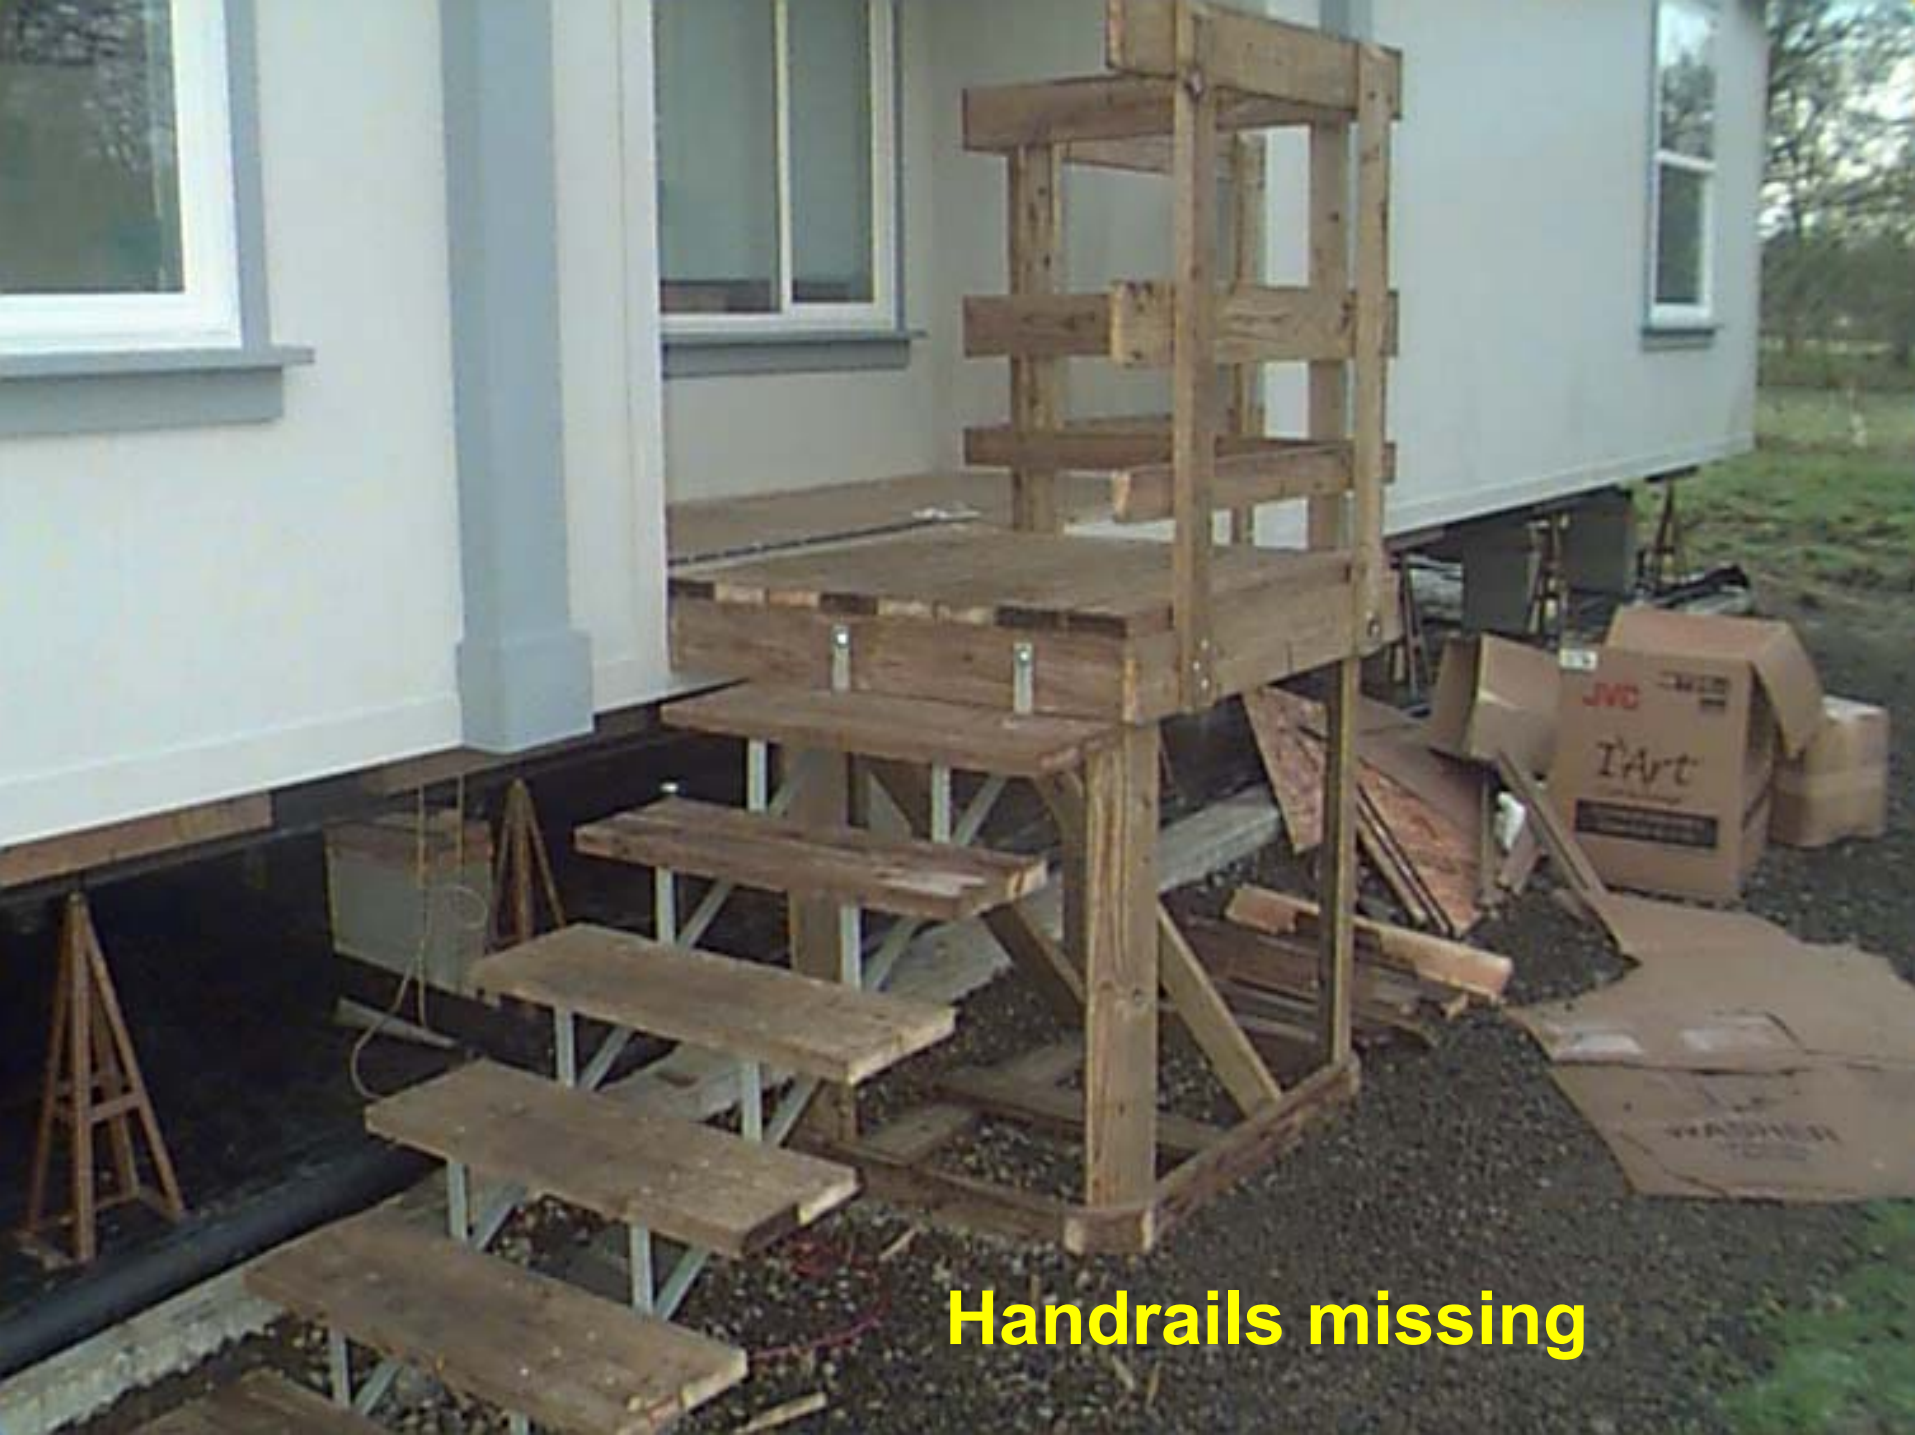
**Handrails missing**

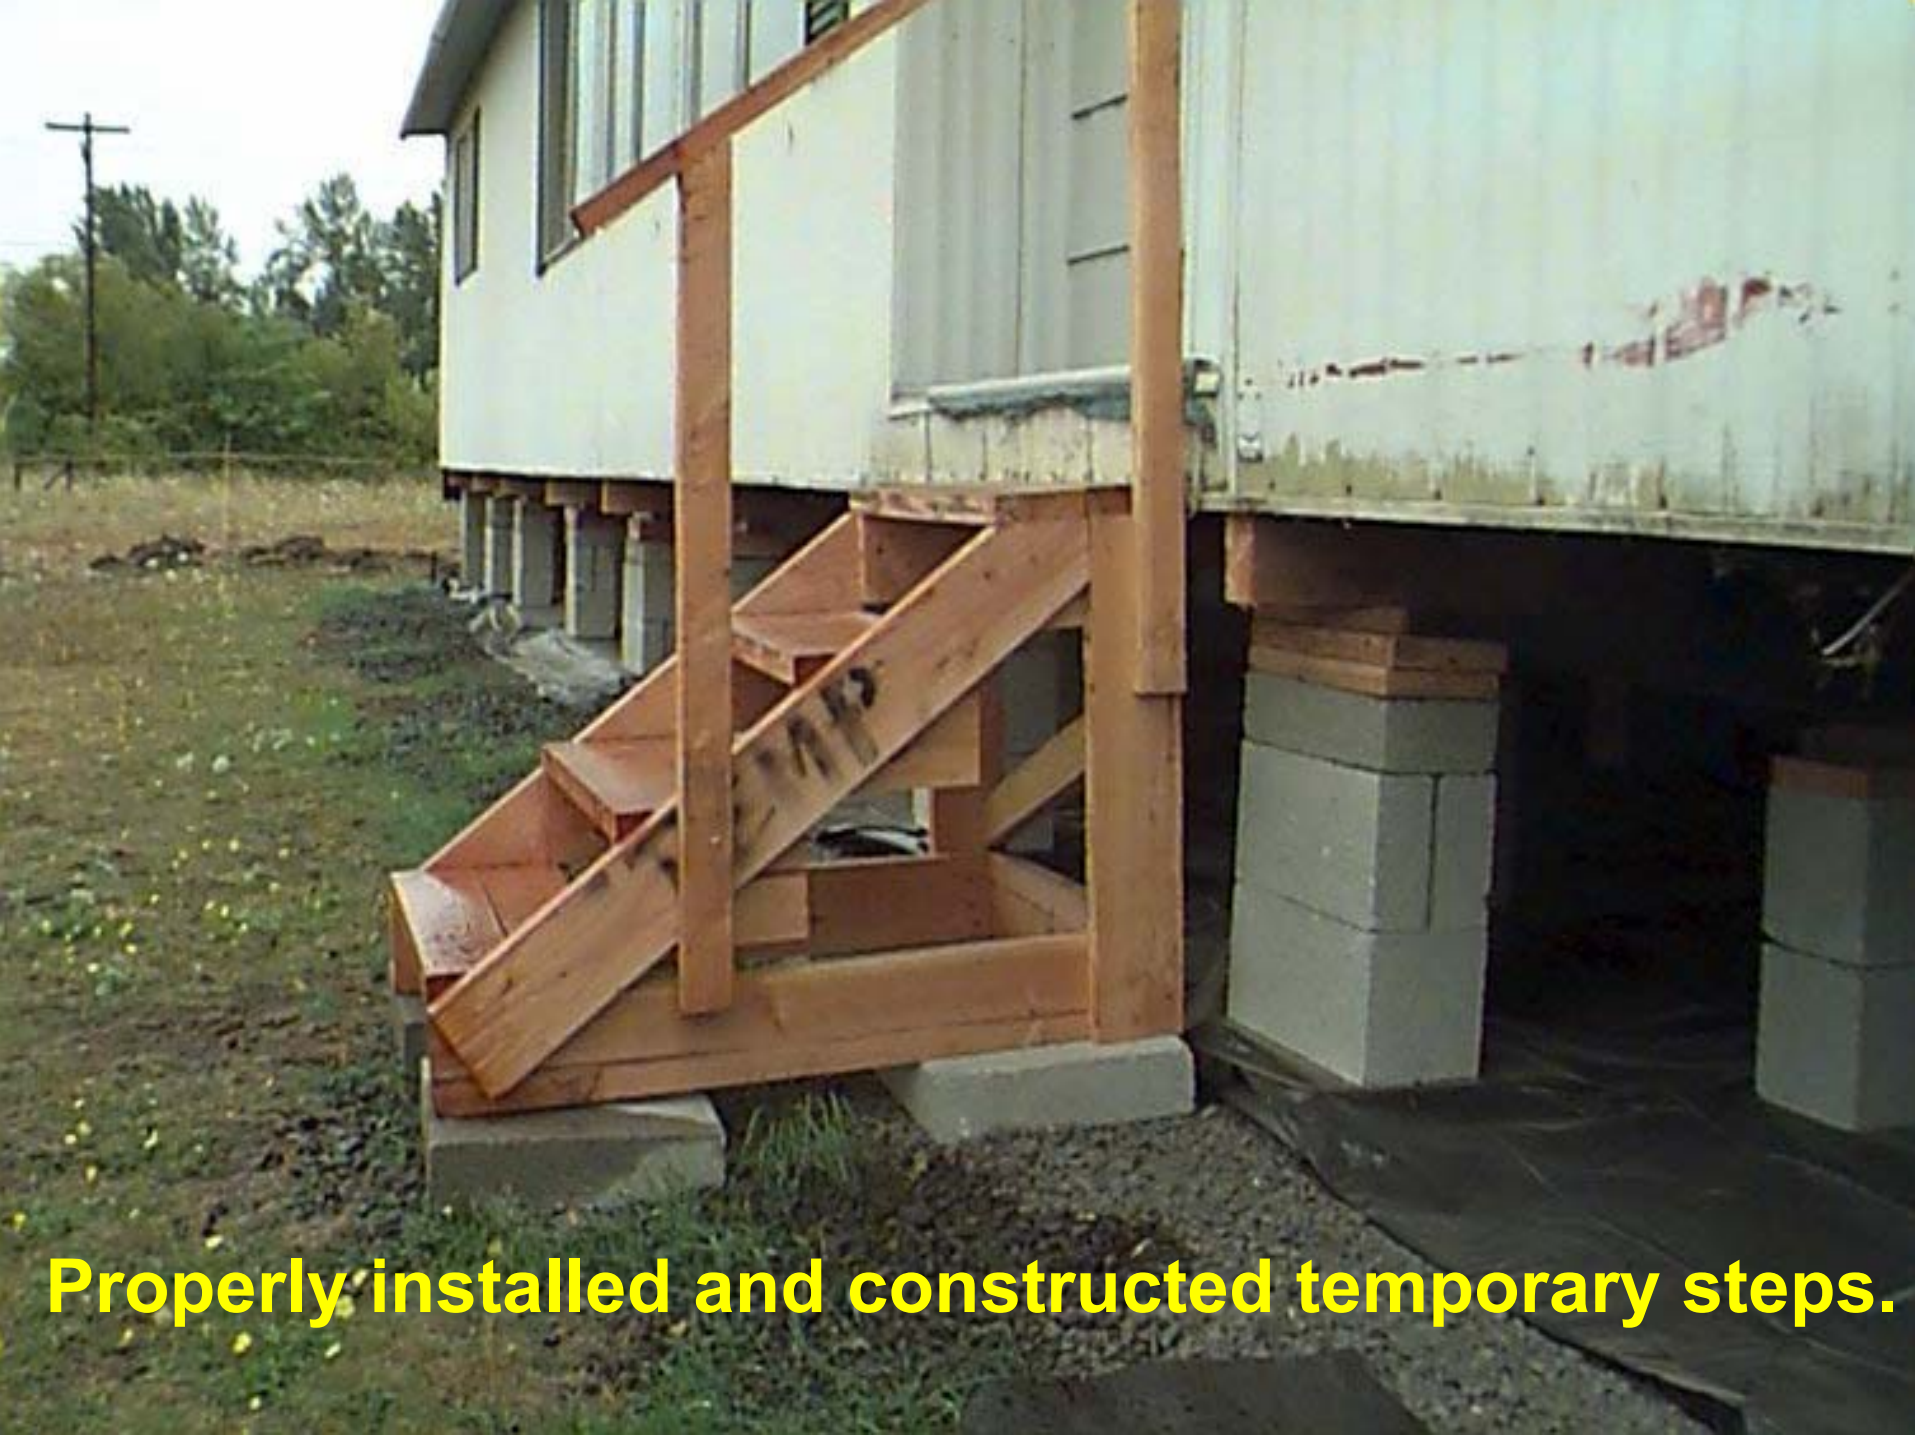
**Properly installed and constructed temporary steps.**

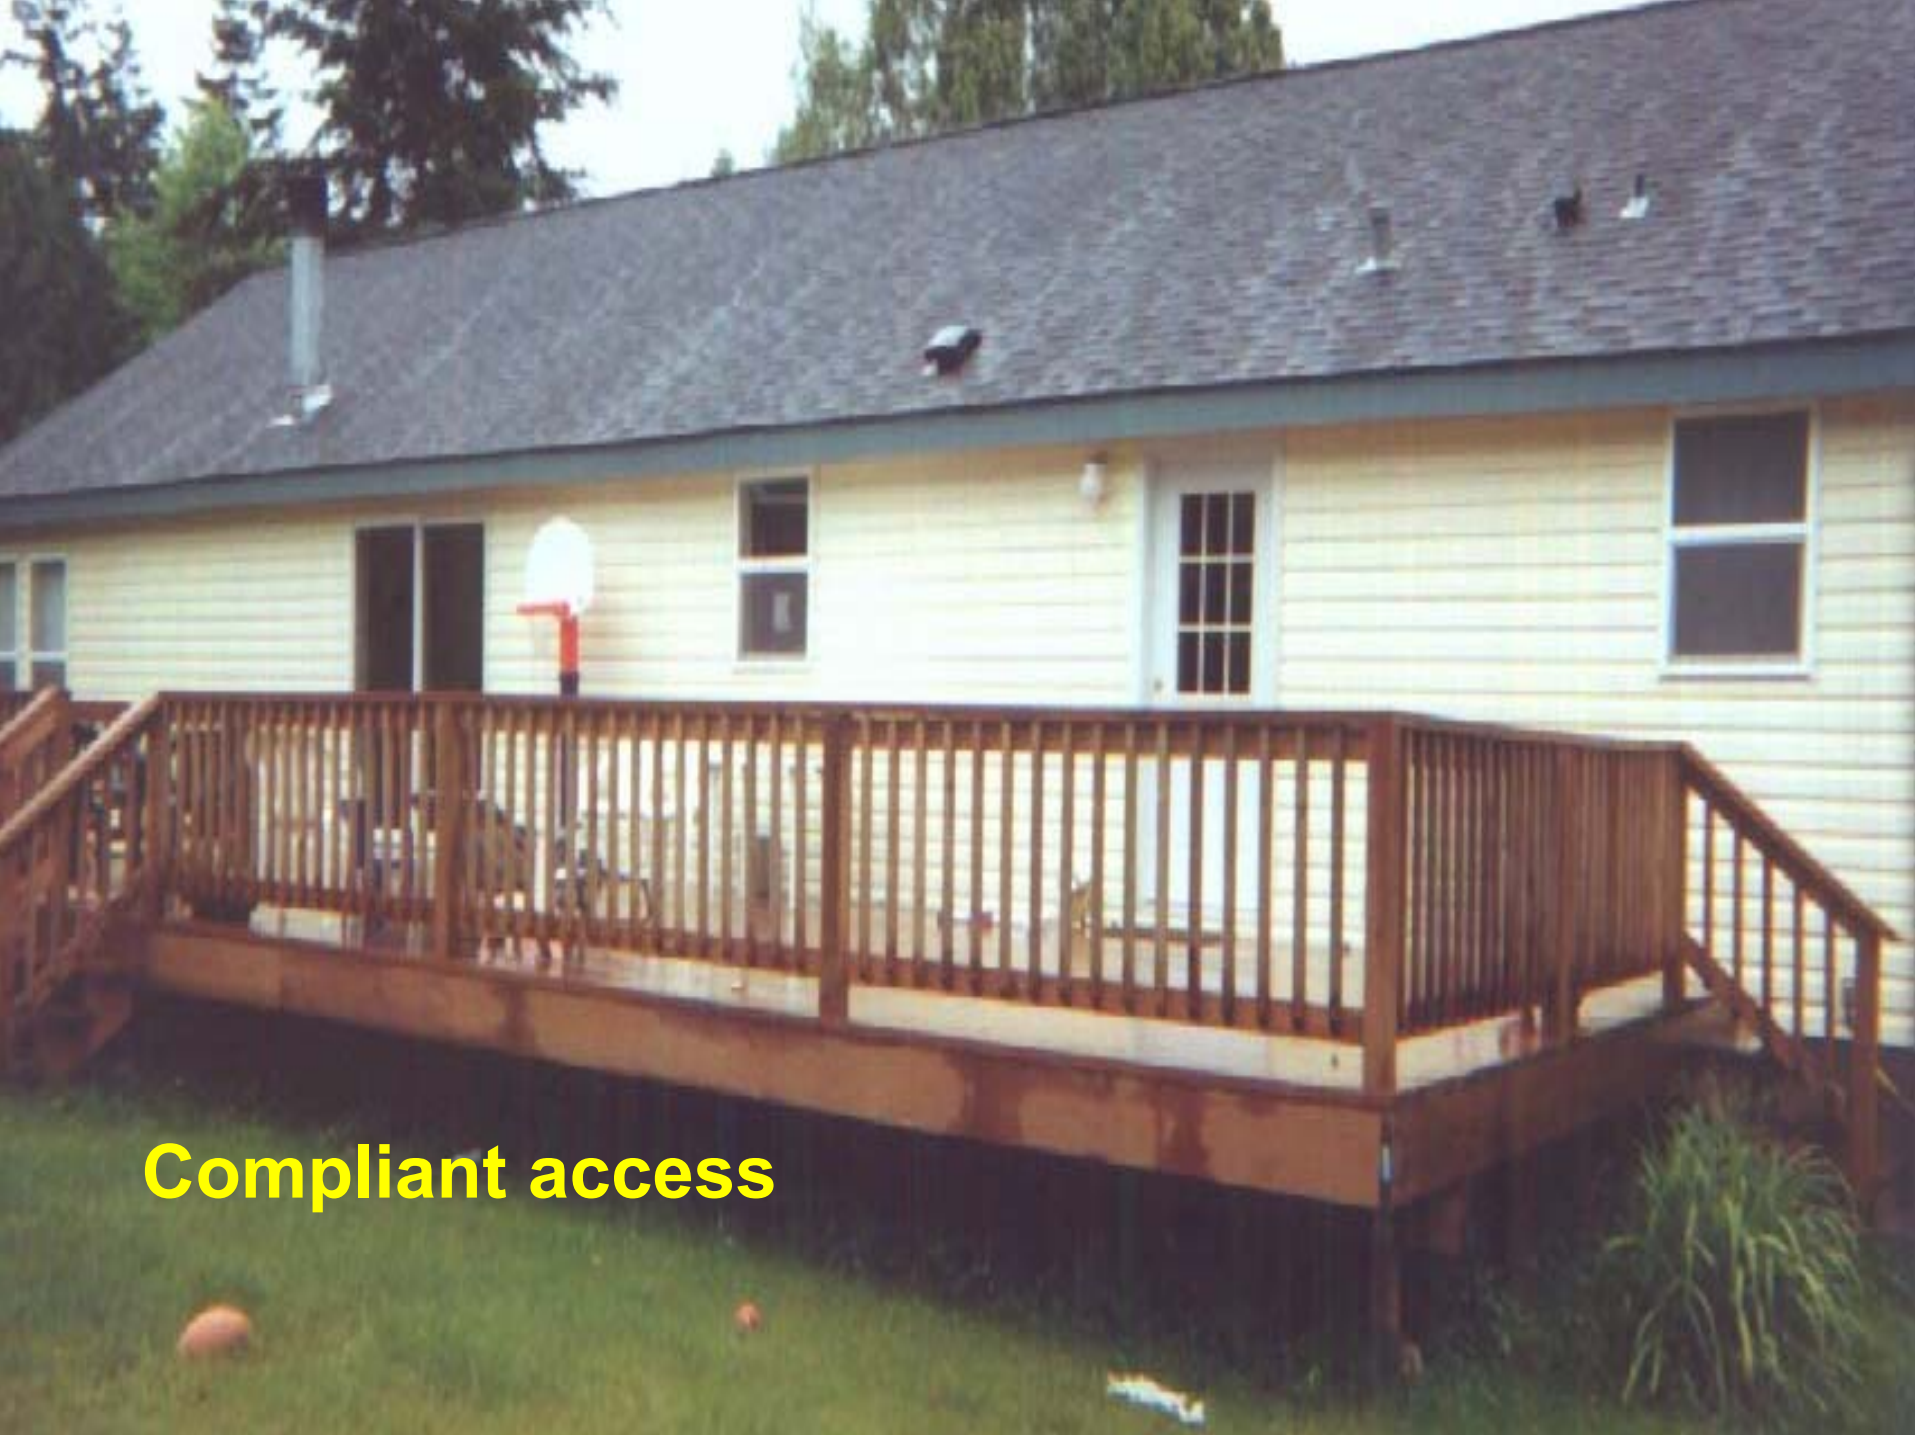
**Compliant access**
